# Americans with Disabilities Act (ADA) Self-Evaluation/Site Access Survey for the Town of Groton

Lost Lake Fire Station
Address: 185 Lost Lake Drive
Groton Fire Chief: Steele McCurdy
Tel: (978) 448-6333
Reviewed by the Commission on Accessibility
December 10, 2018

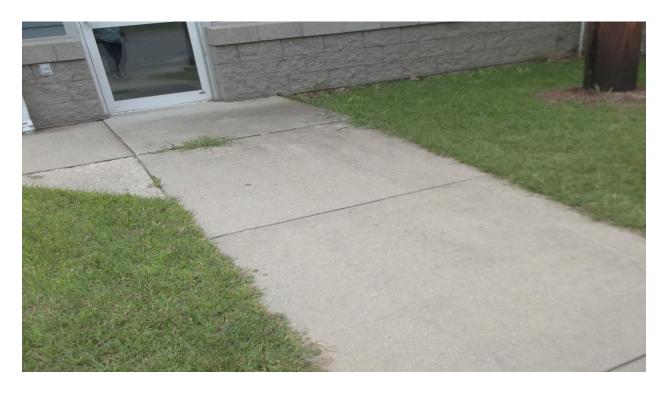
In the rear of the building at the parking lot area, The ADA team found that there are cracks and holes that have formed on the sidewalk that exceed ¾ inch. We recommend these be patched with fresh concrete

The ADA team found that there are cracks and weeds that have formed on the sidewalk that exceed ¾ inch. We recommend these be patched with fresh concrete with a suggested target date of December/2018.

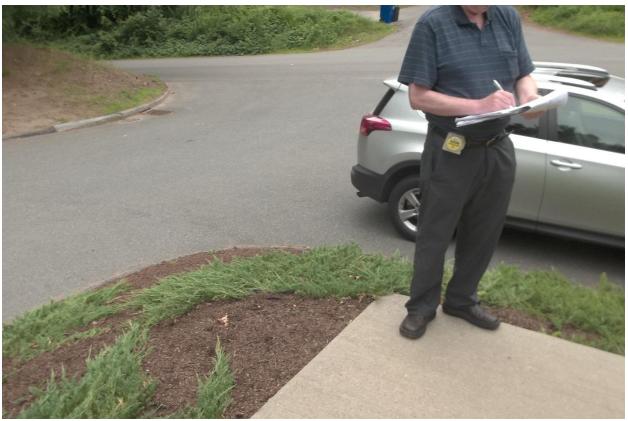
-Approach and Entrance: It is the team's opinion the walkway in front of the building needs railings, to improve safety, on both sides alleviating a potential falling risk. In other words, in order to achieve better accessibility and safety, we recommend that a safety railing be installed on the Fire Station walkway. This may help prevent visitors and staff from falling off onto the hilly area adjacent to the concrete walkway.

In order to achieve better accessibility and safety, we recommend that a protection railing be installed on the Fire Station walkway. This may help prevent visitors and staff from falling off the hilly area adjacent to the concrete walkway.

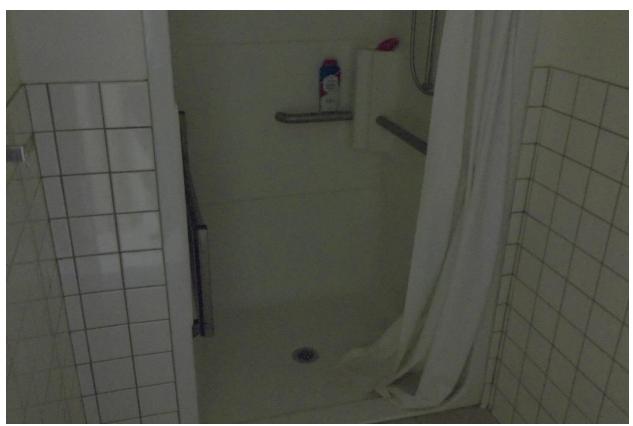
-Restrooms and showers: The team found that the Women's Room shower door was not mounted and needs to be re-installed for privacy as well as to accessibility at this wonderful wheel- in shower.

The team found that the Women's Room shower door was not mounted and needs to be re-installed for privacy as well as to accessibility at this wonderful wheel in shower.

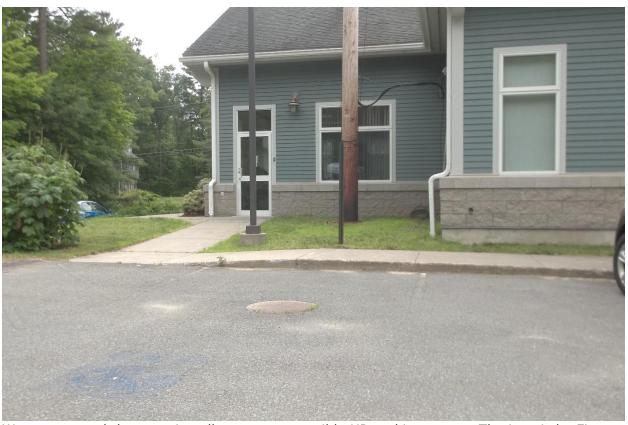
**-Accessible Parking**- Our finding at the site is that the accessible parking (HP) *sign is currently missing*. Because the sign had been broken off, there are presently no designated accessible ('HP') parking spaces provided at the site, and there are no 'Van accessible" spaces designated. The ADA Access Guidelines (ADAAG) require-that one space should be a "Van Accessible" space, 8-foot-wide with an 8-foot access aisle and van accessible sign.

Also, pertinent to note is the ADAAG, section 4.6.4, signage, that requires accessible parking spaces be designated as reserved by an above-ground sign showing the symbol of accessibility." Spaces shall have an additional sign 'Van Accessible' mounted below the symbol of accessibility". We recommend the town install one van -accessible HP parking spot. We have attached a photo (page 9) of the recommended parking spot that will be a corner van space. The best spot in my opinion, is where the old

sign had broken off (please see attached picture of the precise spot). The cost estimate for the sign is approximately \$205.00 (including all materials and labor needs), with a suggested target completion date of December 2018.

These signs need to be mounted 5 to 8 feet above the ground as per the ADAAG requirements. This is to help prevent mistakes being made when snow/ ice, sand etc. covers the signs painted on the ground. For these reasons, we recommend for the ADA Transition Plan, the sign be permanently installed at a height of minimum 5 feet above the ground.

The crosswalk, as well as Accessible Parking space ground markings have become worn out and unreadable due to the effects of weather and wear and tear. This is described in the Massachusetts **AAB**, **Section 23.3.1 location**, "Accessible parking spaces serving a building shall be located on the shortest accessible route of travel to an accessible entrance."

We recommend the town install one van accessible HP parking spot at The Lost Lake Fire Station. The ADA Access Guidelines (ADAAG) require-that one space should be a "Van Accessible" space, 8-foot-wide with an 8-foot access aisle and van accessible sign.

The parking area also needs to have the HP parking area access aisles, etc. re painted, as required in the Massachusetts **AAB**, **in Section23.4.6 (a)** Access aisles. "Parking access aisles shall be part of an access route to the building." This is required, also, as per, Mass AAB regulations, 521 CMR; Section 2.6, Maintenance of Accessible Features, "At all times, accessibility features must be maintained and fully operational. (i.e., access aisles shall kept clear at all times, mechanical devices are kept in operating condition, etc.)."

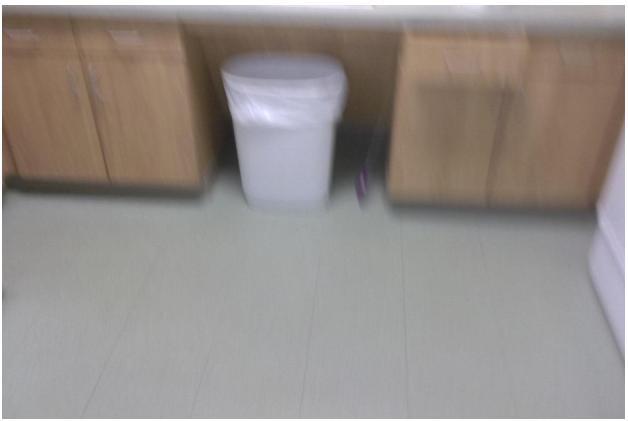
- **-Kitchen:** The team determined that the trash bin in front of the accessible sink needs to be relocated to allow for accessibility to that sink. Otherwise, we found that the kitchen is currently ADA accessible, including a nice accessible sink, refrigerator, and counters that have already been lowered to The ADA specifications. Additionally, the stove has control knobs provided in front of the unit thereby making it accessible also. Kudos to the Town once again for ensuring this high level of ADA compliance at The Fire Station.

The Team noted that the kitchen counters, stove, as well as sinks provided are all in compliance with the ADA. We suggested that the trash barrel pictured above be relocated to make room for people using a wheelchair to be able to use the sink with ease.
