Groton Country Club
ADA Transition Plan

**Americans with Disabilities Act (ADA)
Self-Evaluation/Site Access Survey for the Town of Groton**

**Groton Country Club
Address: 94 Lovers Lane
General Manager Shawn Campbell
978-448-3996
Reviewed by the Commission on Accessibility
December 10, 2018**

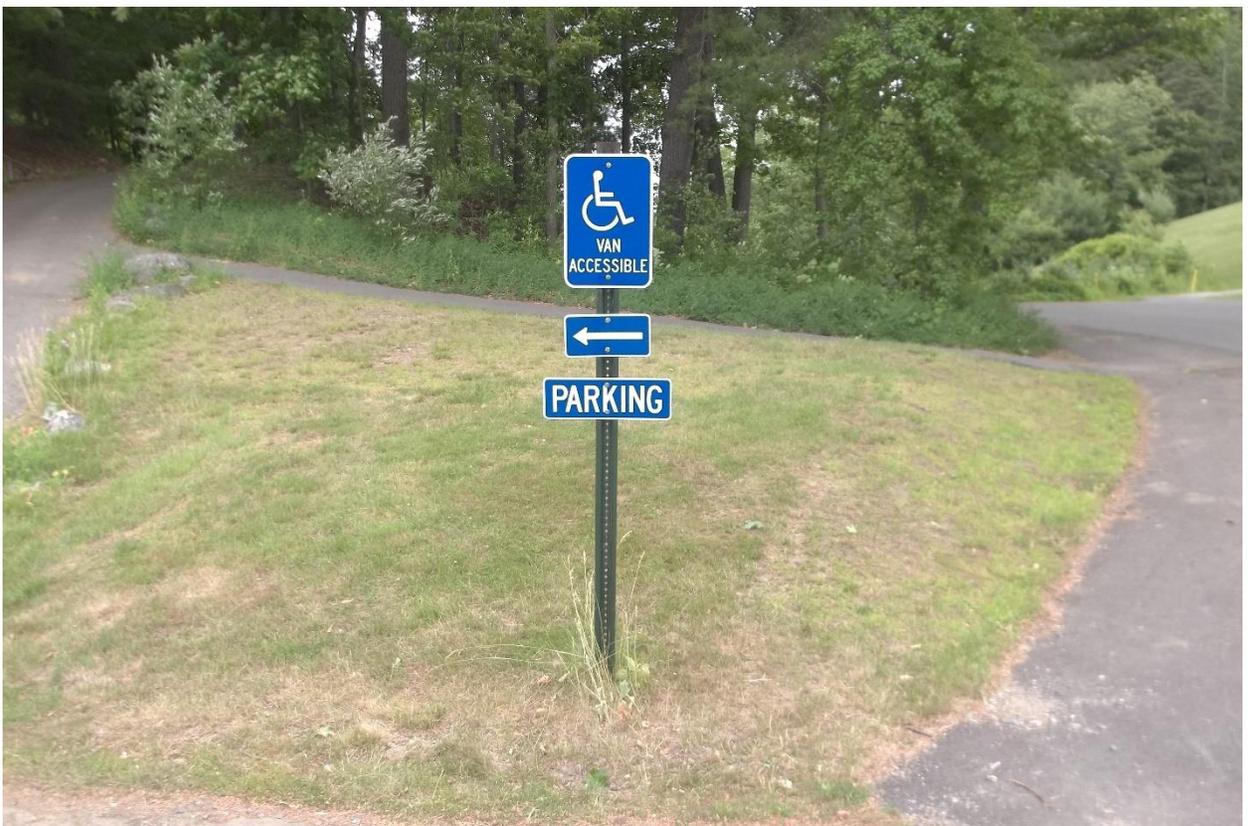
Curbs Cuts: The ADA team also noted that there is no curb cut on the sidewalk near the HP accessible parking spaces on the golf course side of the function hall. We recommend a curb cut be installed at this location allowing for an accessible path from the accessible parking to the entrance.

The ADA team found that there is no curb cut on the sidewalk near the HP accessible parking spaces on the golf course side of the function hall. We recommend that curb cuts be installed at this location allowing for a fully accessible path from the accessible parking to the entrance.

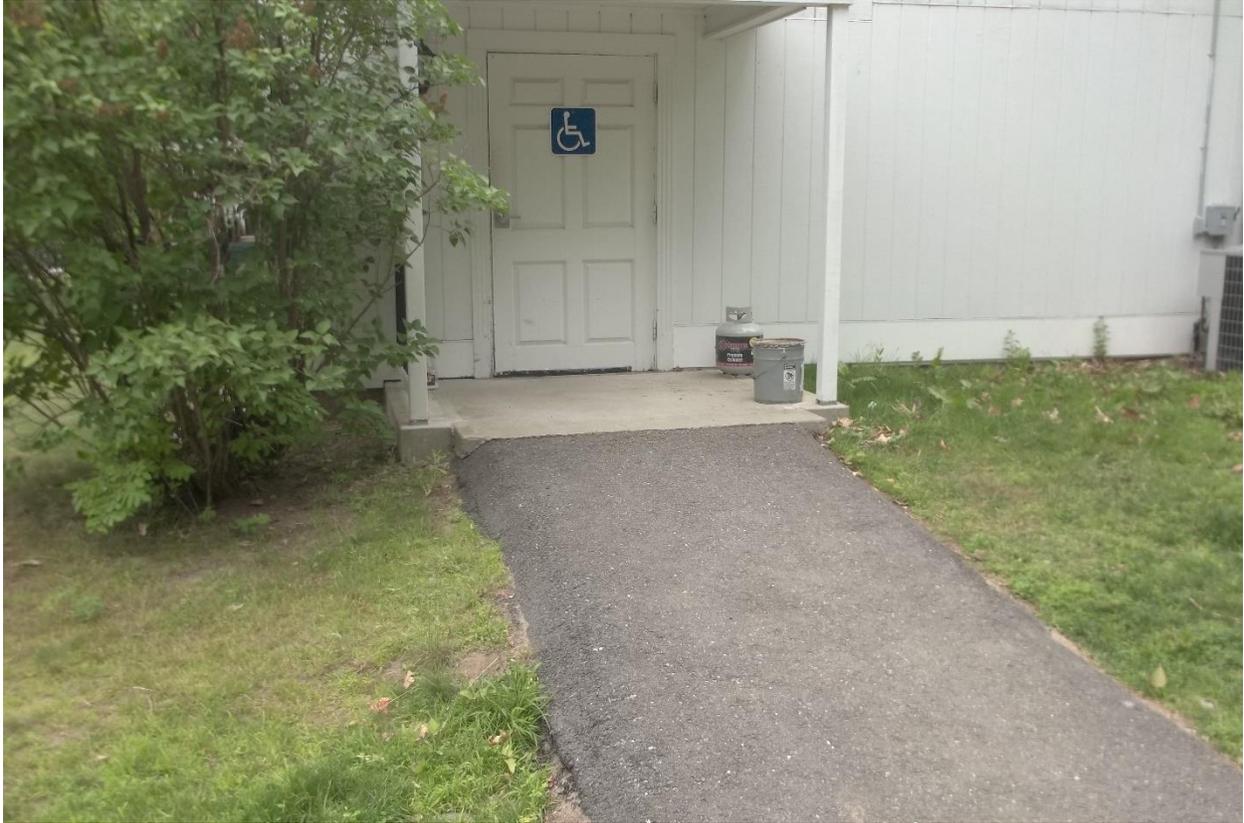
Entrances: The ADA team found that the slope of the walkway to the accessible entrance is too steep at this time (photo on page 10). We recommend the installation of handrails on both sides to achieve fuller ADA compliance and increase safety. We found that there is $\frac{3}{4}$ inch crack on this concrete surface of the accessible entrance to the function hall. We recommend that the crack be filled in and repaired as recommended by Massachusetts AAB, section 2.6, "accessible features must be kept maintained at all times."

The ADA team found that the slope of the walkway to the accessible entrance is too steep. We recommend the installation of handrails on both sides to achieve fuller ADA compliance and increase safety. We found that there is $\frac{3}{4}$ inch crack on the sidewalk surface of the accessible entrance of the function hall. We recommend that the crack be filled in and repaired as recommended by Massachusetts AAB, section 2.6, "accessible features must be kept maintained at all times."

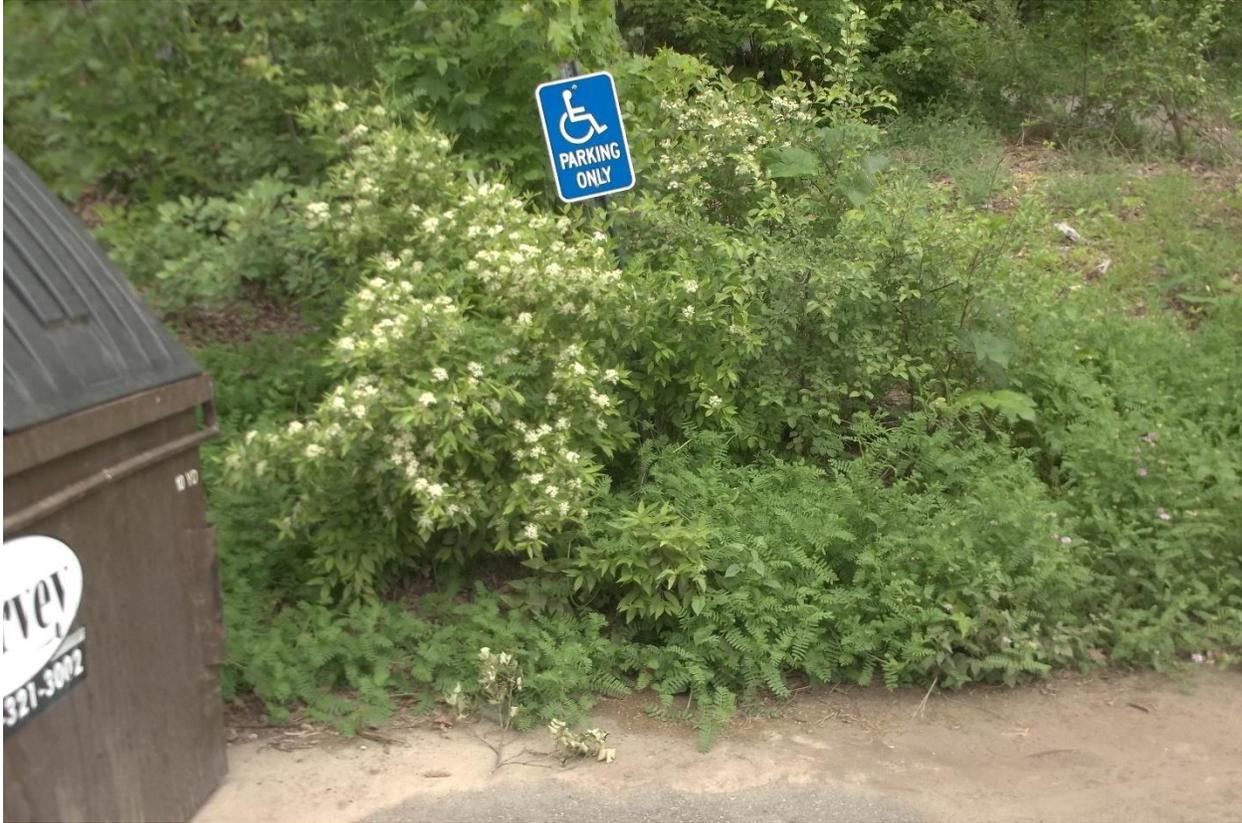
Accessible Parking: The ADA team found that there is a dumpster currently blocking the designated HP accessible parking space near the accessible entrance. We recommend the dumpster be relocated to allow for the accessibility of that parking space. We found that there is not a designated "Van Accessible" parking space at this location. We recommend that a "Van Accessible" sign be purchased and mounted where the current accessible HP parking space is located.

There is a dumpster currently blocking the designated HP accessible parking space that is located at the accessible entrance. We recommend the dumpster be relocated to allow for the accessibility of that parking space. There is not a designated "Van Accessible" parking space at Groton Country Club. We recommend that a "Van Accessible" sign be purchased and mounted where the current accessible HP parking space is located.

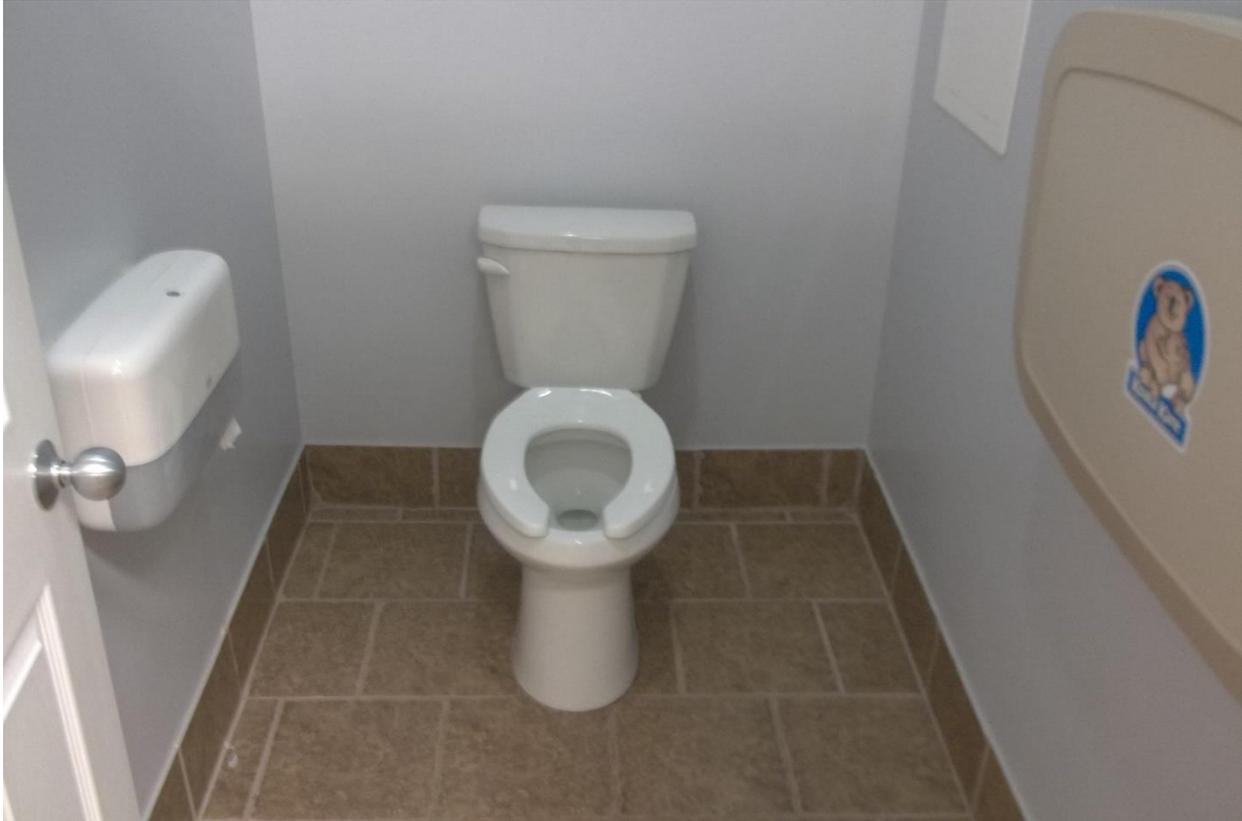
We also found there are no ADA accessible toilets in either restroom with the height of each seat ranging from 17 – 19 inches above the ground. We recommend removing one toilet in

each restroom and replacing it with an accessible toilet as per ADA 2010 Standards Priority 3 -Toilet Rooms, as well as Section 603.4.

There are no ADA accessible toilets in either restroom with the height of each seat ranging from 17 – 19 inches above the ground. We recommend removing one toilet in each restroom and replacing it with an accessible toilet as per ADA 2010 Standards Priority 3 - Toilet Rooms, as well as Section 603.4.

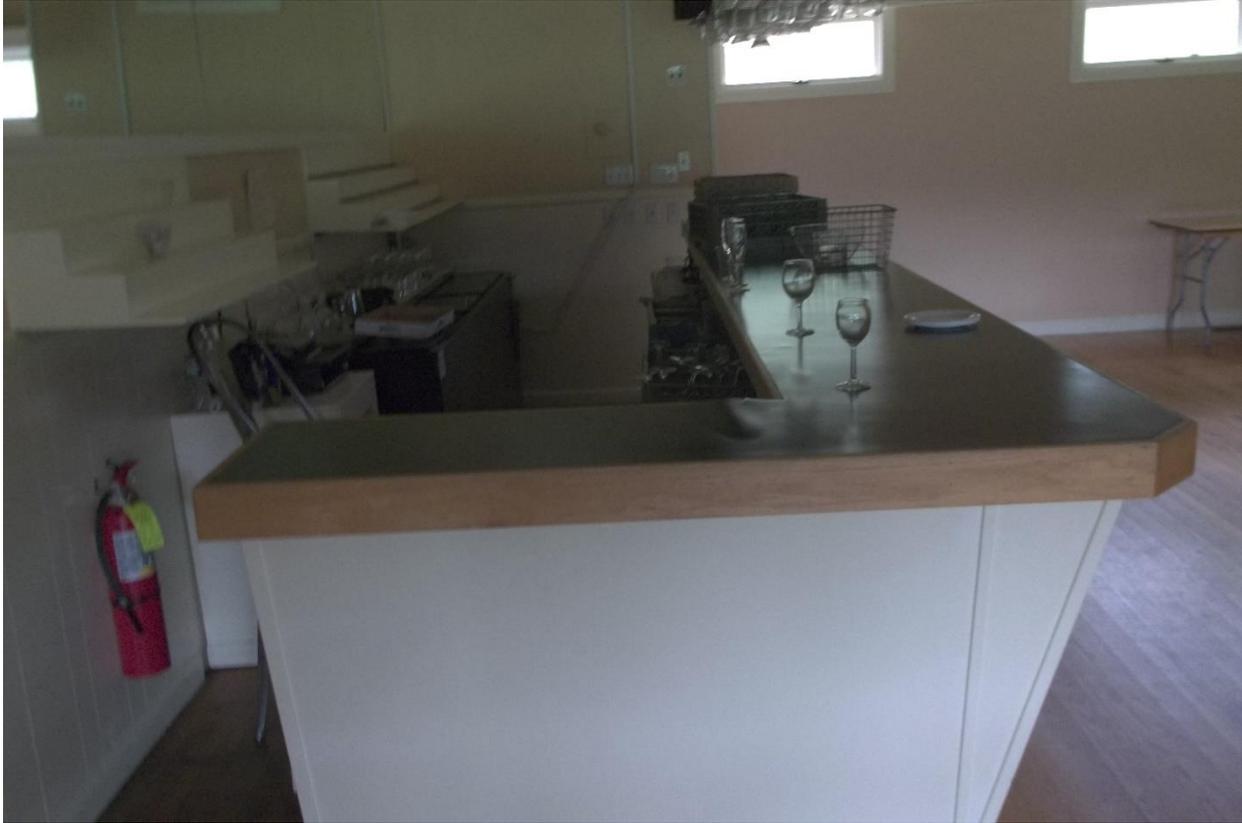
Bar/Function Hall: The ADA team found that there is not an accessible portion of the bar located in the function hall. We recommend a 3 foot accessible section be added to the bar as recommended by the ADA 2010 Standards Section 904.4 " There shall be clear floor space of 36 inches wide x 48 inches long for a forward and parallel approach to the bar."

The ADA team found that there is not an accessible section of the bar located in the function hall. We recommend a 3 foot accessible section be installed at the bar as recommended by the ADA 2010 Standards Section 904.4 " There shall be clear floor space of 36 inches wide x 48 inches long for a forward and parallel approach to the bar."

According to The Disability Rights and Education defense Fund (DREDF): "If the bar exceeds 34 inches in height, a 60-inch long portion of the counter must be lowered, where it is readily achievable, to between 28 and 34 inches from the floor to the top of the bar with knee space at least 27 inches high, 30 inches wide, and 19 inches deep, for customers who use wheelchairs."
