On Site Existing Conditions Assessment

Building Envelope Sciences

Photo 1 – Overall view of the Groton Public Library from the Main Street entrance. The yellow line indicates the approximate limits of the original 1893 structure and the 1999 addition.

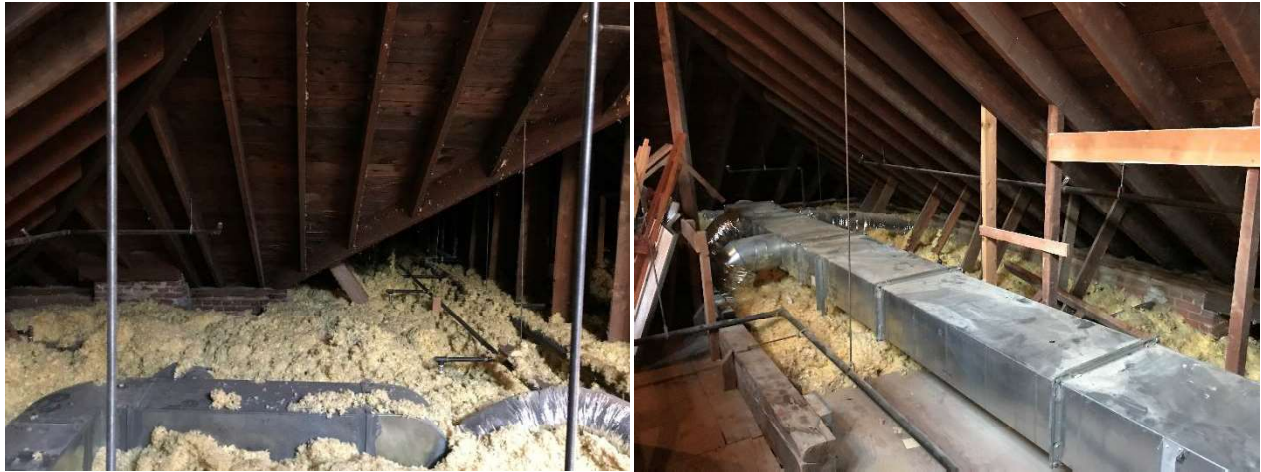
Photo 2 – Partial view of the underside of steep-slope, slate shingle roof system. The roof is composed of 1x9 tongue and groove deck boards on 2x9 rafters at approximately 2'-0" on center. Renovation design documents indicated that new R-38 fiberglass batt insulation was to be installed throughout the existing attic. Approximately 1'-0" of batt insulation was observed, unevenly distributed throughout original attic area. Also note that uninsulated ductwork for the building HVAC system has been located above the ceiling insulation.

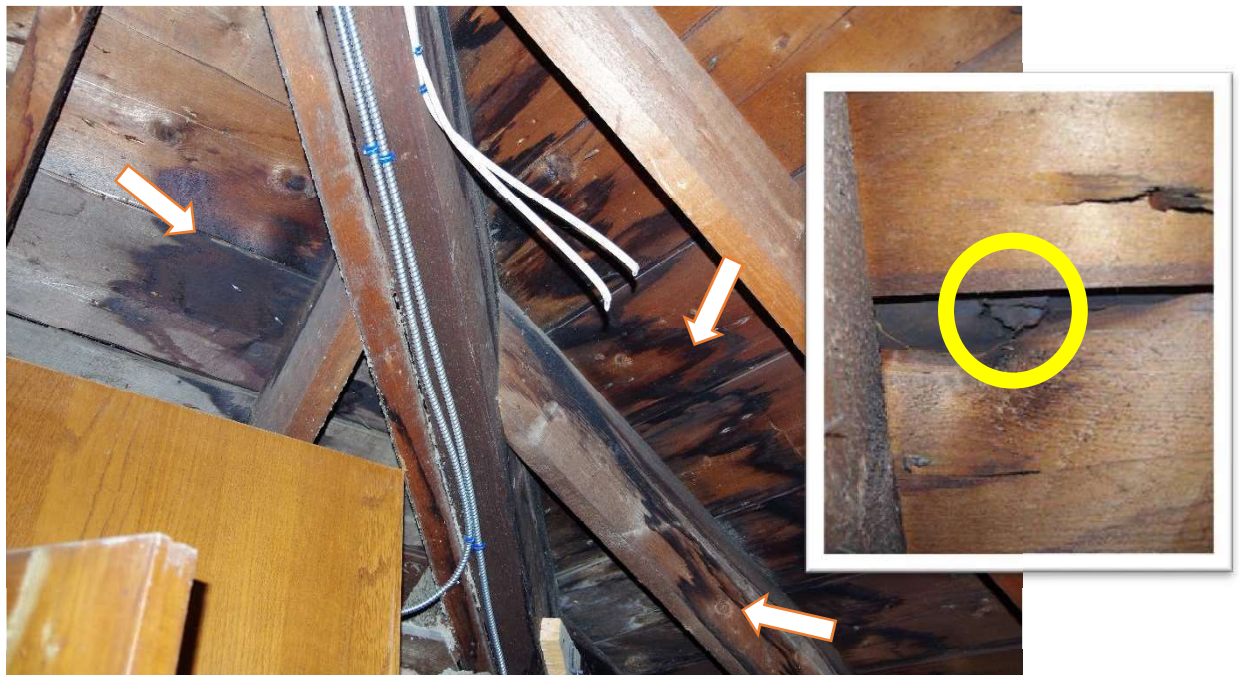
Photo 3 – Partial view of the underside of steep-slope, slate shingle roof system at the 1893 Library Building. Arrows indicate water staining that is typical throughout the underside the roof deck and rafters; however, it could not be determined if the staining is from previous or active leaks. Damaged tongue and groove roof planks were observed in isolated areas. The circle indicates a punctured roofing underlayment observed at damaged roof plank location.

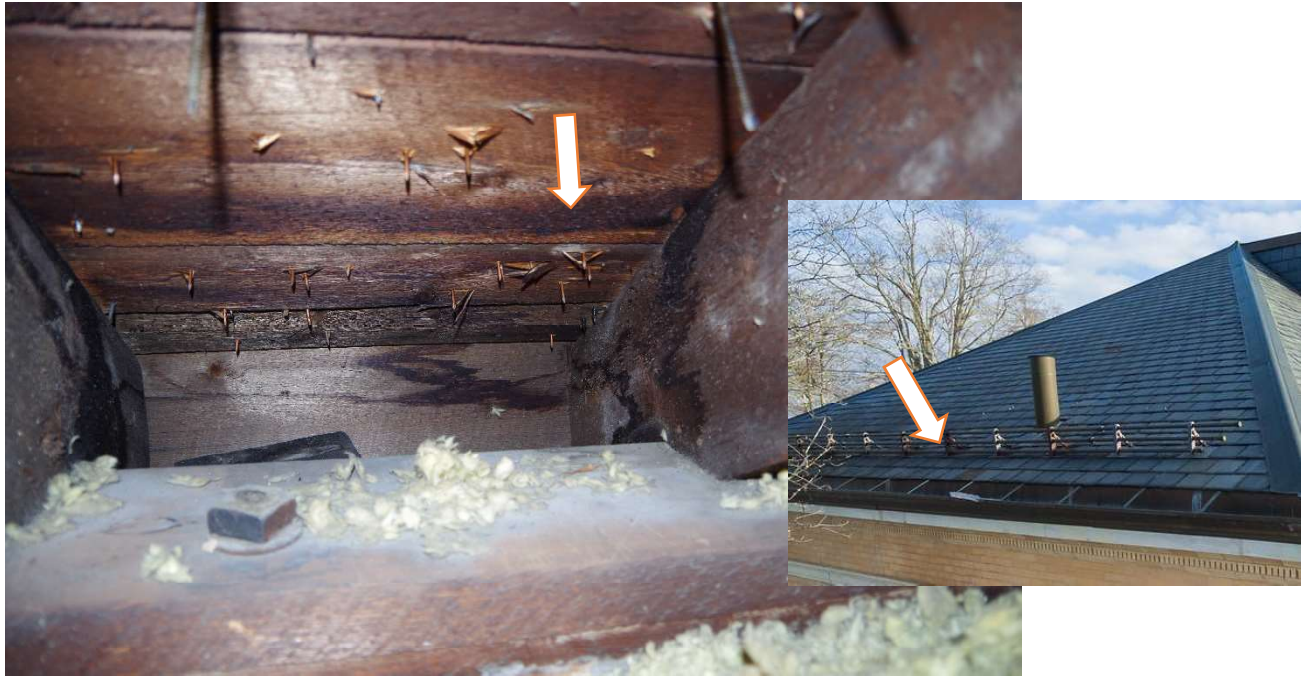
Photo 4 – Partial view of the eave condition at steep-slope slate roofing system on the north side of the 1893 Library Building below the snow rails mounted to the wood deck installed with the 1999 building addition. Water staining was observed at the fascia board, rafters, and plank decking. GRLA could not verify if the staining is from previous or active leaks.

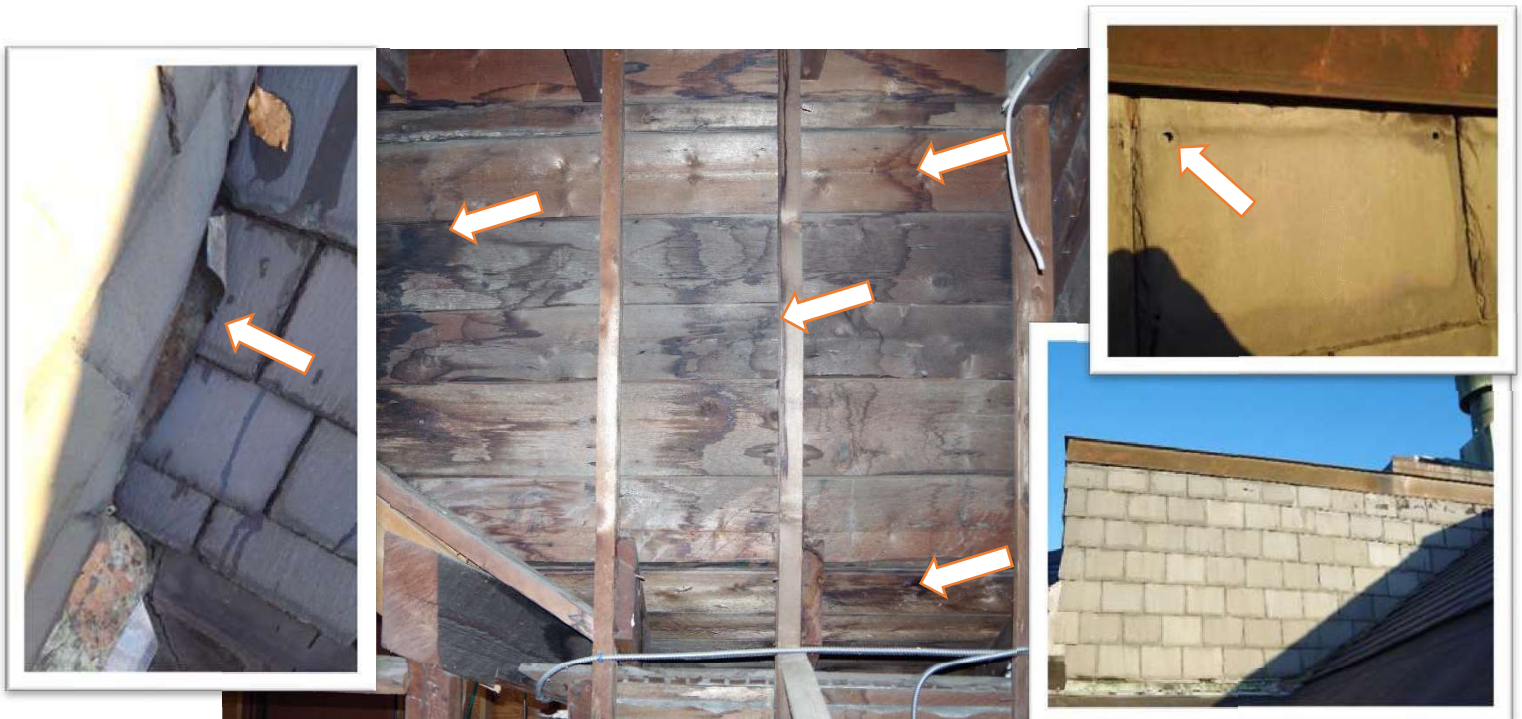
Photo 5 – Moisture staining observed on interior wood roof sheathing behind steep slope slate roofing and below low slope flat seam copper roof (lower right photo) at the 1893 building. Deteriorated sheet metal flashing was observed at the closed valley in this area (left photo). Flashing at the top of the slate shingled wall does not appear to conceal holes in the slate shingles from previously installed fasteners (top right photo). GRLA could not verify if the staining is from previous or active leaks.

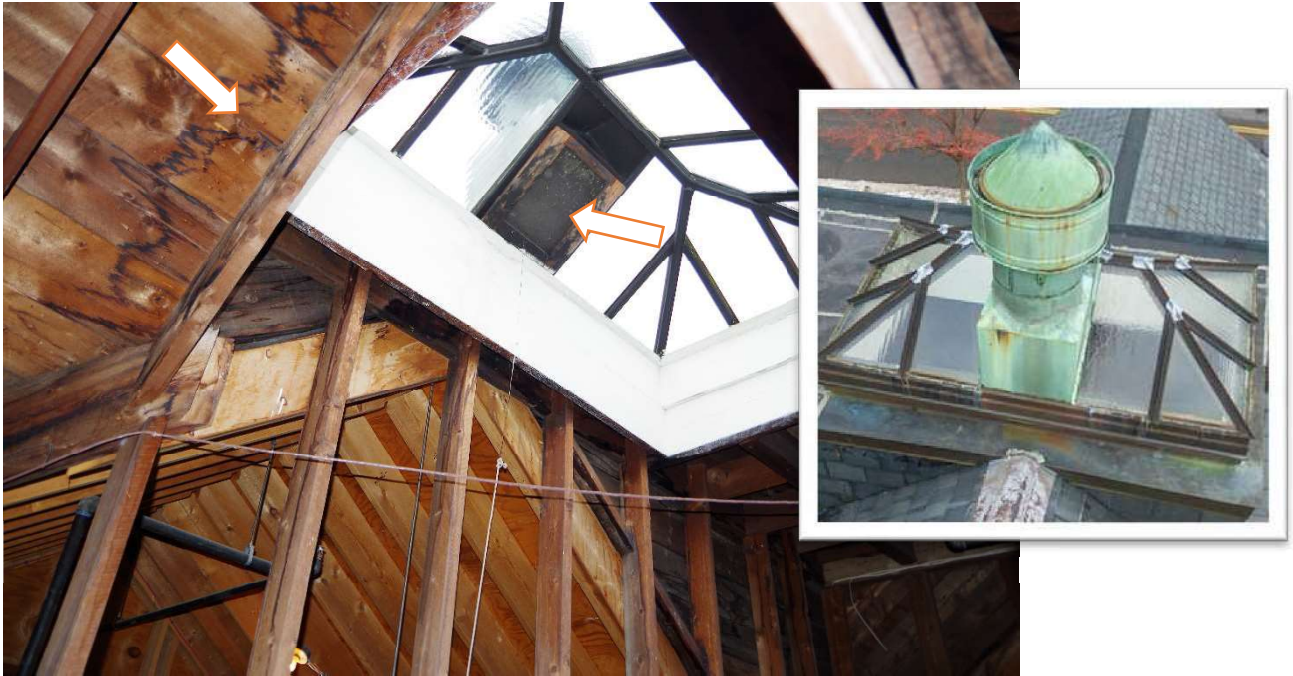
Photo 6 –View of the underside of the hipped glass skylight and copper ventilator located at the low-slope, copper roof system on the 1893 Building. Water staining was observed at the copper ventilator and adjacent plank roof deck. It appears that the copper ventilator is manually operated. GRLA could not verify if the staining is from previous or active leaks.

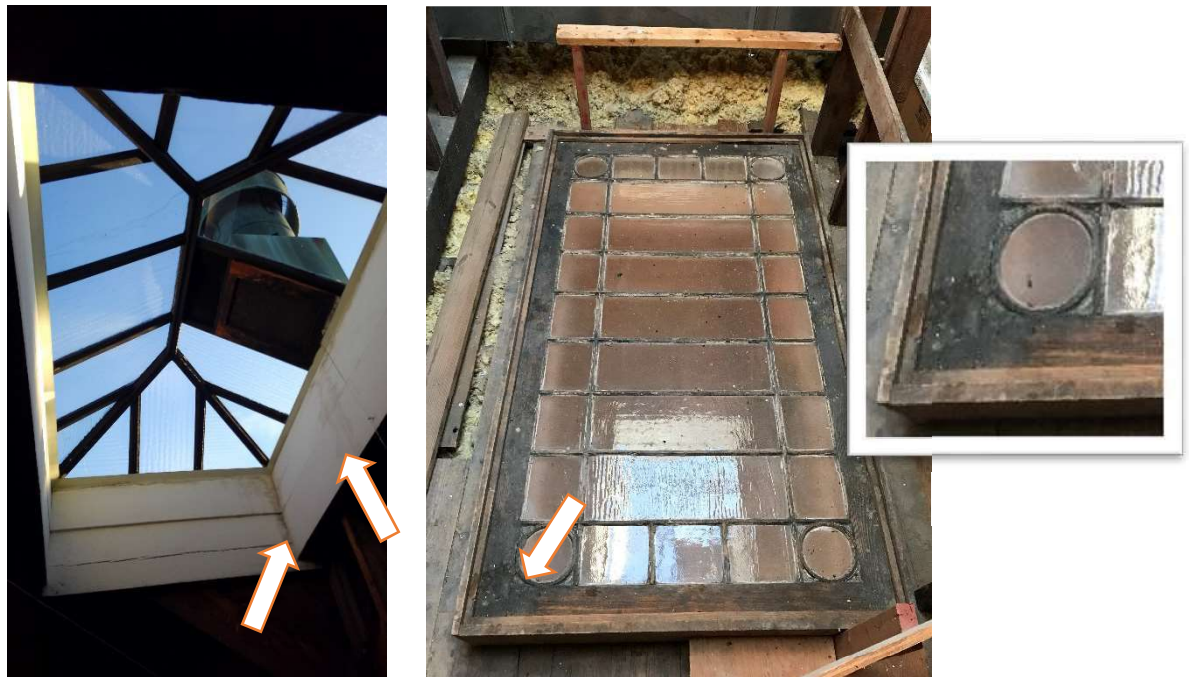
Photo 7 – Interior view of the skylight and associated interior laylight at the underside of low-slope, flat-seam, copper roof system at the 1893 building. Water staining was observed at the interior framing of the exterior skylight. Water staining was also observed throughout the perimeter wood surface of the interior laylight, located directly below. GRLA could not verify if the staining is from previous or active leaks.

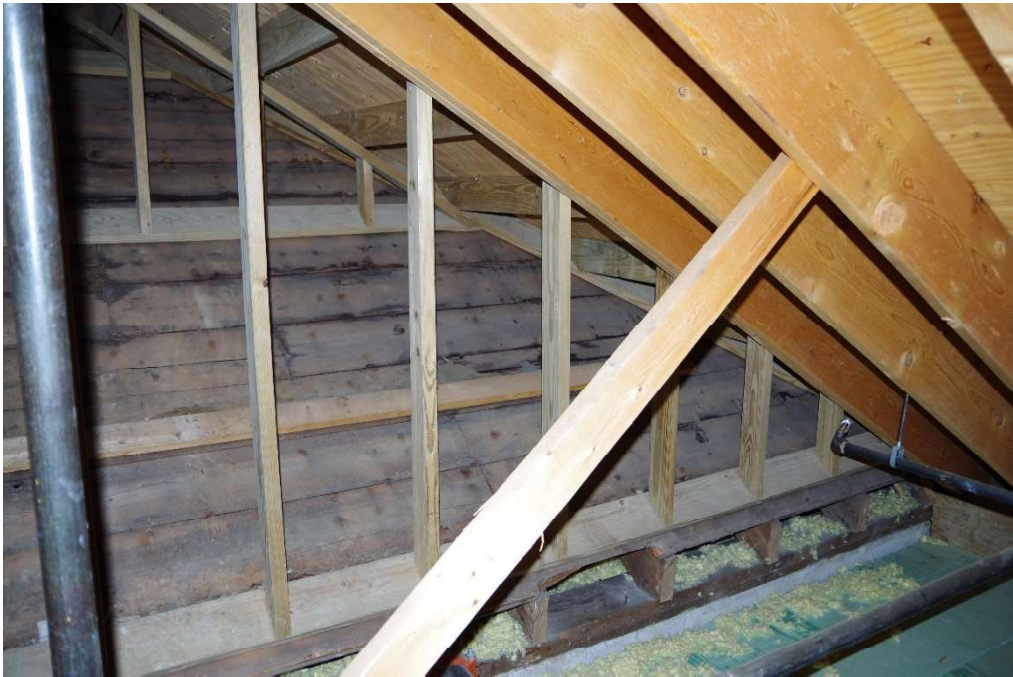
Photo 8 – Partial view of the structural abutment of the original 1893 building and 1999 addition at the south corner. At this location, a 2x6 stud wall acts as a roof plate or top plate on top of an 8" CMU block wall. 2x4 stud walls, spaced at 4'-0" on center, support connective joists. The original tongue and groove decking can be observed through the new 2x4 stud walls. Insulation at the eaves of the 1893 structure can be observed. 2" of rigid insulation is installed across the concrete attic floor within the addition.

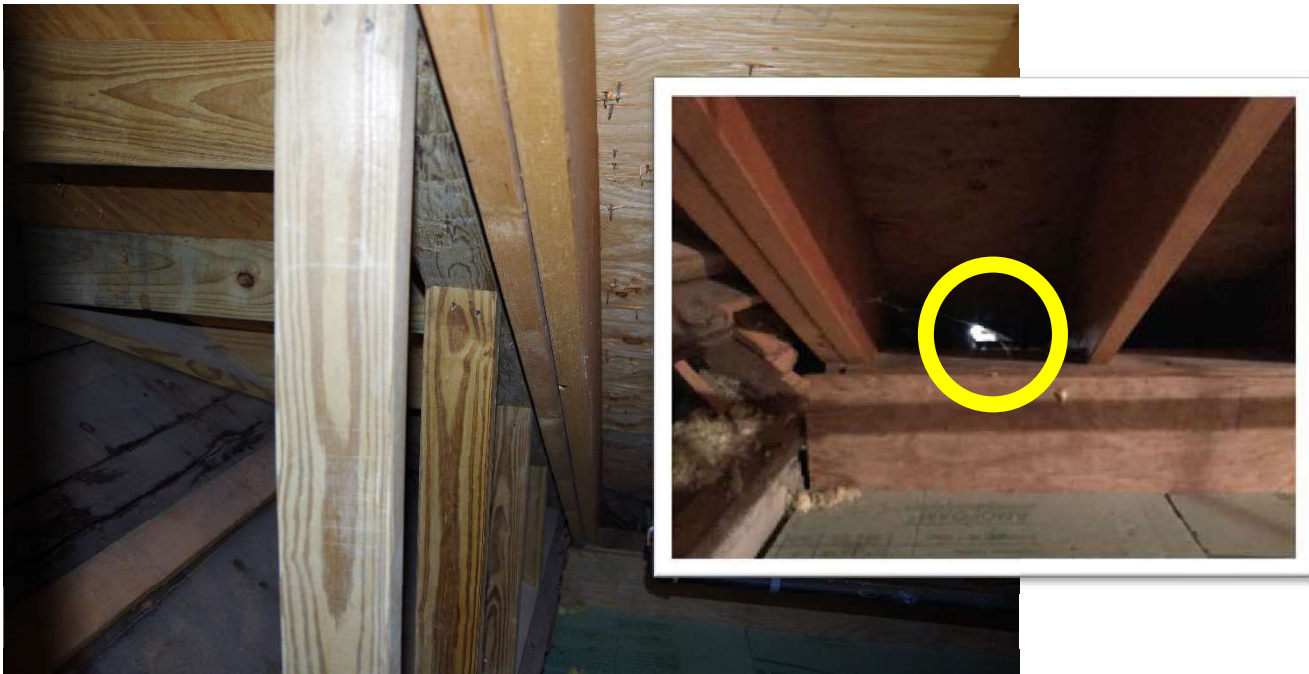
Photo 9 – Partial view of the structural connection of the original 1893 building and 1999 addition at the south corner above the main stairwell where previous leaks have been reported. The circle indicates where daylight could be observed through an opening in the roof sheathing, which appears to connect to the exterior gutter.

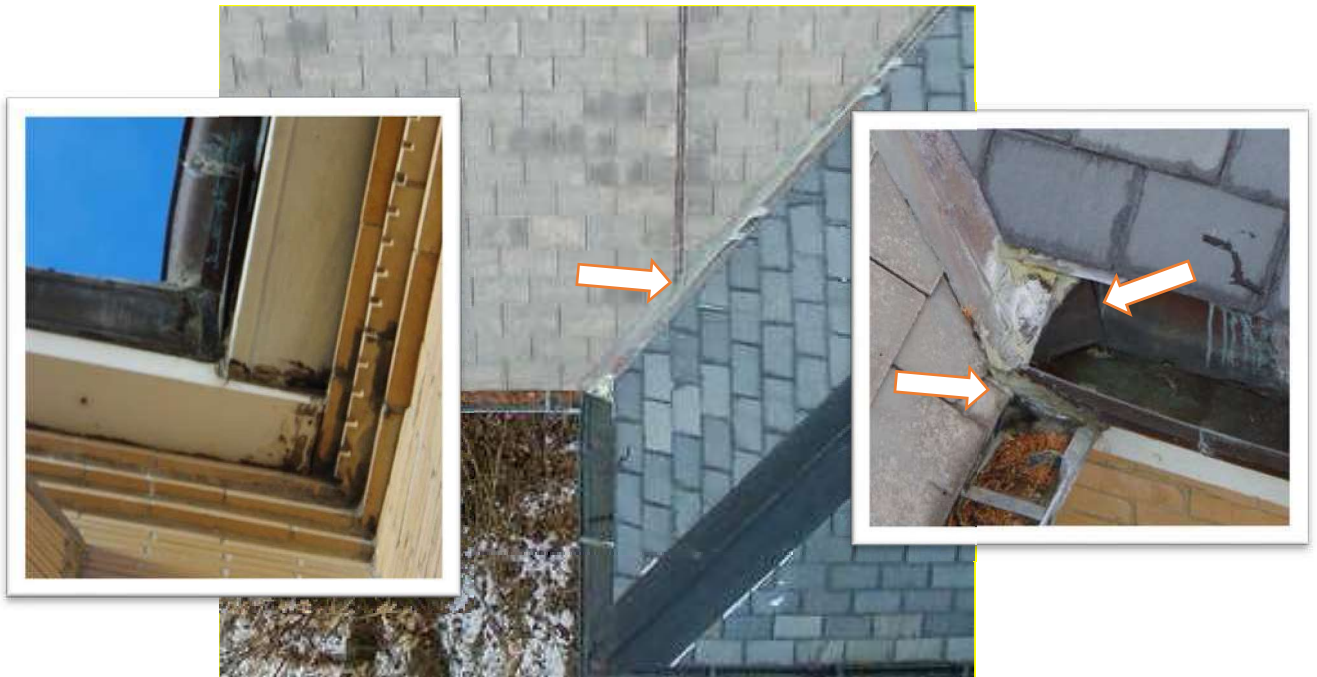
Photo 10 – Close-up view of the roof expansion joint on the south side of the building. Note that the roof expansion joint terminates into the roof valley and may be a potential source of moisture infiltration (center photo). Also note the poor termination of the two section of roof gutter below the valley with open seams in the sheet metal and inappropriate sealant repairs observed (right photo). The eaves and gutters at the intersection of the original building and addition do not appear to align vertically (left photo). This area is located above the main stairwell where previous leaks have been reported.

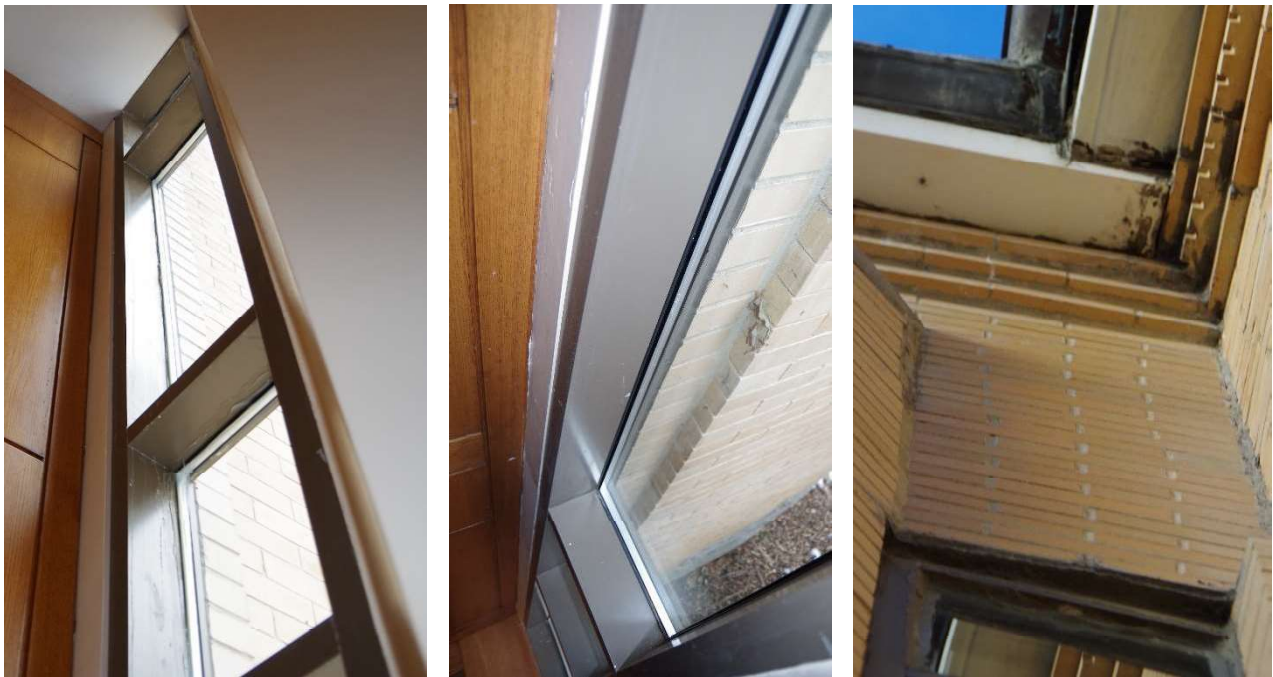
Photo 11 – Interior view of multi-story stairwell window located at the building expansion joint and below the abutment of the two gutter systems where previous leaks are reported. Interior finishes have been repaired and exterior sealant repairs were reported at the brick masonry and window, which appear to be in poor condition.

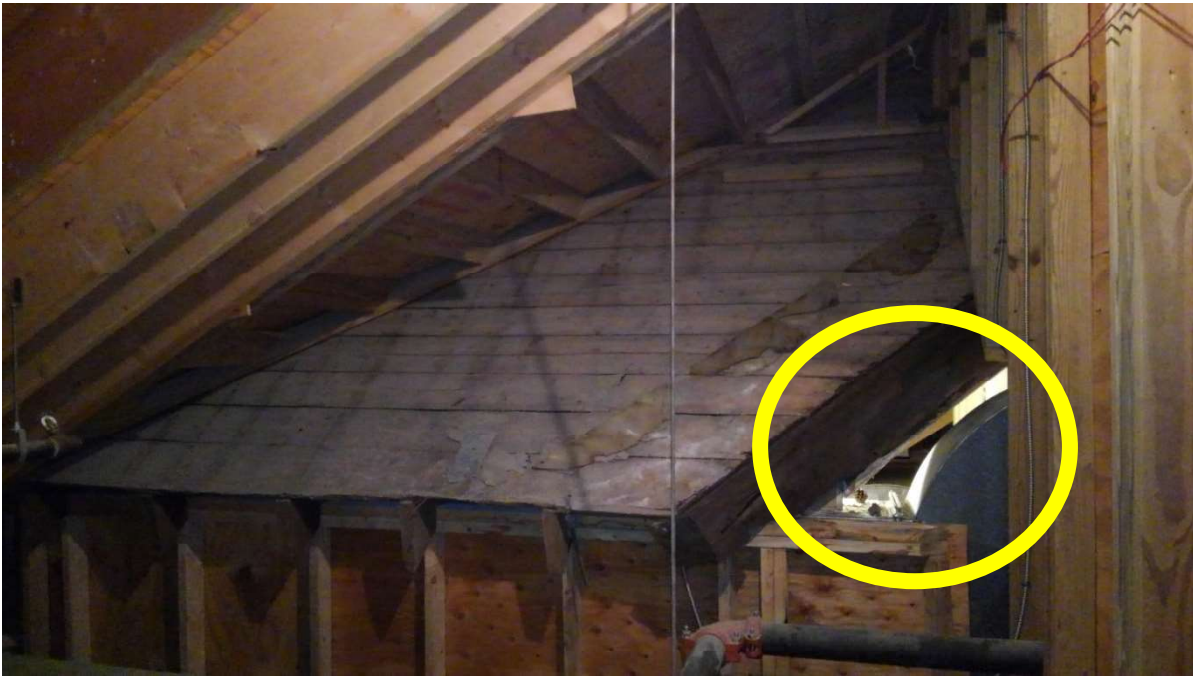
Photo 12 – Partial view of the structural abutment of the original 1893 building and 1999 addition at the north corner. The 2x4 stud walls found at the opposite corner (and structural drawings) are noticeably absent. The circle indicates where the roof deck is open to the original 1893 attic, connecting the two attic areas. HVAC ductwork at the attic stair can be observed through the open roof deck.

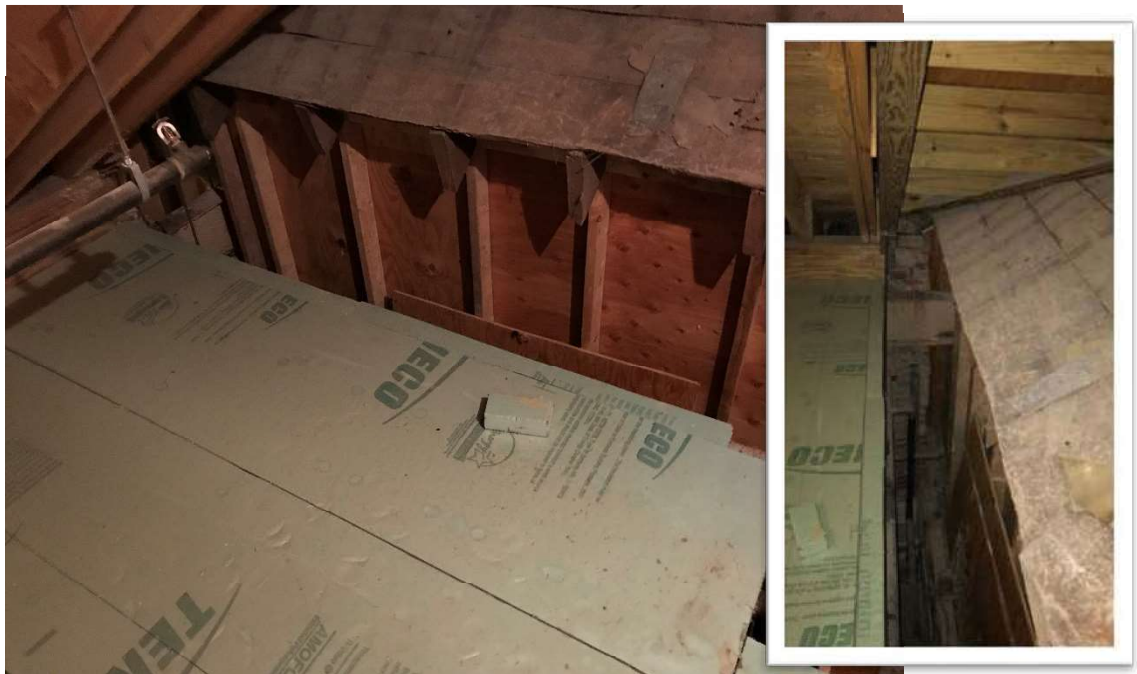
Photo 13 –Additional view of the abutment of the original 1893 building and 1999 addition at the north corner. The composite concrete deck does not extend to the original structure, creating an approximate 2'-0" (width) x 10'-6" (length) multi-story void between the two building sections where leaks have been reported below.

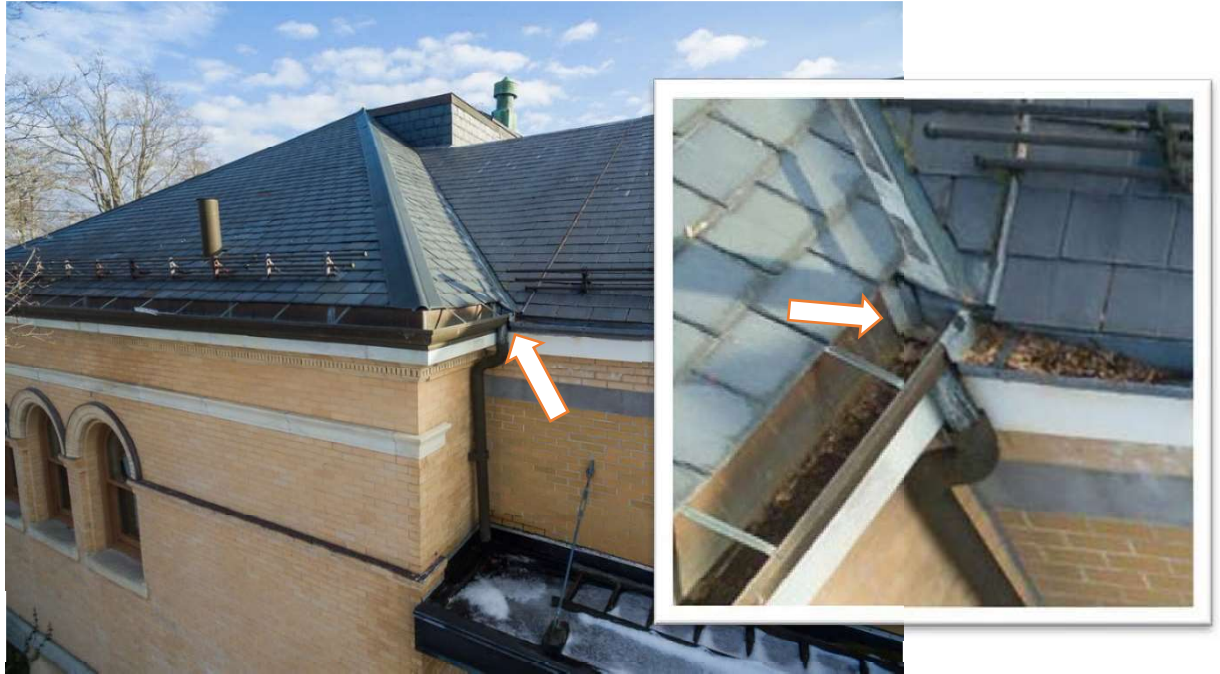
Photo 14 – View of copper gutter at building expansion joint (abutment of original building and addition) on the north elevation. The two gutter systems do not align, drain to separate downspouts, and are different sizes. The downspout shown drains the original gutter system only. The connection of the two gutter systems appears to consist of several overlapping pieces of both copper and lead coated copper. This area has a history of reported leaks.

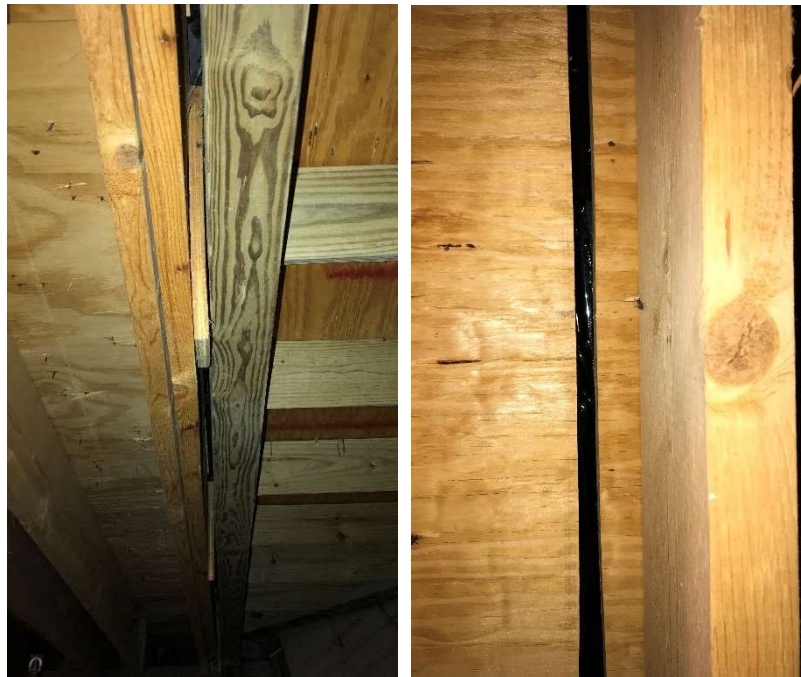
Photo 15 – Partial view of the structural abutment of the original 1893 building and 1999 addition at the north corner over the multi-story void. Two roof sheathing expansion conditions were observed in this area. There is the true expansion joint condition (left photo) that aligns with exterior wall expansion joint and a secondary unsupported $\frac{1}{2}$ "-1" joint in the sheathing a few feet away, serving an unknown purpose. Self-adhered modified bitumen ice and water shield could be observed through the joints. Isolated nails were observed to penetrate the membrane and may be a source of moisture infiltration.

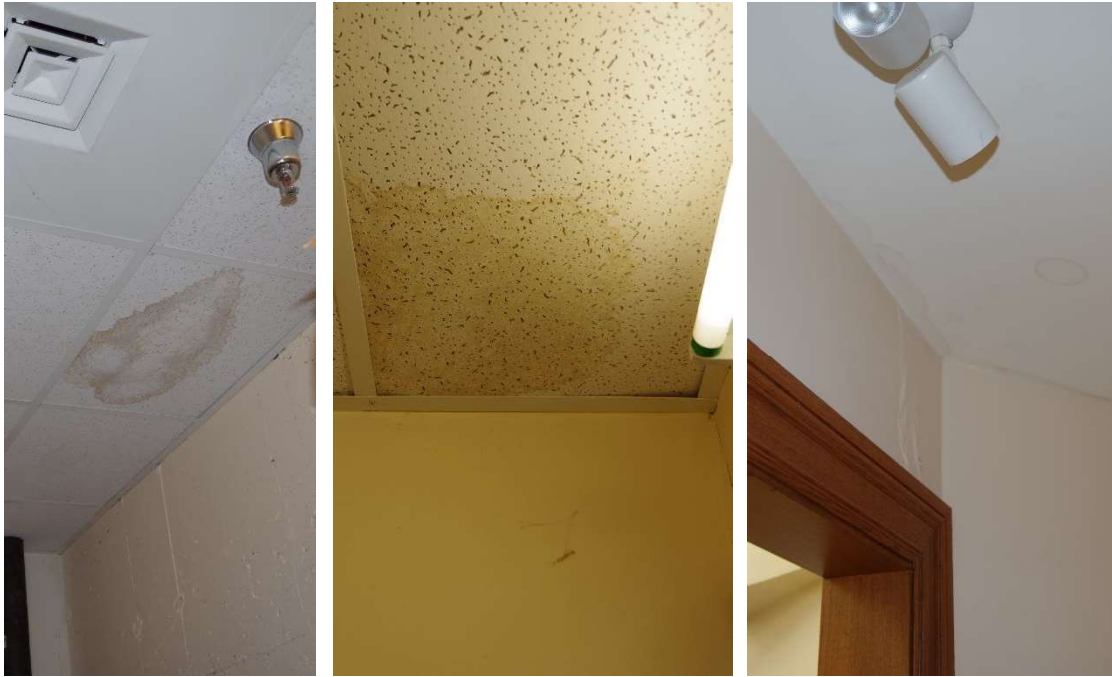
Photo 16 – View of isolated areas of water staining observed at suspended ceiling tiles and gypsum wallboard finishes below near the multi-story expansion joint void shown above. Staining was observed at all levels of the building near the building expansion joint.

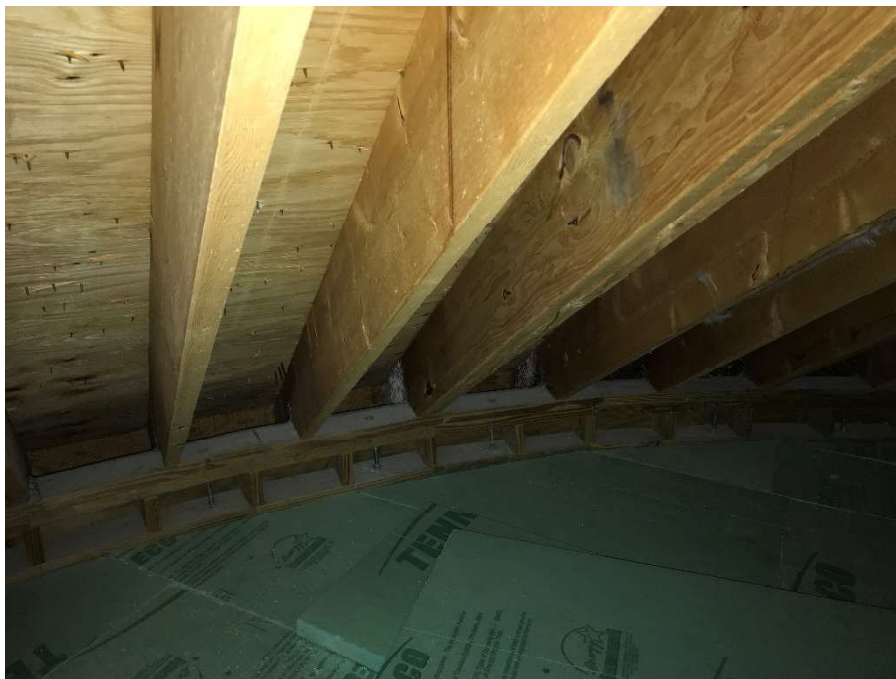
Photo 17 – Partial view of the underside of steep-slope, synthetic slate shingle roof system at the 1999 building addition. The roof is composed of 3/4" plywood roof deck on 2x10 rafters at 1'-4" on center. The rafters sit on a 2x6 stud wall (roof plate) that is anchor bolted at 2'-0" on center to a composite concrete deck. 2" of rigid insulation is located atop the composite deck. HVAC ducts extend throughout the attic above the rigid insulation.

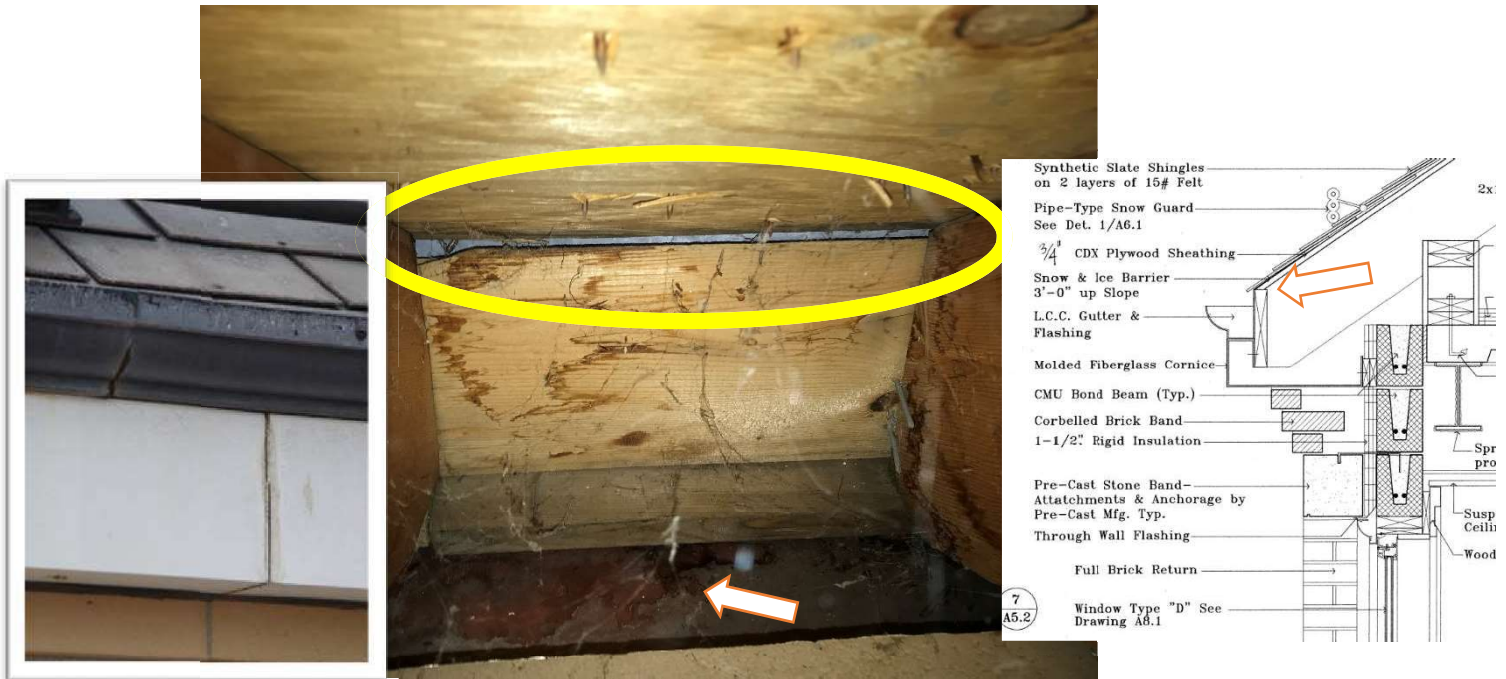
Photo 18—View of a representative eave condition at the 1999 addition. The circle indicates where the back side of the gutter could be observed between the fascia board and roof sheathing. The design detail shown (left) indicates the location of the circled area. Leaks through joints in the sheet metal gutters may infiltrate to the fascia as shown. The gutter appears to have a “built-in” profile with the fiberglass cornice, which may allow overflowing water from the gutters or leaks through the joints to infiltrate to the fiberglass cornice below as evidenced by water staining in the photo above (arrow).

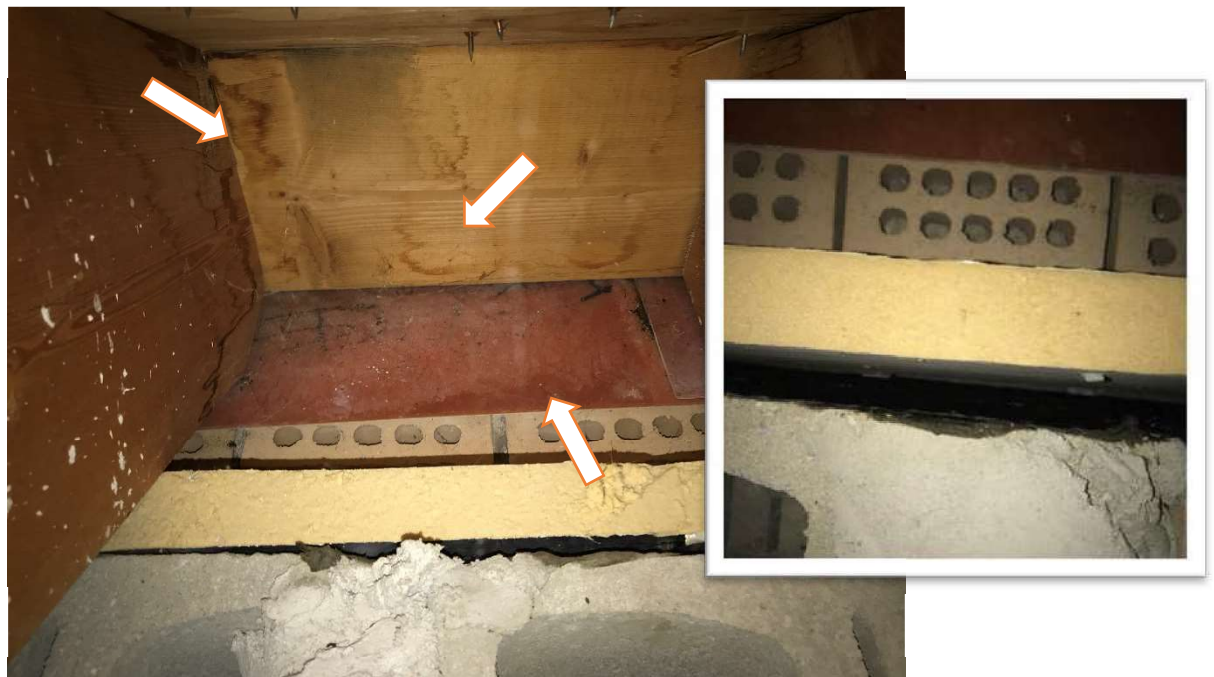
Photo 19— Additional view of an eave condition at the 1999 addition. Arrows indicate where water staining was observed at the interior of the wood fascia and fiberglass cornice. The right photo shows the top of the cavity wall below where moisture may be allowed to bypass wall dampproofing at the top of the wall.

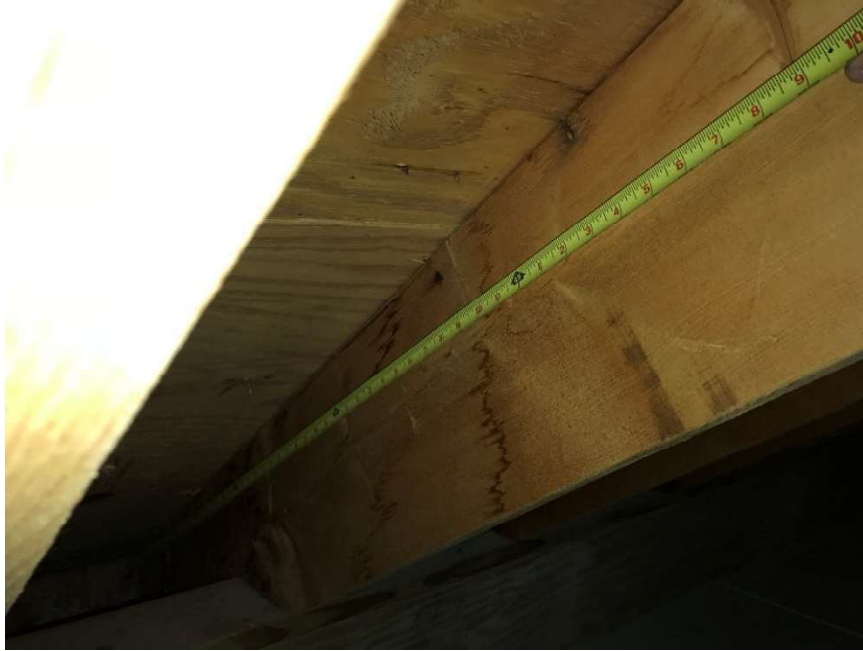
Photo 20 – Partial view of 2x10 rafters at the 1999 addition. Design drawings indicate that snow and ice barrier was installed 3'-0" up the roof slope. Water staining was observed approximately 4'-0" up from the fascia board, indicating moisture is bypassing the roof underlayment above the ice and water shield.

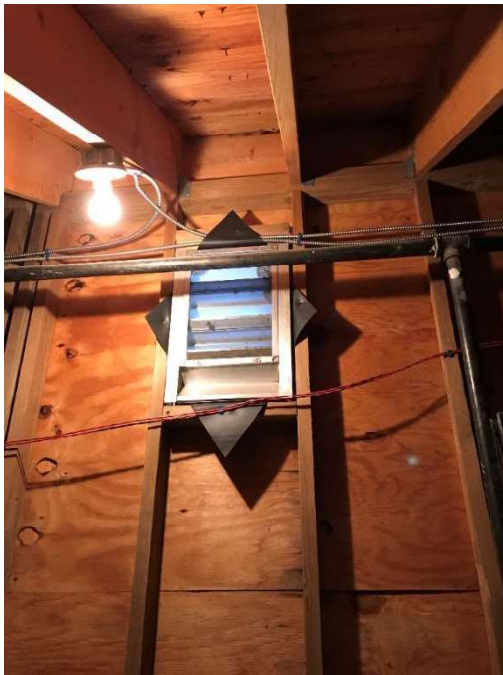
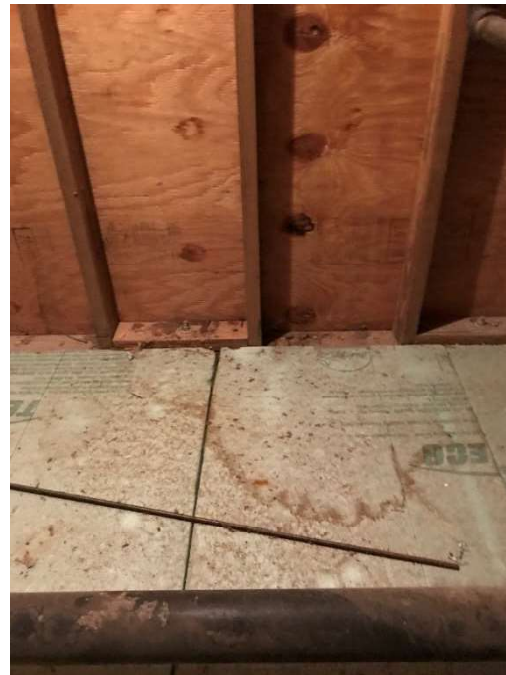
Photo 21 – View of aluminum wall louver at single-ply elastomeric (EPDM) wall cladding. Water staining was observed at the interior rigid insulation below.

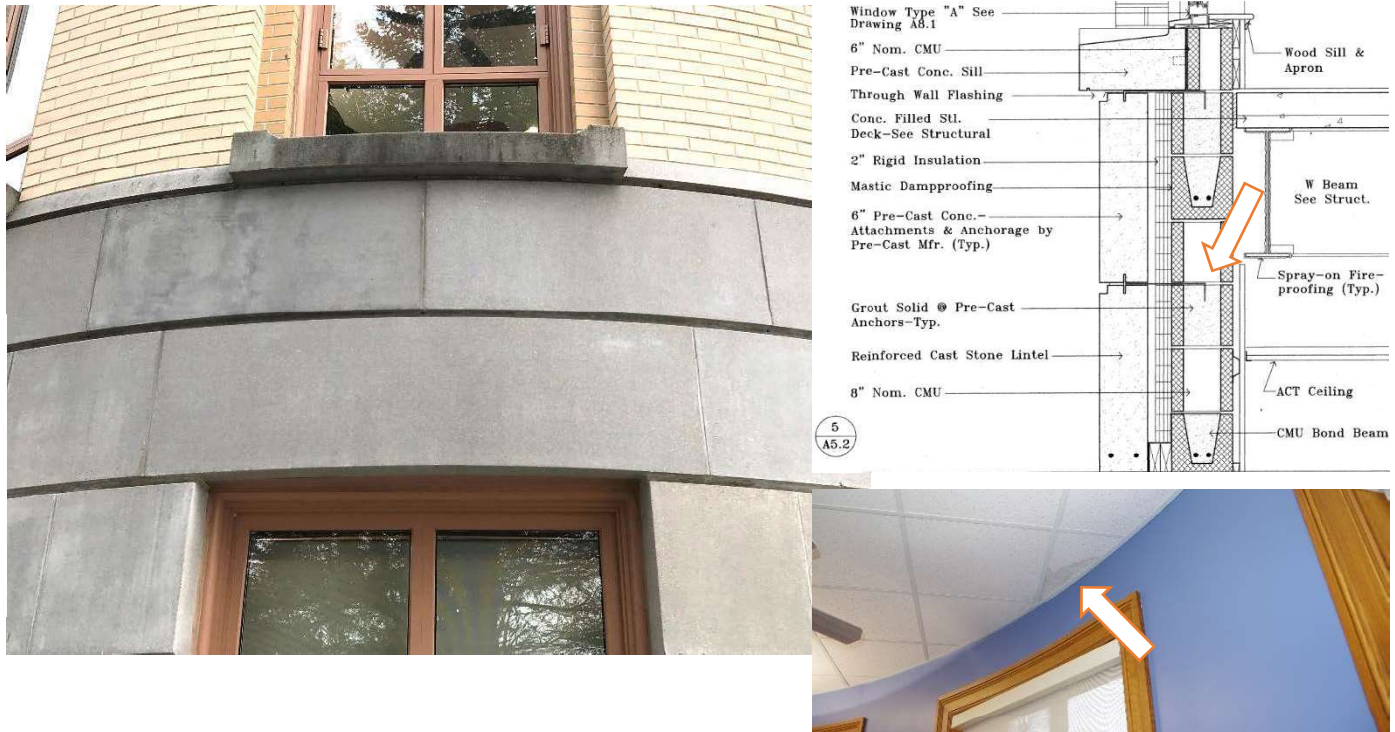
Photo 22 – Flashing configurations and precast veneer anchors are suspected sources of moisture infiltration above the first floor windows on the West Elevation. Presence of embedded throughwall flashings could not be confirmed at the lower level precast veneer wall areas. Additionally, precast veneer anchors appear to penetrate the mastic dampproofing applied to the exterior walls (upper right detail), which may be a source of moisture infiltration above the finished ceiling (lower right photo).

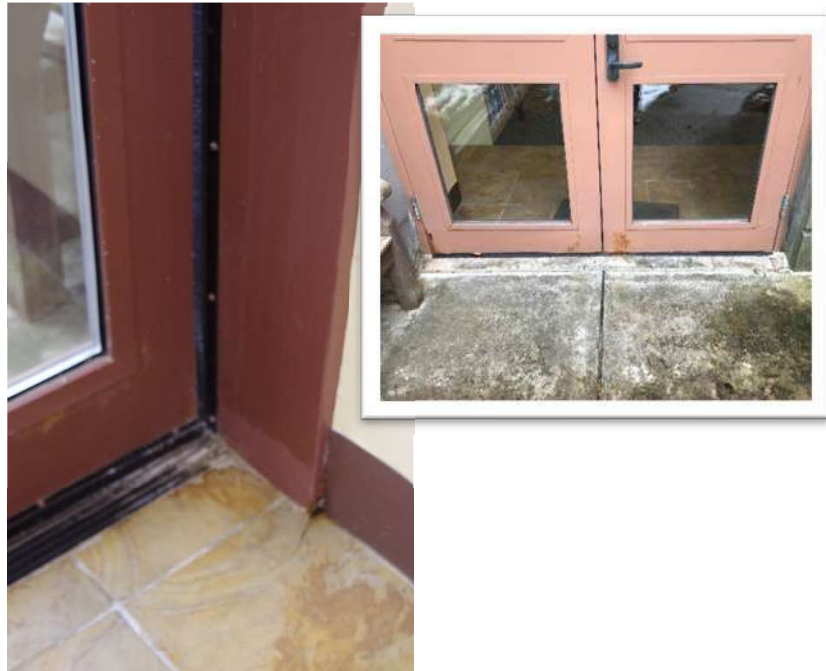
Photo 23 – View of isolated areas of water staining observed at the aluminum door framing at the lower level Children's Room. Leaks were previously reported at the threshold of the exterior aluminum doors. The concrete slab in this area was reportedly repaired in 2012 following reports of moisture infiltration. Poor drainage in this area may contribute to moisture infiltration at the door. GRLA is not aware if staining observed is from active or previous leaks.

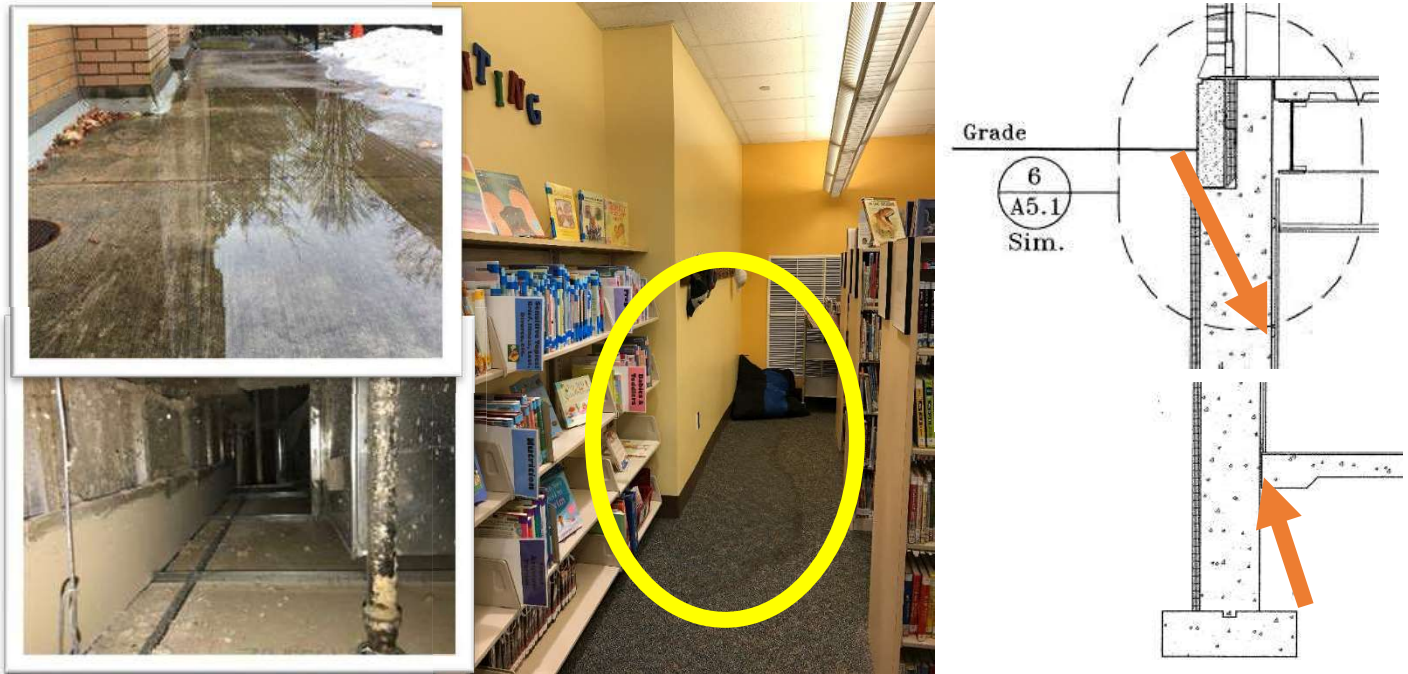
Photo 24 – View of isolated areas of water staining observed at the carpeting and gypsum wallboard finishes at the lower level Children’s Room (center photo) within the below-grade portion at the 1999 renovation. Poor drainage and ponding water issues are reported at grade level (upper left photo). Visual observation above the suspended ceiling tiles (lower left photo) did not reveal any potential sources of moisture infiltration. Maintenance records indicate a history of concrete repair and waterproofing applications at the building’s exterior. Design drawings of the addition indicate the exterior wall flashing may be installed below grade and may not provide a water tight connection to the foundation dampproofing, which could allow moisture to infiltrate through the concrete walls and onto the interior walls and floor slab (top arrow, right photo). Leaks may also occur due to hydrostatic pressure at the intersection of the floor slab and foundation wall (bottom arrow, right photo).

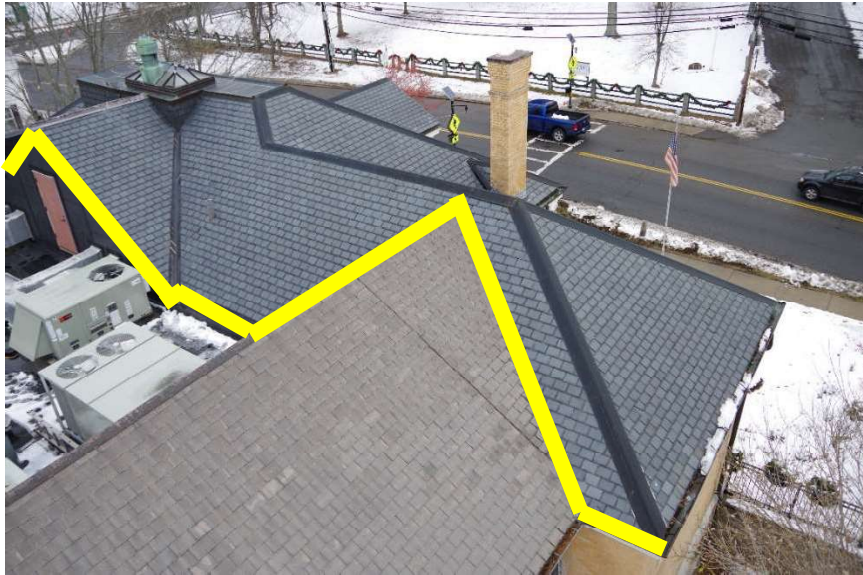
Photo 25 – Partial view of the steep-slope, slate shingle roof system. The yellow line indicates the approximate limits of the slate roof area on the original library building. The roof system consists of gray slate shingles in a uniform pattern with open copper valleys and copper ridge and hip caps. Generally, the slate shingles appear to be in fair condition, however, cracked, broken, displaced, and missing slate shingles were observed throughout the roof.

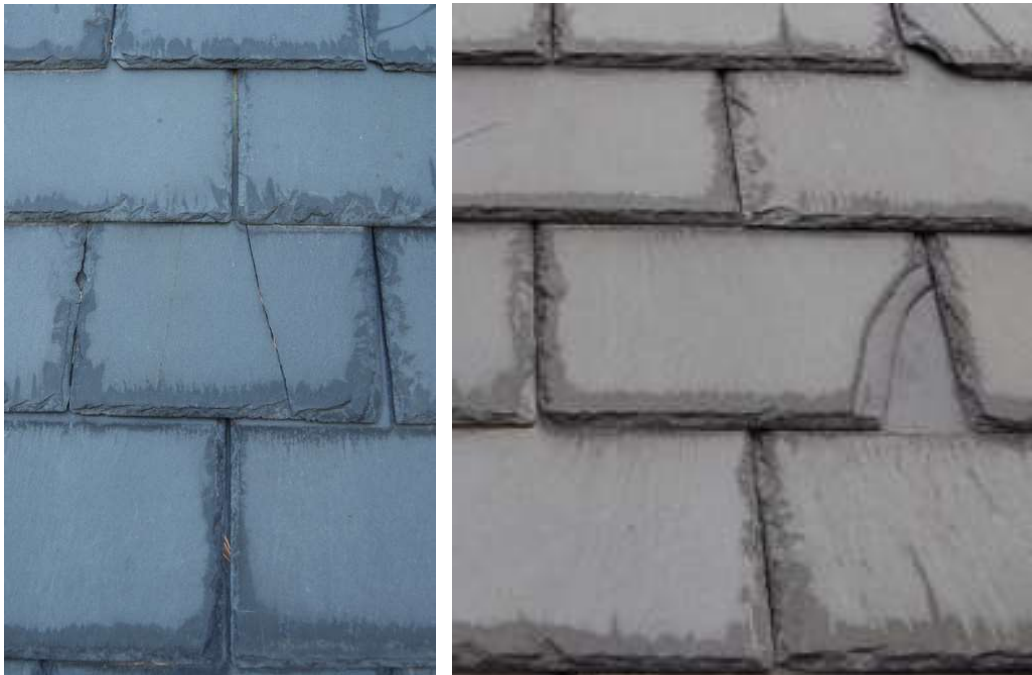
Photo 26 – View of cracked and broken slate shingles observed.
