On Site Existing Conditions Assessment

Building Envelope Sciences

Photo 1 – Overall view of the Groton Public Library from the Main Street entrance. The yellow line indicates the approximate limits of the original 1893 structure and the 1999 addition.

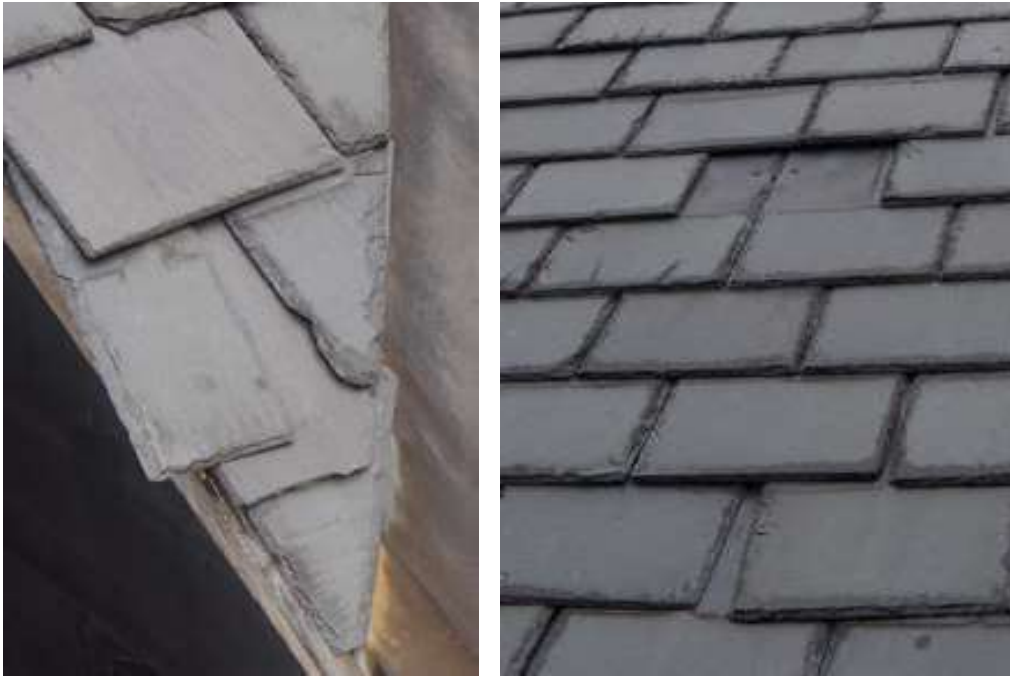
Photo 27 – View of displaced and missing slate shingles observed.

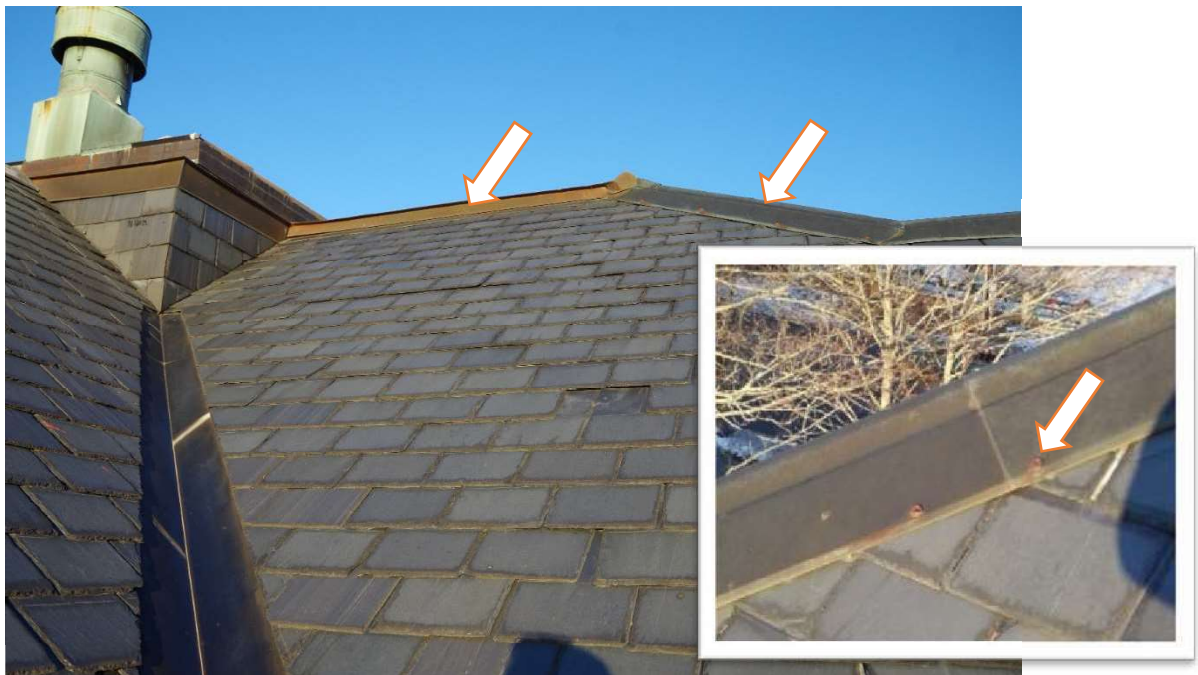
Photo 28 – Partial view of copper ridge and hip caps and open copper valley which appear to be in good condition, however, corroded fasteners were observed.

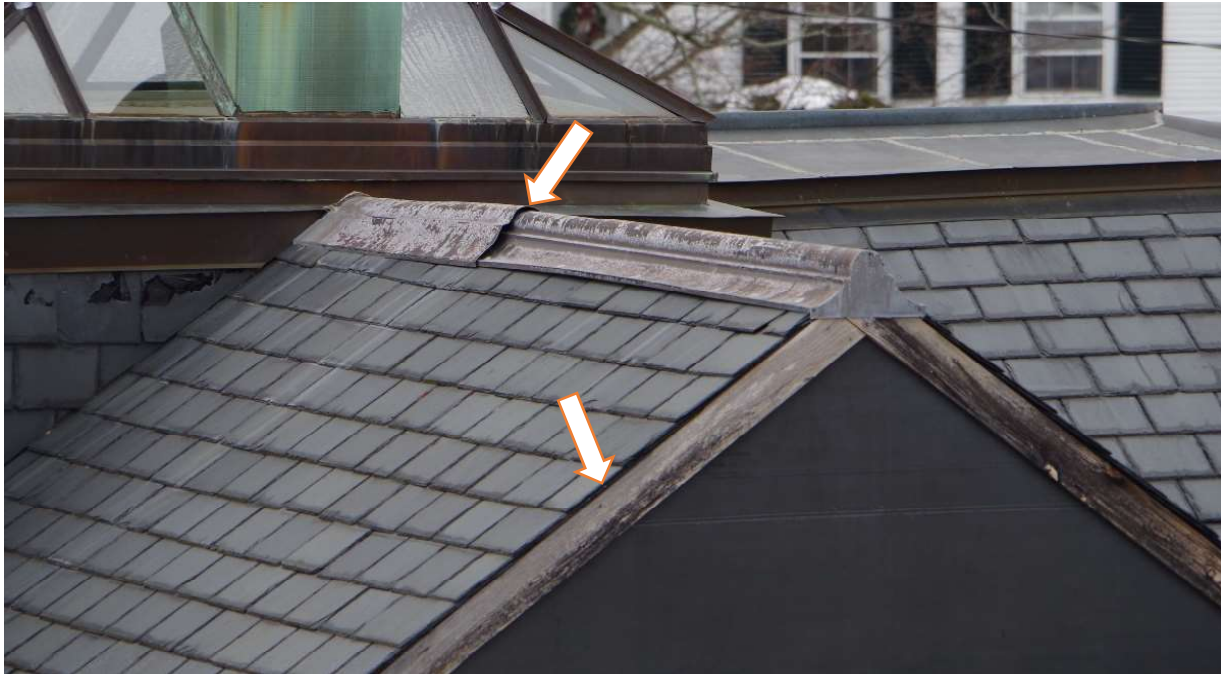
Photo 29 – An isolated section of lead coated copper ridge cap installed on the west gable. Voids and open seams in the ridge flashing were observed. Wood trim on the gable end of the roof appears to be weathered and deteriorated.

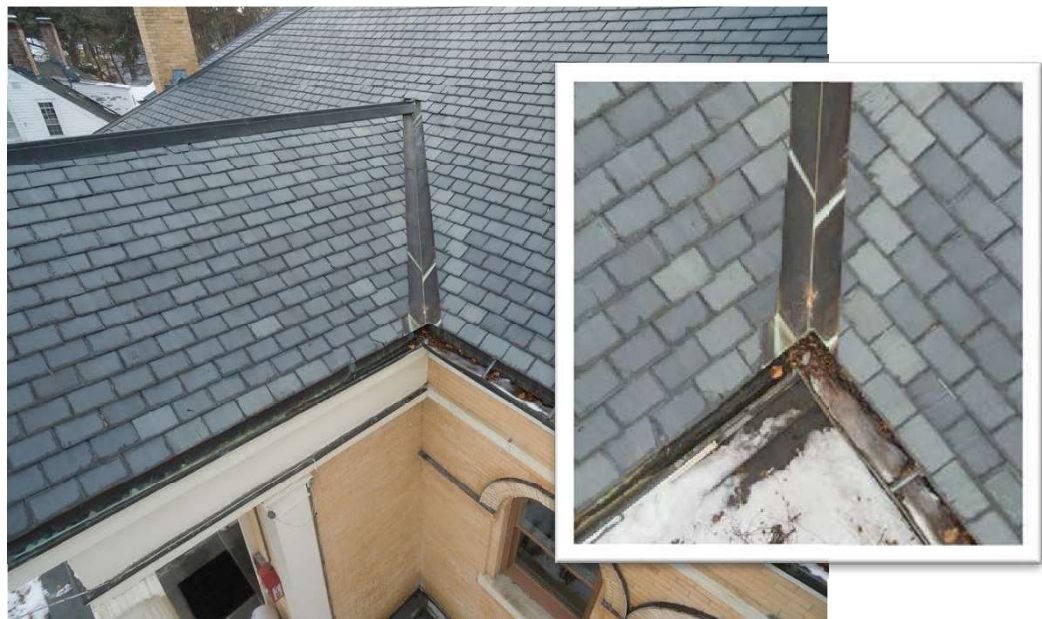
Photo 30 – View of copper gutter transition at the entrance portico and east elevation. The entrance portico has a wood gutter with copper lining (reportedly replaced in 1999), whereas the east elevation has a hung copper gutter.

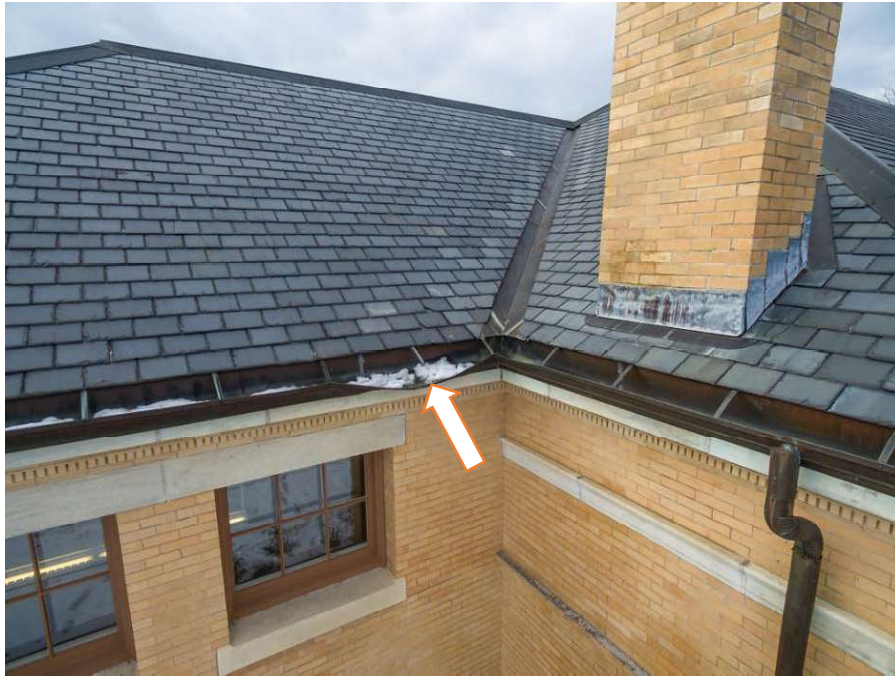
Photo 31 – View of damaged copper gutter at east elevation. The damage appears to be from snow and ice build-up in the gutter near the valley and has resulted in a gutter strap becoming detached leading to deformation of the gutter.

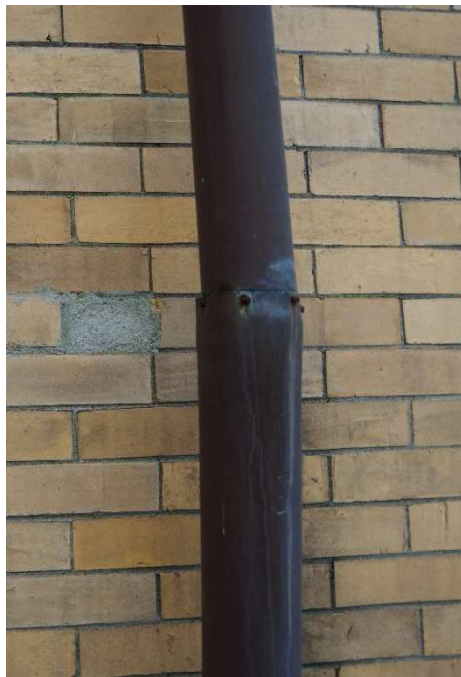
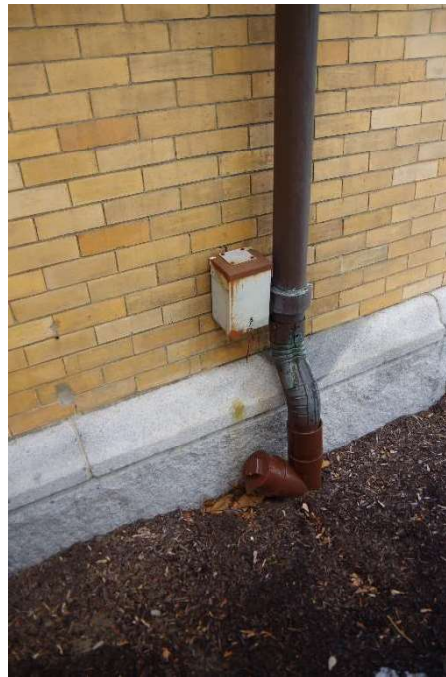
Photo 32 – Drain leader connections are in poor condition with corroded fasteners. Drain leaders typically tied into sub-grade site drainage system.

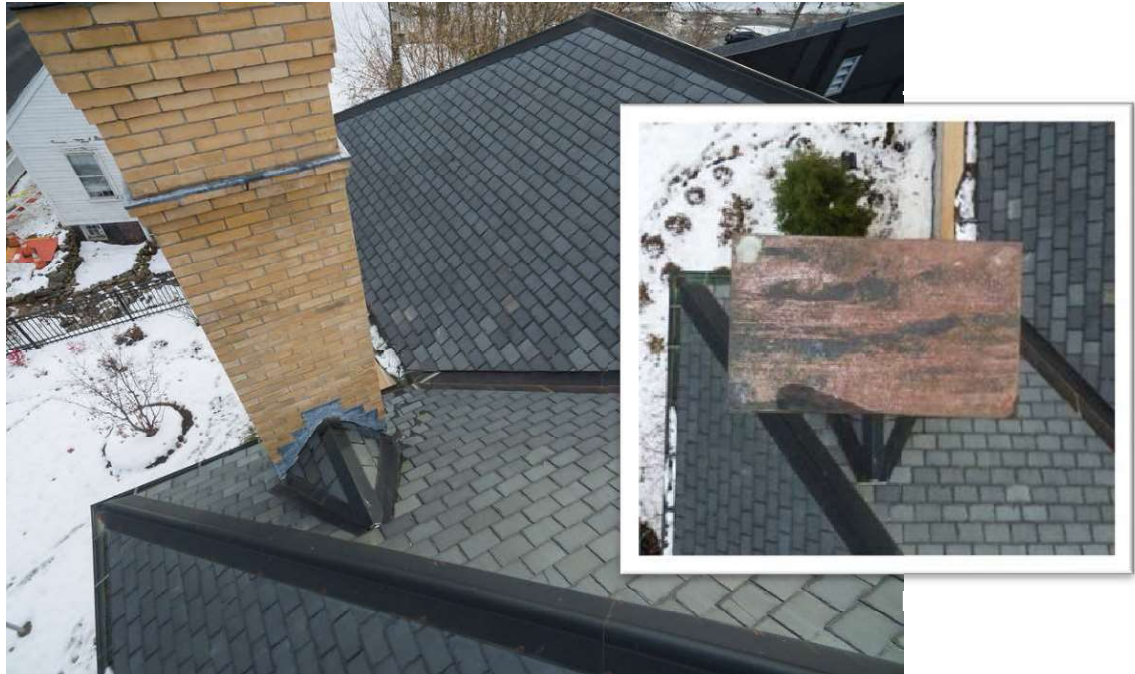
Photo 33 – View of previously repaired roof cricket and sheet metal step flashings at chimney. Cricket flashing diverts snow and rain away from the chimney. The masonry chimney appears to be in fair condition. The top of chimney is capped with copper flashing.

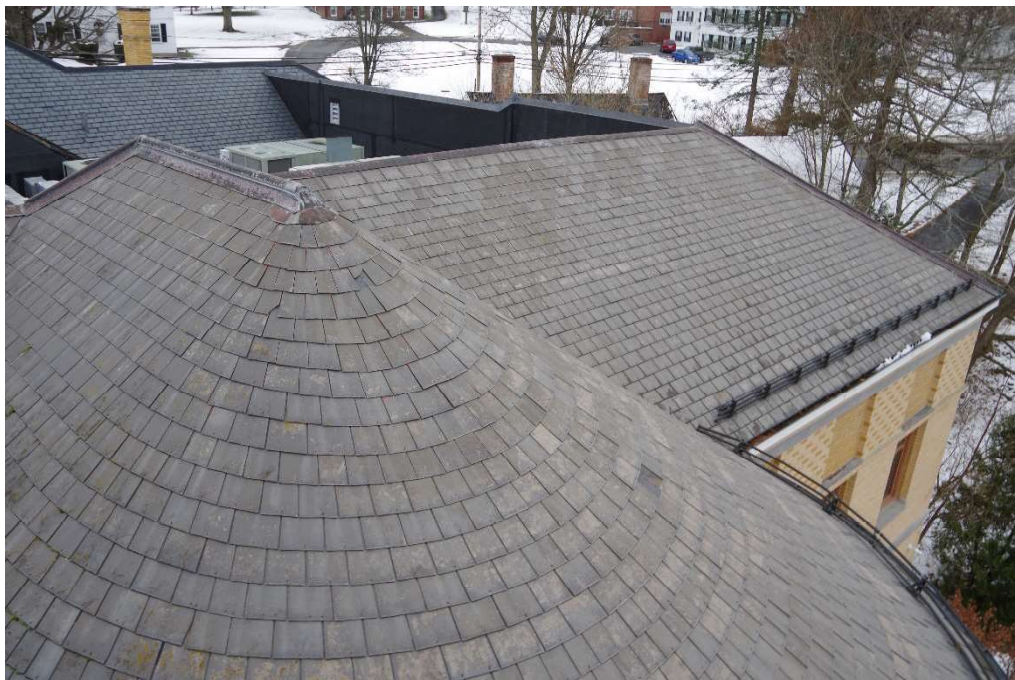
Photo 34 – Partial view of the steep-slope, synthetic slate shingle roof system. Overall, the synthetic slate appears to have a fairly uniform size and exposure throughout the roof surface. Most of the color has faded or worn off, leaving the base material color exposed. Sheet metal flashings consist of lead coated copper and are installed at the hips and ridges. The roof has open sheet metal valleys and lead coated copper gutters. A three-rail, pipe-style, snow guard system is installed along the majority of the building perimeter of the addition.

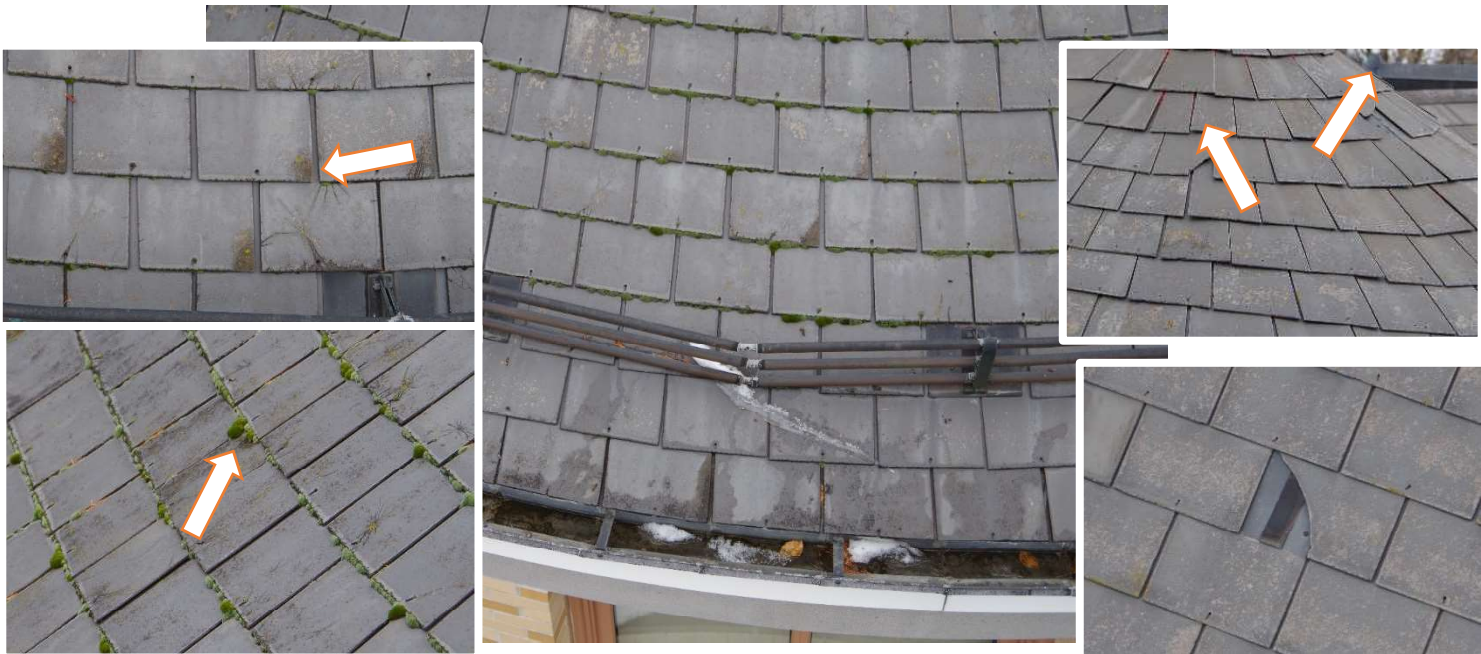
Photo 35 – Deteriorated synthetic slate shingles were observed throughout the 1999 addition mansard roof. Defects included cracked and broken shingles, loss of protective coating/discoloration, moisture absorption and vegetative growth on the shingles. Cracking on shingles appears to occur where fasteners for the underlying shingle are placed below and may indicate that fasteners are backing out of the substrates

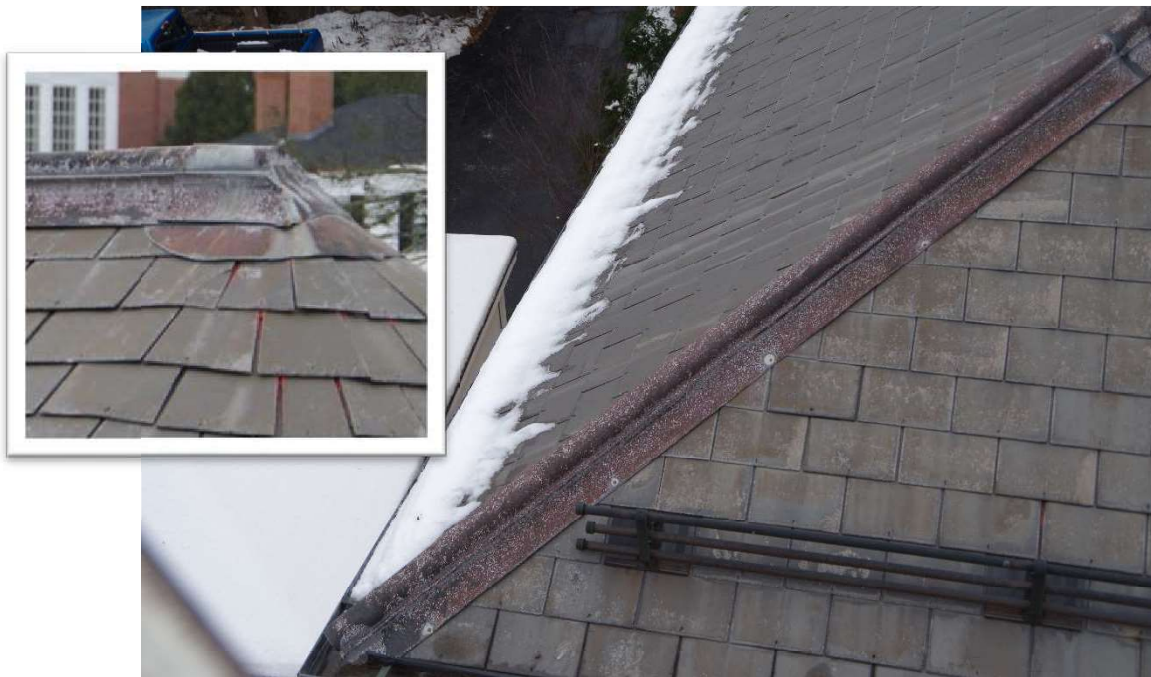
Photo 36 – Partial view of lead coated copper ridge and hip cap flashings that have patinaed. Seams in the sheet metal copings appear to be overlapped. Isolated seams appear to have gaps between pieces of sheet metal. Flashings are typically surface fastened.

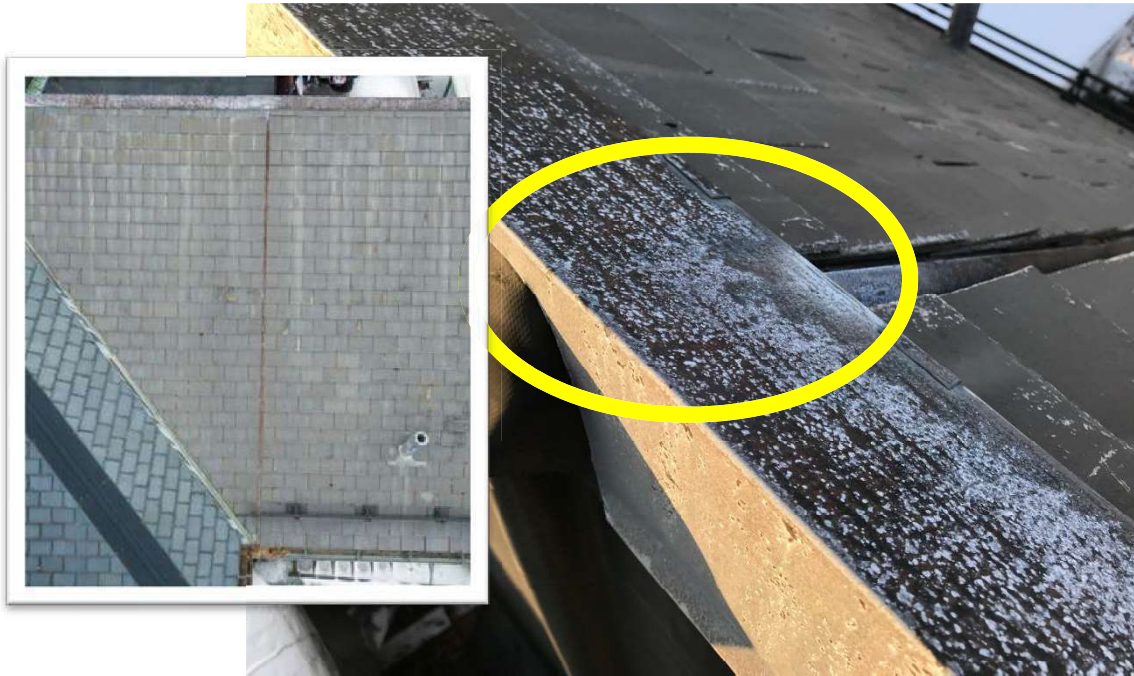
Photo 37 – Close up view of the building expansion joint where the synthetic slate mansard roof meets the low slope EPDM roof. The circle indicates where continuous expansion has not been provided in the sheet metal coping between the two roof areas.

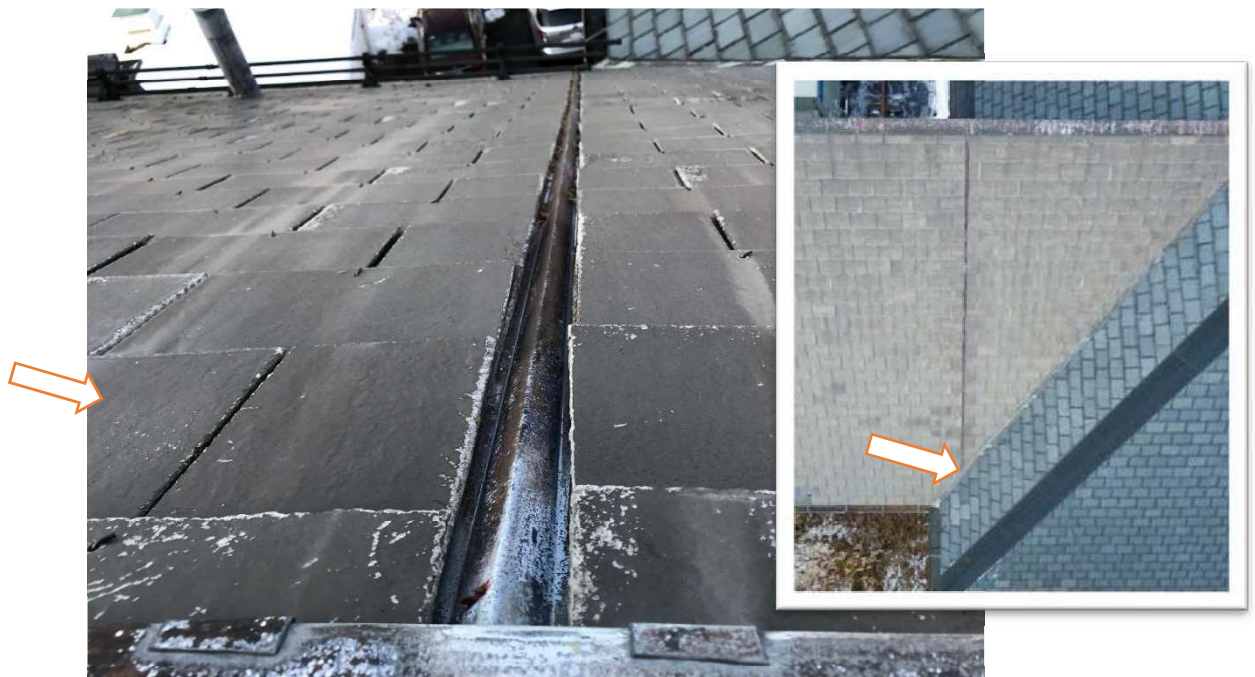
Photo 38 – Partial view of the building expansion joint at the synthetic slate roof system. The expansion joints consist of a sheet metal flashing between adjacent sections of synthetic slate shingle roofing. The expansion joints on both sides of the building do not appear to provide continuous building expansion as they transition to the other roof areas and walls below. The expansion joint on the south side of the building (right insert photo) above the main stairwell does not align with the plane of the original building wall below and extends into the roof valley.

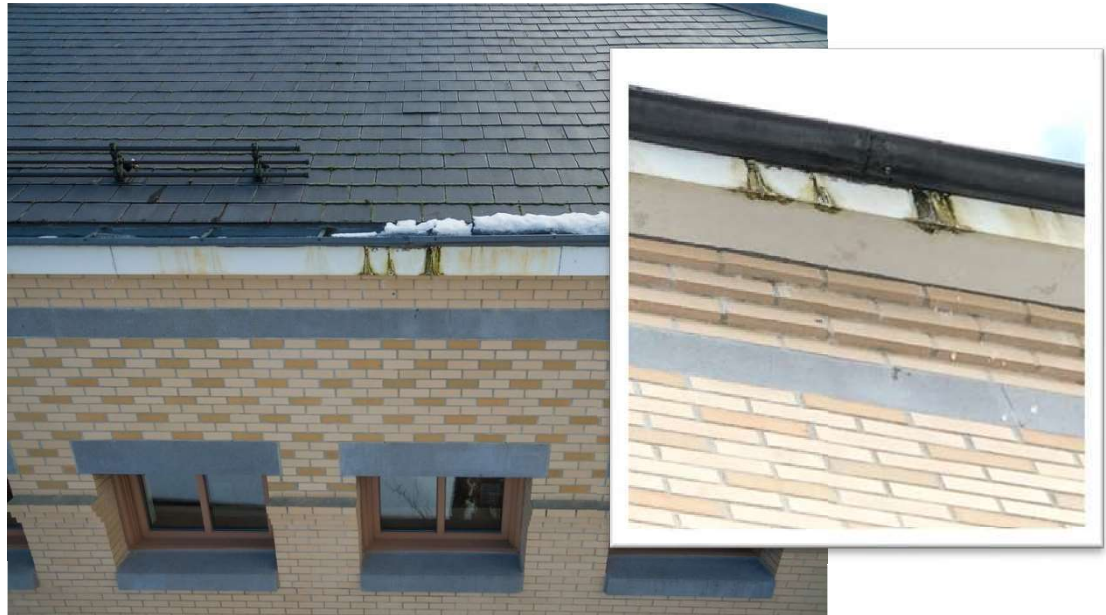
Photo 39 – View of damaged gutter at the north elevation. The damage appears to be from snow and ice build-up in the gutter and has resulted in the separation of the gutter joint, active leaking, and discoloration of the fiberglass cornice.

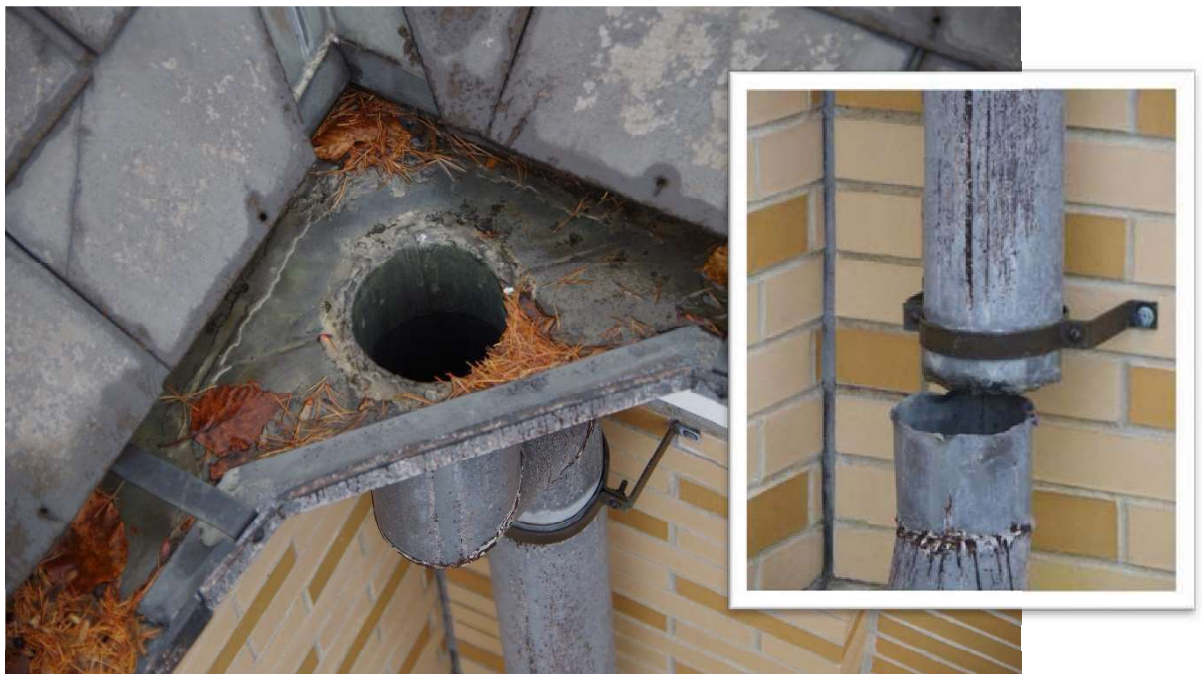
Photo 40 – View of typical sheet metal gutter at synthetic slate roof system. Leaves and pine needles were observed at most gutter locations. Drain leader damage was observed at several locations, typically consisting of disconnected downspout sections.

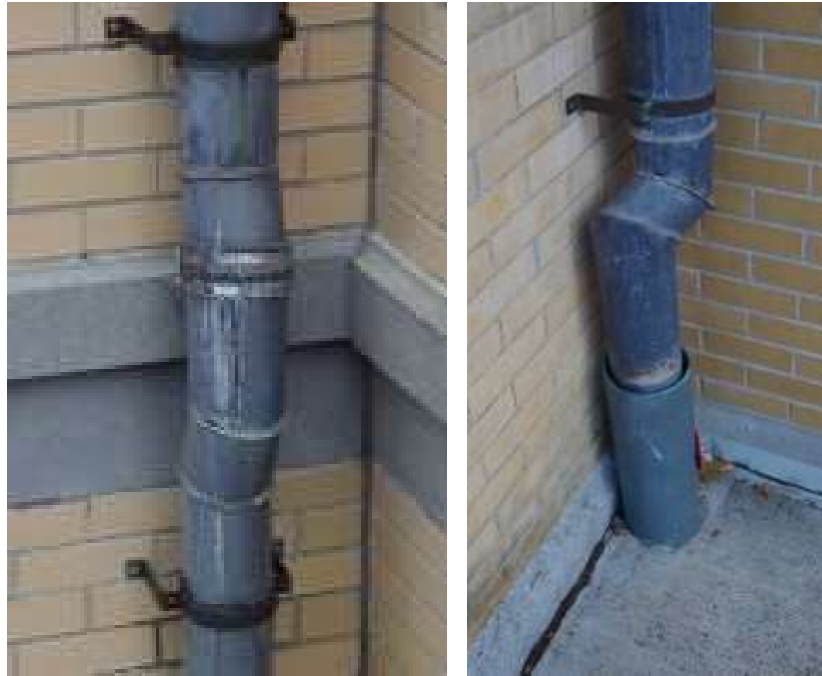
Photo 41 – View of stainless steel hose clamp repairs observed at several broken downspout joint locations. Drain leaders typically tied into sub-grade site drainage system.
