The Library has been experiencing water infiltration into the building in all areas since the 1999 renovation and addition. After years of fixing each issue separately (with a total cost exceeding \$100,000), the Library Trustees (with CPA and State Aid funding) hired Building Envelope Scientists from Gorman Richardson Lewis Architects (GRLA) to do a thorough study of the building systems to make an overall recommendation on what needs to be done. GRLA's evaluation is that the library is experiencing widespread failure of the existing steep slope synthetic slate and original slate roofing systems, associated flashings, and gutters resulting in moisture infiltration throughout the building. Based on their findings, they are recommending complete replacement of all roofs (including the central low-slope EPDM roof with skylights), gutters, and drainage systems, as well as masonry and window repairs.

Town of Groton, Massachusetts

Proposed Capital Plan FY 2020 - 2024

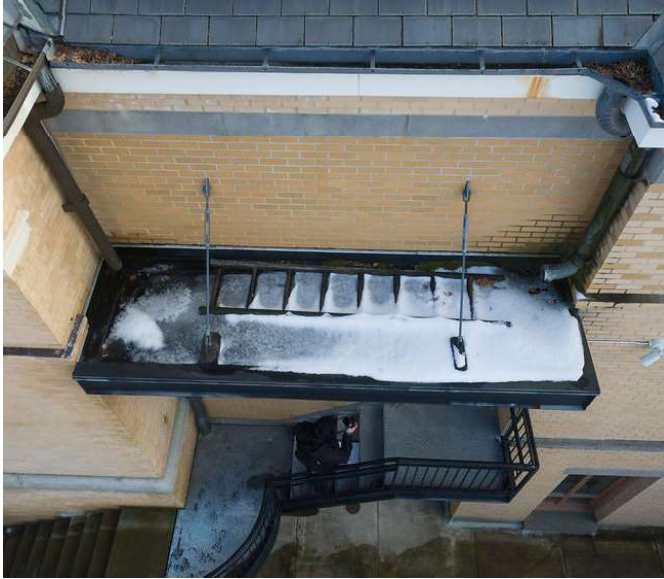
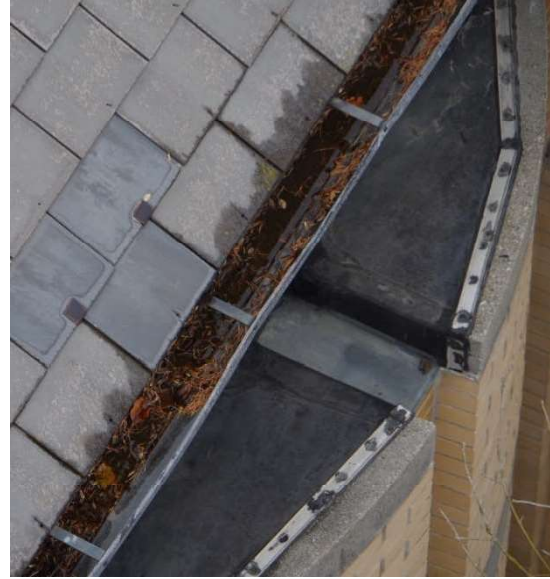
Photo 47 – Other isolated roof areas and canopies were observed to have single-ply elastomeric roof systems located at the north and south elevations. At both locations, the roof membrane terminates with a termination bar and sealant.

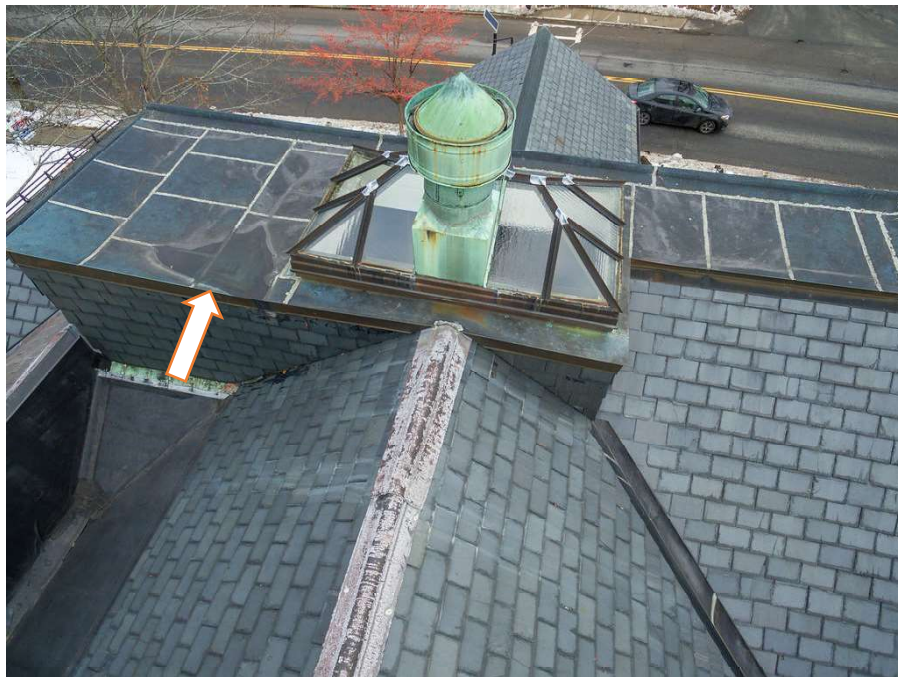
Photo 48 – Overall view of low-slope, flat-seam, copper roof system with soldered joints. Maintenance records indicate that this roof was replaced during November 1999 to September 2000 roof repairs. It includes a hipped glass skylight and copper ventilator. Ponding water was observed.

A flat seam copper roof system is located over the center of the 1893 roof system and was reportedly replaced during the November 1999 to September 2000 roof repairs. Depressions in the sheet metal roof system have allowed water to accumulate on the roof surface. GRLA recommends removal and replacement of this roof area in conjunction with the slate roofing system to coordinate connection of flashings between the roof areas, provide continuity in the age of sheet metal flashings throughout the roof system, and to provide positive roof slope to reduce ponding water potential. GRLA further recommends restoration or replacement of the skylight at this roof area to reduce moisture infiltration.

4. Removal and replacement of skylights in conjunction with roof system replacement.

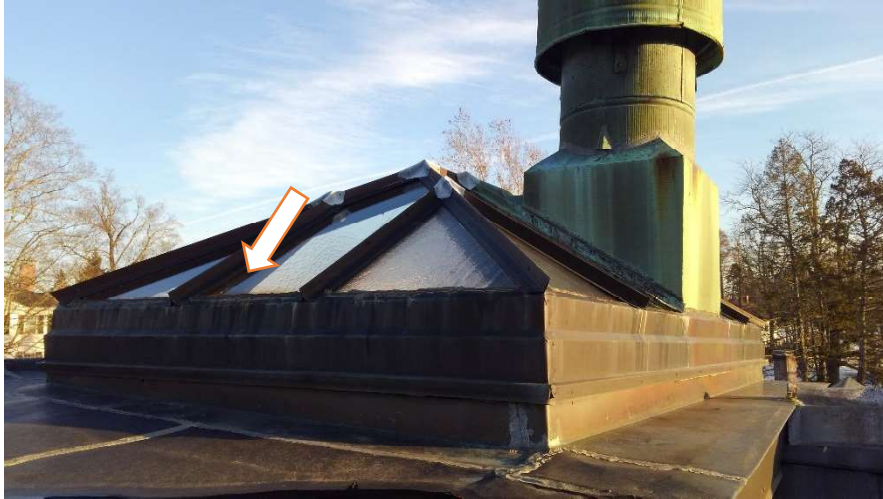
Photo 49 – Partial view of hipped skylight and edge metal at copper roof. Previous flashing repairs were observed at the skylight. The arrow indicates failed glazing seals that were observed. It also appears that some of the glazing has been previously replaced.

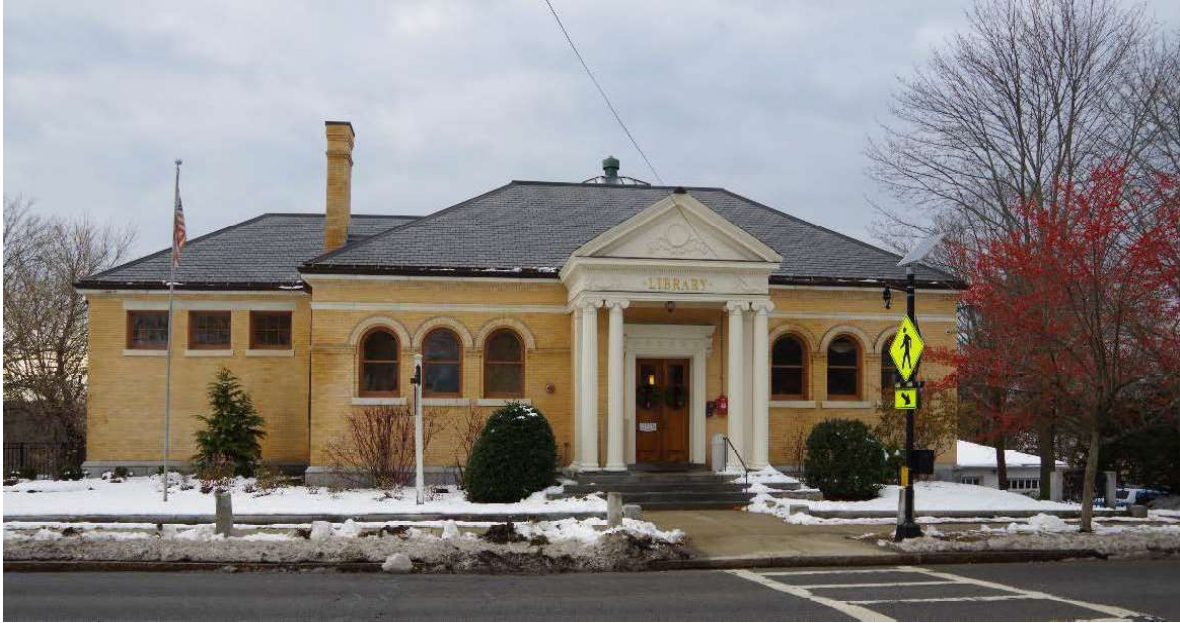
Photo 50 – Overall view of the east elevation. At the original structure, the above-grade exterior masonry walls are primarily constructed of 3-wythes of brick masonry. The main upper level elevation includes coursed granite water table, corbeled brick string course, brick roman arches, marble string course, and terra cotta and marble cornice. Lower level window openings (not shown) have granite sills and lintels. Upper level window openings have marble sills and either marble lintels or brick roman arches. The painted wood entrance portico appears to be in fair condition.

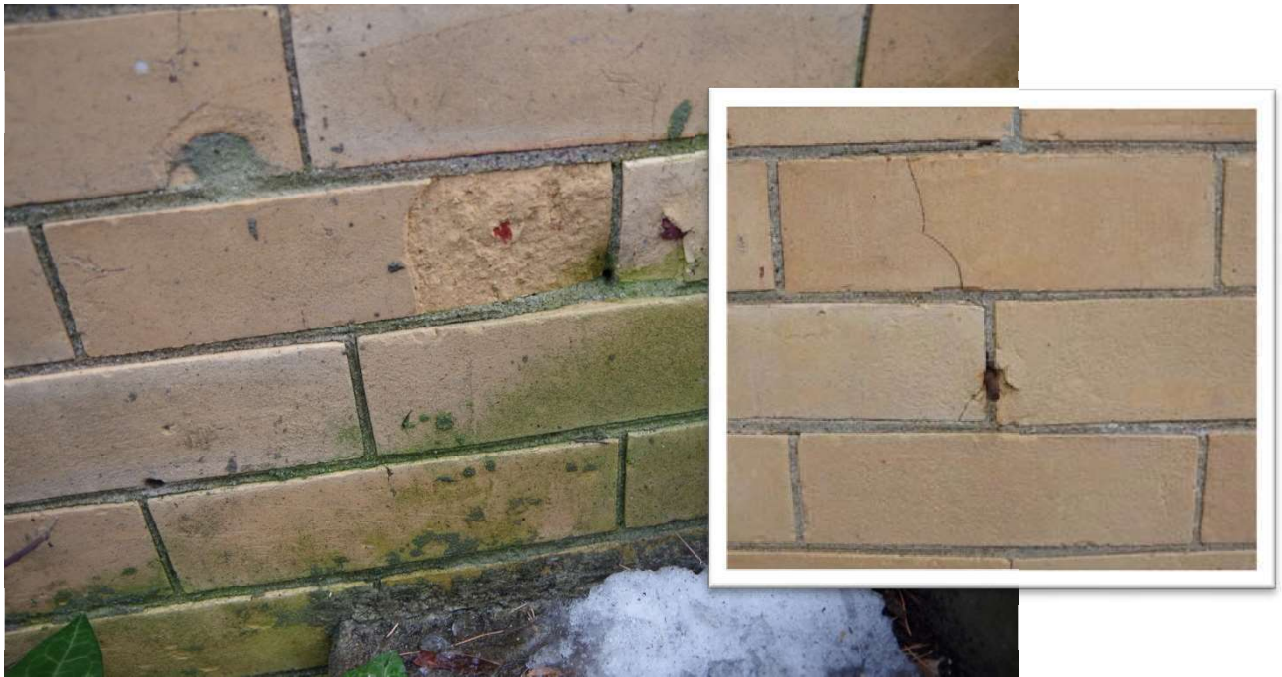
Photo 51 – The exterior brick masonry wythe is laid in a running bond. Isolated areas of cracked, spalled, and delaminated brick were observed throughout. Efflorescence, metal anchors, and vegetative growth were also observed.

The exterior brick masonry wythe is laid in a running bond. Brick masonry units measured approximately 8" (length) x 3-1/2" (width) x 2-1/2" (height). Isolated areas of cracked, spalled, and delaminated brick were observed throughout. Efflorescence, metal anchors, and vegetative growth were also observed.

5. Perform spot masonry repairs of brick masonry and deteriorated mortar at the 1893 library building.
 - a. Consider removal and replacement of existing flashings.
6. Perform spot repointing repairs of brick masonry and deteriorated mortar at the 1999 Library Addition.
 - a. Review condition and configuration of embedded flashings for potential sources of leaks.
7. Add new masonry expansion joints at masonry cavity wall areas in accordance with industry standards. Stabilize masonry on each side of the new joints with helical ties.
8. Perform additional exploratory of lower level window head leaks related to the precast concrete veneer and associated flashing and anchors.

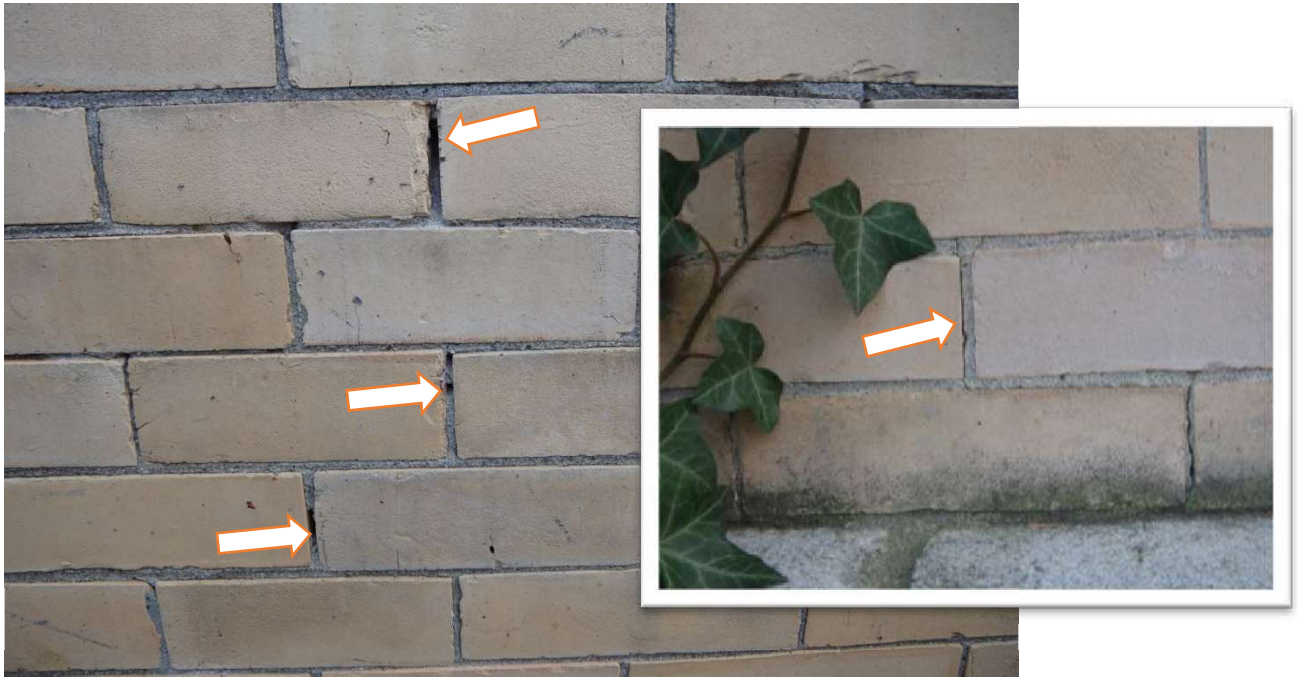
Photo 52 – The exterior mortar joints have a concave profile with a primary mortar type that appears to be original mortar. The secondary mortar type appears to be repair mortar. Overall, the original mortar appears to be in fair condition, however, isolated areas of open or debonded mortar and step cracking were observed.

The exterior mortar joints have a concave profile and measured approximately 1/8" to 1/4" wide. The primary mortar type appears to be original mortar (lime and sand). The secondary mortar type appears to be replacement mortar (Portland cement) from previous repairs. Overall, the original mortar appears to be in fair condition, however, isolated areas of open or delaminated mortar and step cracking were observed. The water table, string courses, and cornice appear to have the most concentrated areas of mortar deterioration.

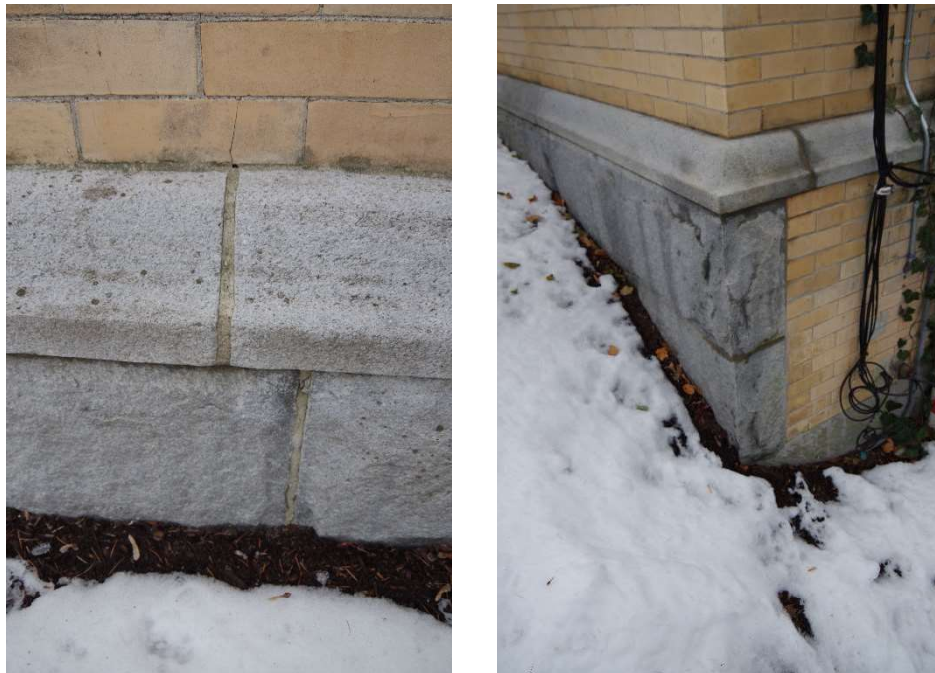
Photo 53 – Partial view of coursed granite water table and foundation. Overall, the granite and mortar appeared in good condition. The granite water table has a concentrated area of mortar deterioration at sky facing bed joints.

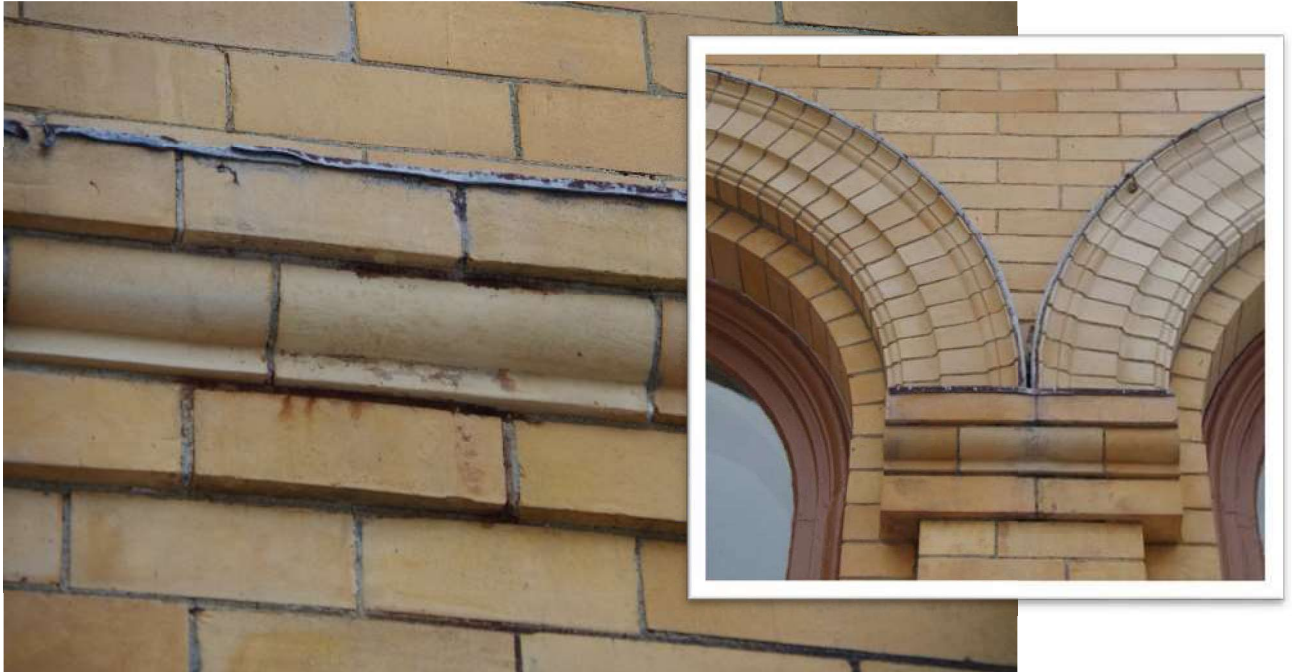
Photo 54 – Partial view of corbelled brick string course and roman arches. Weathered lead coated copper flashings were observed above the corbeled brick string course and roman arches. The string course has a concentrated area of mortar deterioration along its entire length.

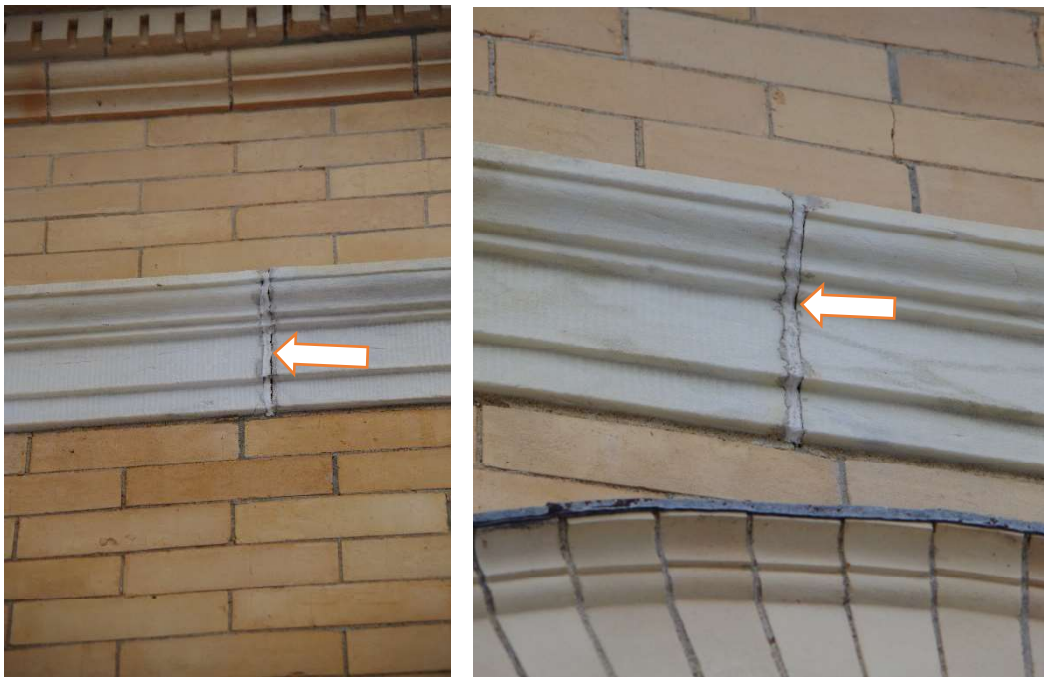
Photo 55 – Partial view of marble string course where mortar deterioration was observed at the head joints.

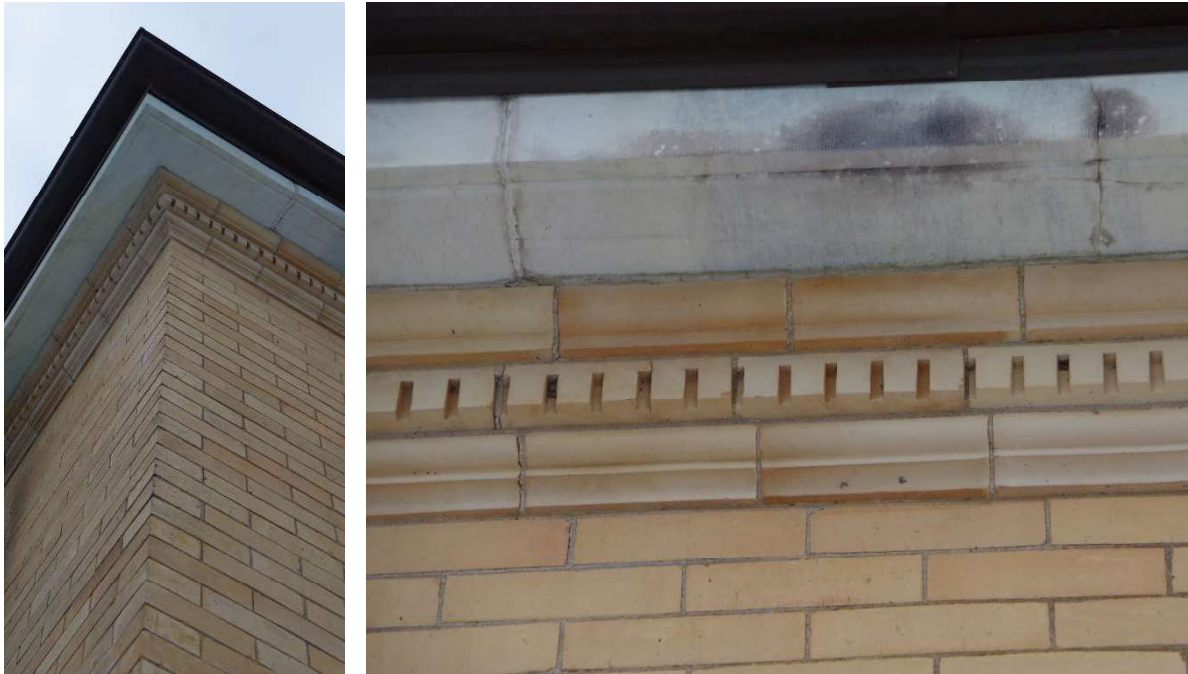
Photo 56 – Partial view of marble cornice where cracked and discolored stone was observed. Isolated areas of mortar deterioration were observed at both the marble and terra cotta elements of the cornice.

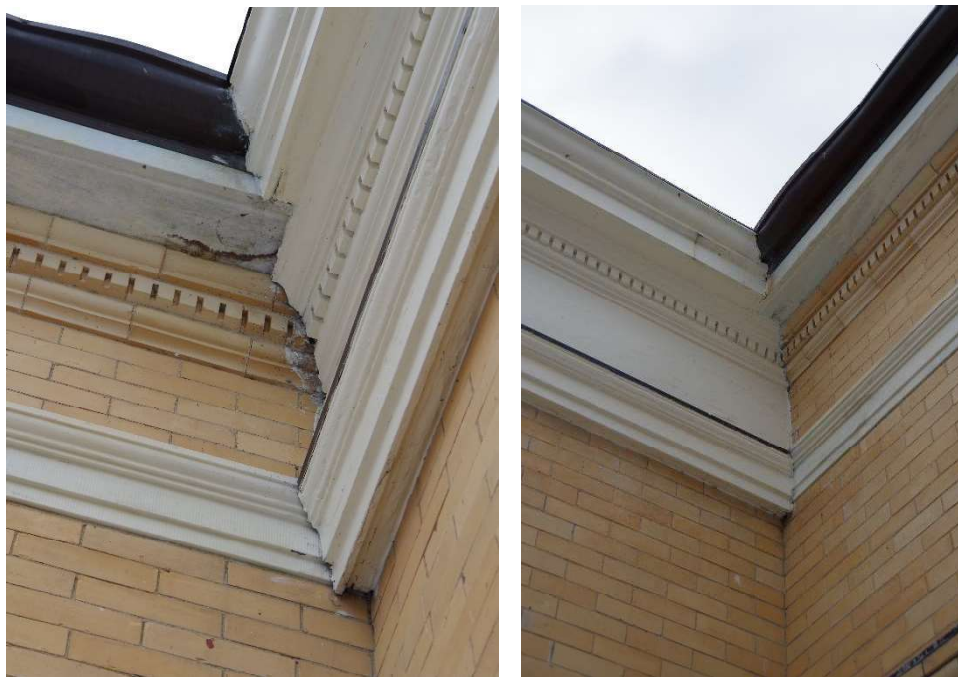
Photo 57 – Partial view of entrance portico's wood entablature transitioning to the stone and brick entablature of the east elevation. This is also where the wood gutter with copper lining transitions to the hanging copper gutter.

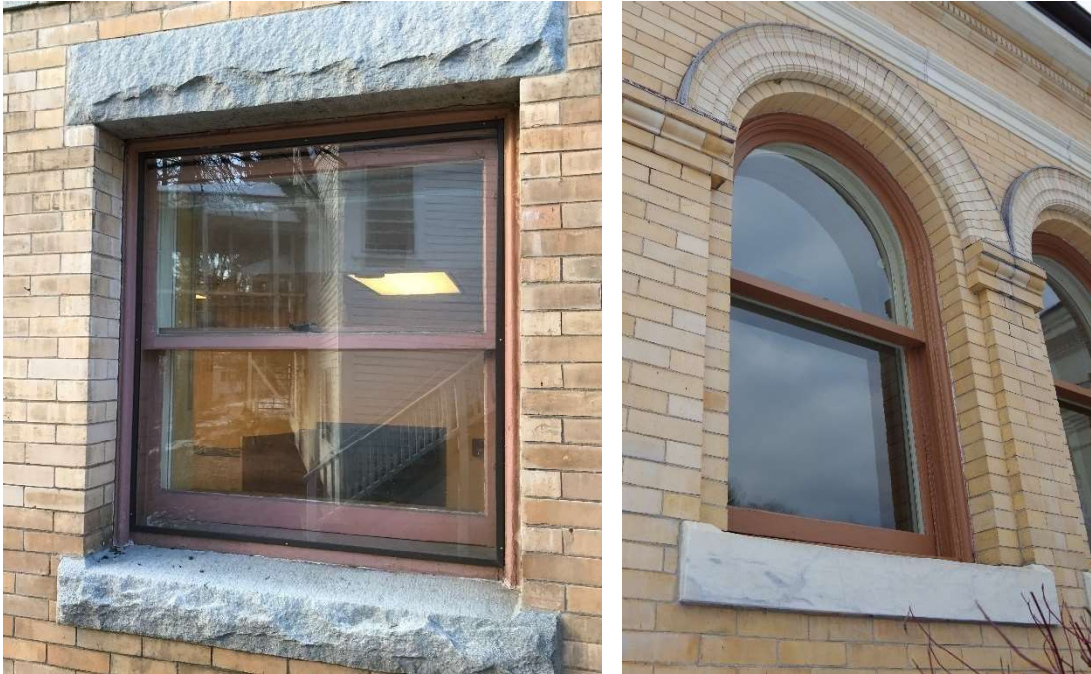
Photo 58 – Lower level windows appear to be wood, single-glazed, double-hung units with exterior painted wood brick mold. Window hardware appeared in poor condition and window sashes did not appear locked. Fixed exterior storms were observed at three lower level windows on the south elevation, for additional insulation and weather protection. Six upper level windows are wood, single-glazed, single-hung arch tops with exterior painted wood brick mold. Interior storm windows were installed at these window units for additional insulation. Exterior paint coatings appeared to be weathered and beginning to fail in several locations. Failed exterior perimeter sealants were observed at most locations.

At the exterior multi-wythe masonry walls, window units appear to be original hung and fixed, single glazed wood windows. Failed paint was observed at exterior wood brick molds and sills. Failed exterior perimeter sealant was observed at most window locations. At three ground floor locations, aluminum storm windows were fastened directly to the exterior wood trim. At several upper floor locations, interior storms were installed. Perimeter sealants were not observed at any (exterior or interior) storm window locations. Paint appeared in good condition at interior wood trim, stools, and aprons. Isolated windows appeared to have failed or broken hardware resulting in the windows to be left partially open.

GRLA recommends restoration of the wood window components, including replacement of paint coatings, sealants and hardware. Interior storm windows appear to be in good condition and may remain. Exterior storm windows are recommended to be considered for replacement.

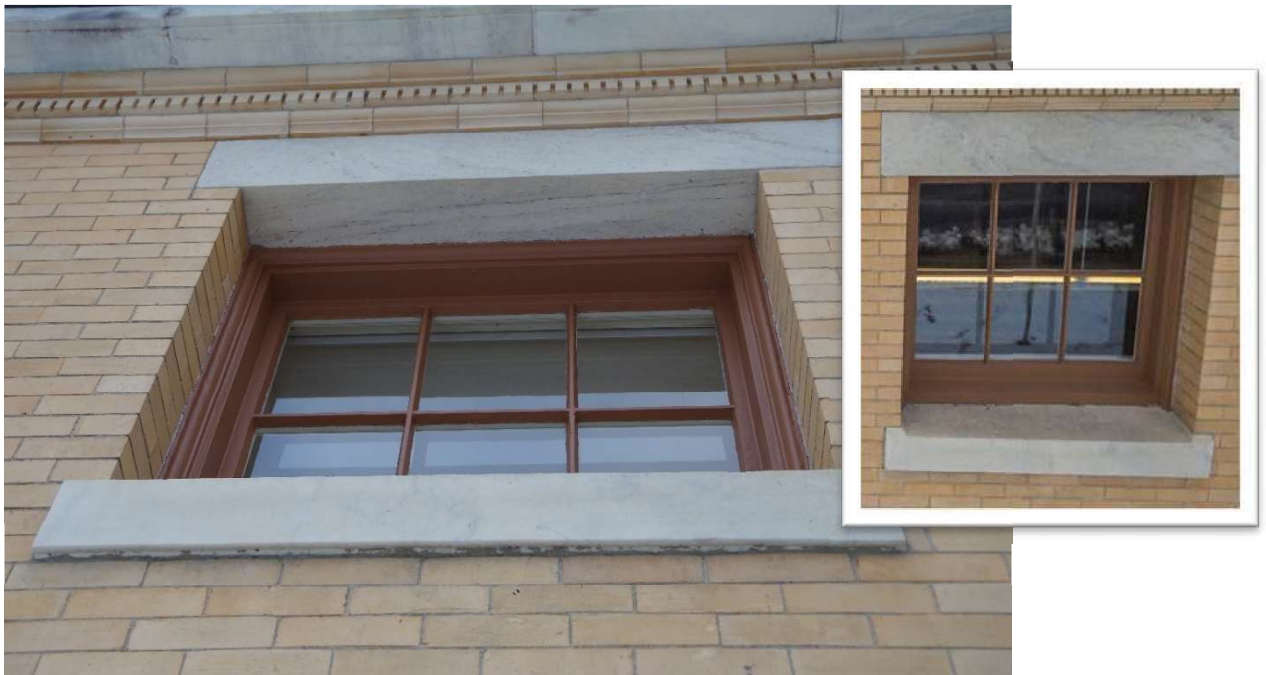
Photo 59 – Upper level wood, single-glazed, clerestory window with six lights and exterior painted wood brick mold appear to be in fair condition. Interior storm windows were installed at these window units.

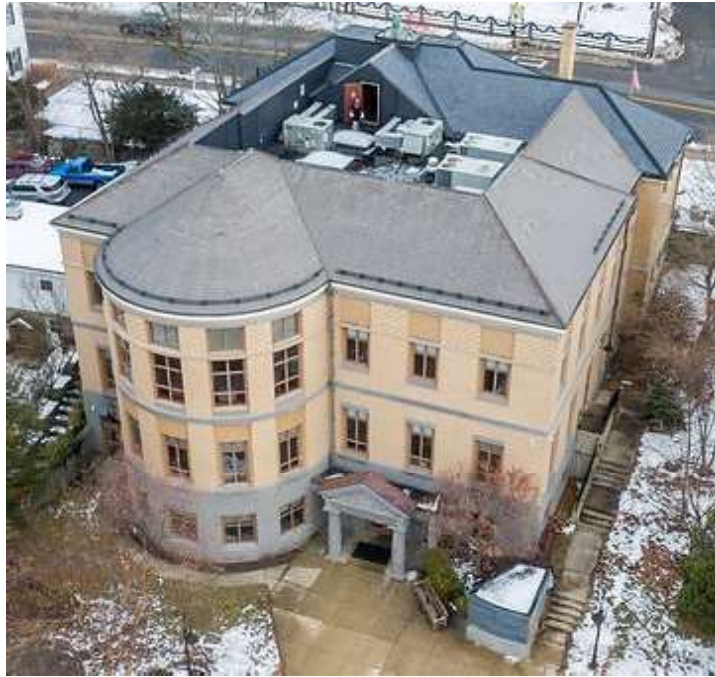
Photo 60 – The above-grade exterior masonry walls are primarily constructed of a brick or precast concrete veneer and CMU backup wall. At the west elevation, the lower level is a coursed precast concrete veneer with precast concrete water table. The middle and upper levels are brick veneer and include precast concrete string courses, corbelled brick string courses, and a corbelled brick and fiberglass cornice.

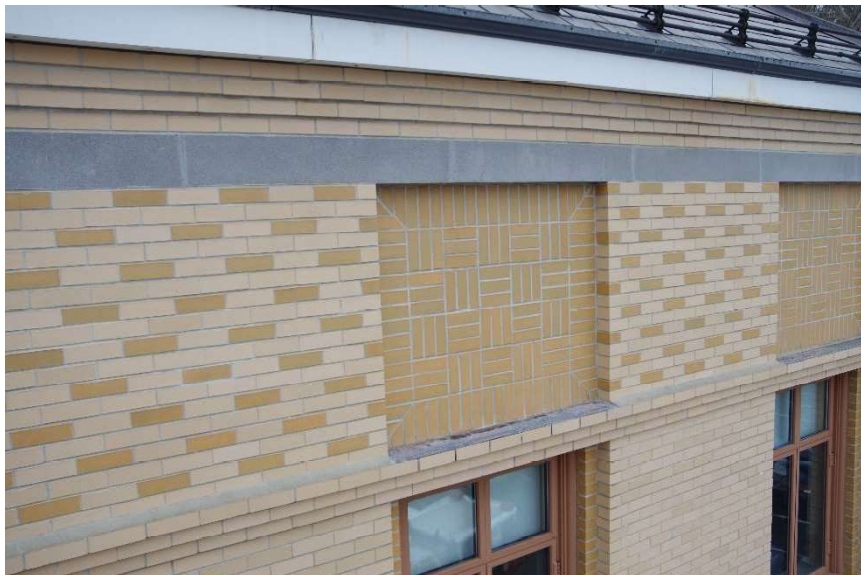
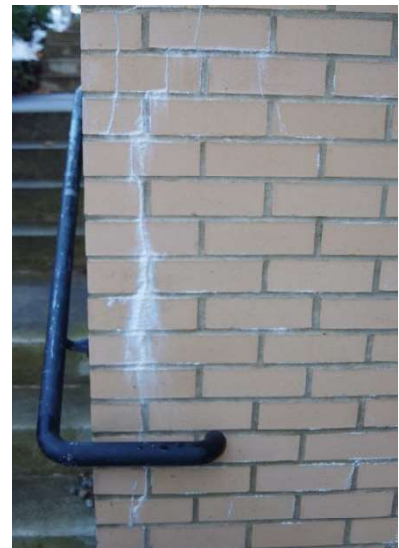
Photo 61 – The primary area of the exterior brick veneer is laid in a running bond and concave mortar profile. Secondary areas are laid in a Flemish or basket weave bond. Overall, the brick units were observed to be in good condition with isolated areas of deterioration including step cracks and efflorescence.

The primary area of the exterior brick veneer is laid in a running bond. Secondary areas are laid in a Flemish or basket weave bond. Brick masonry units measured approximately 7-3/4" (length) x 3-5/8" (width) x 2-1/2" (height). Overall, the brick units were observed to be in good condition with no major defects. Isolated areas of efflorescence were observed.

Brick masonry expansion joints in the veneer did not appear to be spaced per industry standards and may be responsible for isolated step cracking in the veneer. Industry standards recommend vertical expansion joints be placed in the brick masonry veneer approximately every 20 to 25 feet to reduce the potential for cracking and displacement of mortar. GPL may wish to consider adding brick masonry expansion joints near building corners and at windows with signs of step cracking. GRLA recommends stabilizing the masonry on each side of the joint with additional reinforcement prior to cutting new expansion joints.

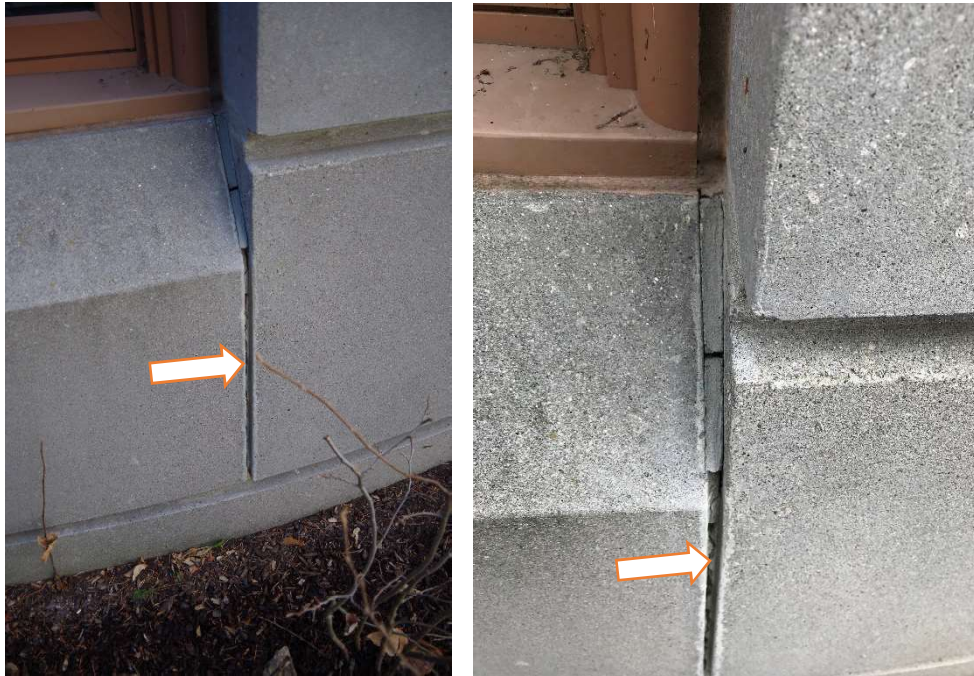
Photo 62 – Isolated areas of cracked or open mortar joints were observed at the areas of precast concrete veneer, particularly at the window sills.

The exterior mortar joints have a concave profile and measured approximately 3/8" wide. Overall, the mortar (Portland cement) appears to be in fair condition, however, isolated areas of open or delaminated mortar and were observed. The precast concrete coursing, precast concrete water table, corbelled brick string courses, and corbelled brick cornice appear to have the most concentrated areas of mortar deterioration.

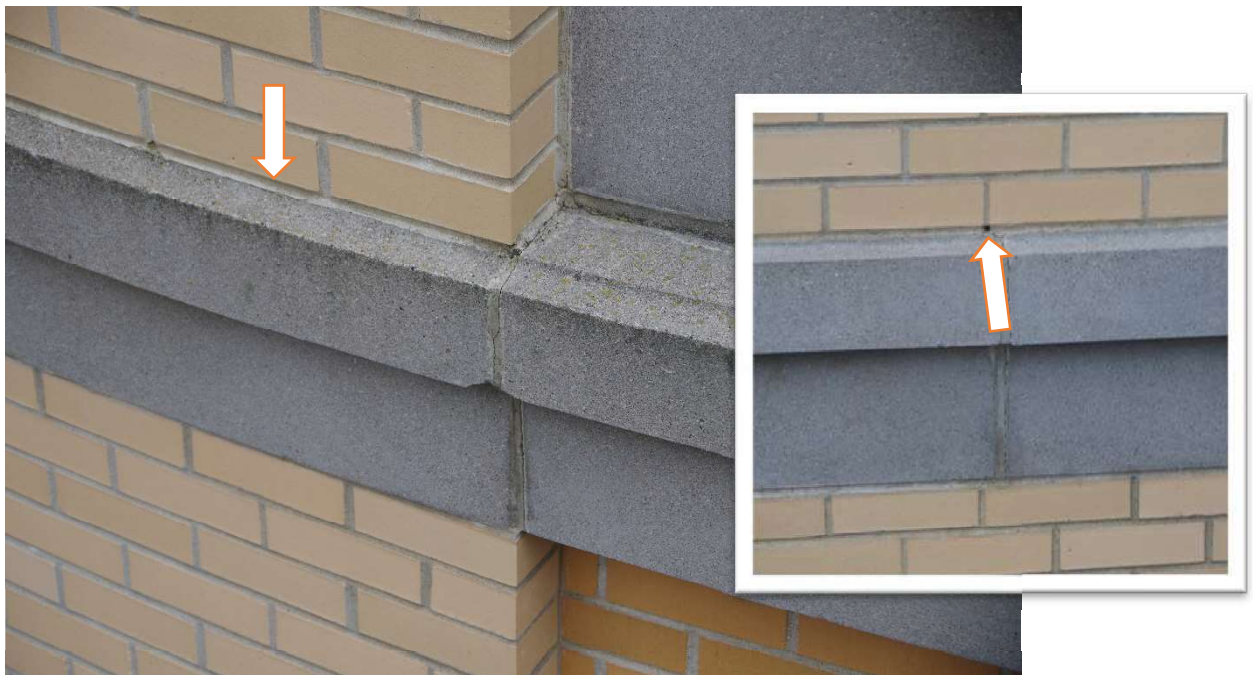
Photo 63 – Sheet metal flashings shown on the original design drawings are not visible from the exterior and may be embedded within the masonry mortar joints at typical locations throughout the building including above window heads, stringer courses and transitions between the brick masonry and precast veneer. Weep holes were observed above the precast stringer courses, indicating likely flashing locations.

Sheet metal flashings appear to be embedded in the mortar joints at select locations evidenced by weep hole openings at window heads and similar locations. Flashings do not extend out beyond the plane of the brick veneer, which may allow moisture to bypass below the flashing and infiltrate other areas of the wall cavity or building interior.

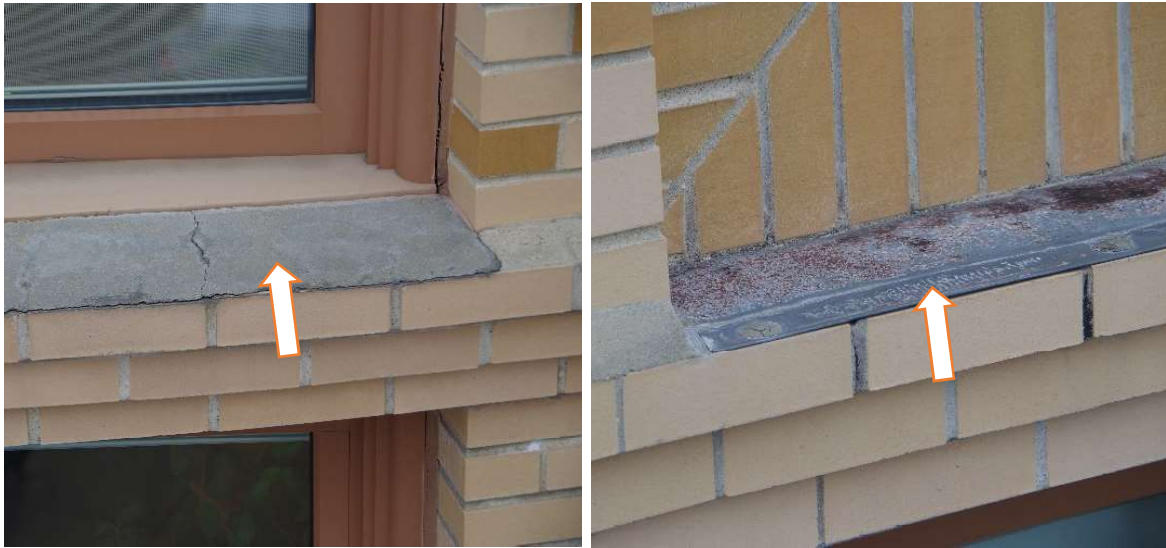
Photo 64 – Mortar cants/washes are installed above the corbelled brick stringer courses in several locations to shed water off of the horizontal surfaces. At isolated areas, this mortar cant/wash is cracked or spalled. Other areas were observed to have lead coated copper flashings atop the corbelled masonry in lieu of the mortar wash.

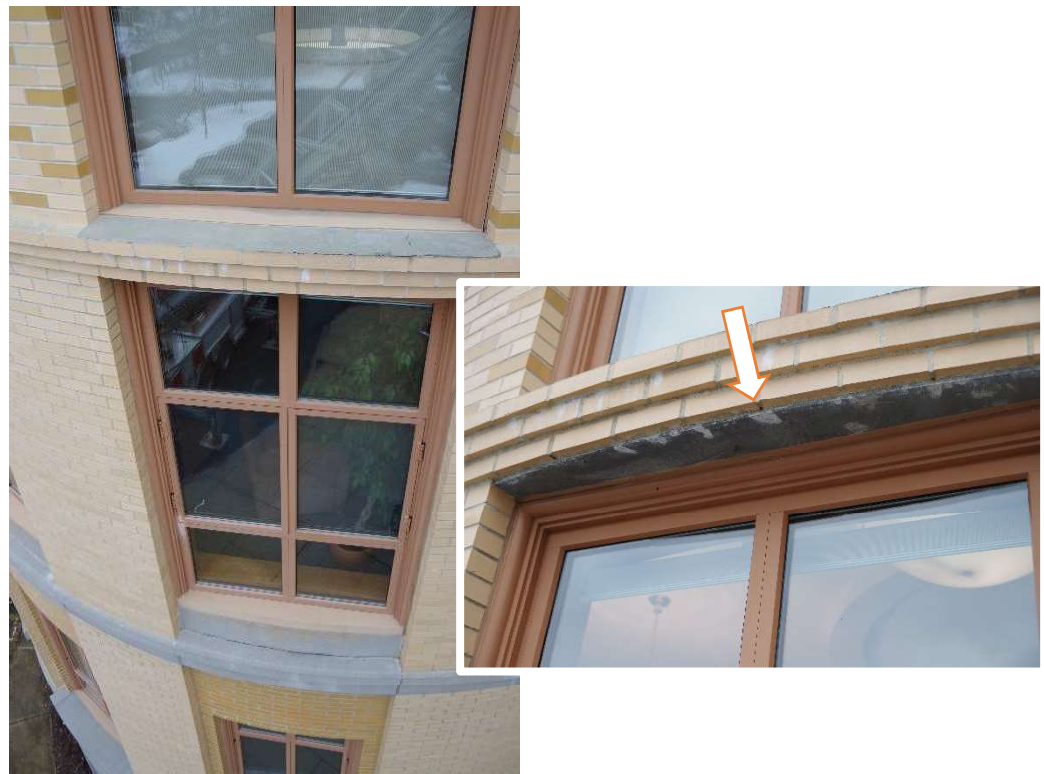
Photo 65 – Aluminum framed windows consist of fixed and project out casement operation with insulated glazing. Embedded steel lintels to support the masonry veneer components above the window were not partially visible and consist of galvanized steel. Weep holes and moisture stains observed above lintels appear to indicate the presence of embedded flashings.

At the exterior masonry cavity walls, window units are aluminum casement and fixed windows. Exterior casings and sills are also aluminum. No exterior paint defects were observed at the window units, casings, or sills. Interior casements and stools were primarily wood. However, interior gypsum returns were also observed at some locations. Failed exterior perimeter sealants were observed at most window locations. Isolated areas of water staining were observed at these interior finishes.

GRLA recommends the removal and replacement of window perimeter sealants at these window units.

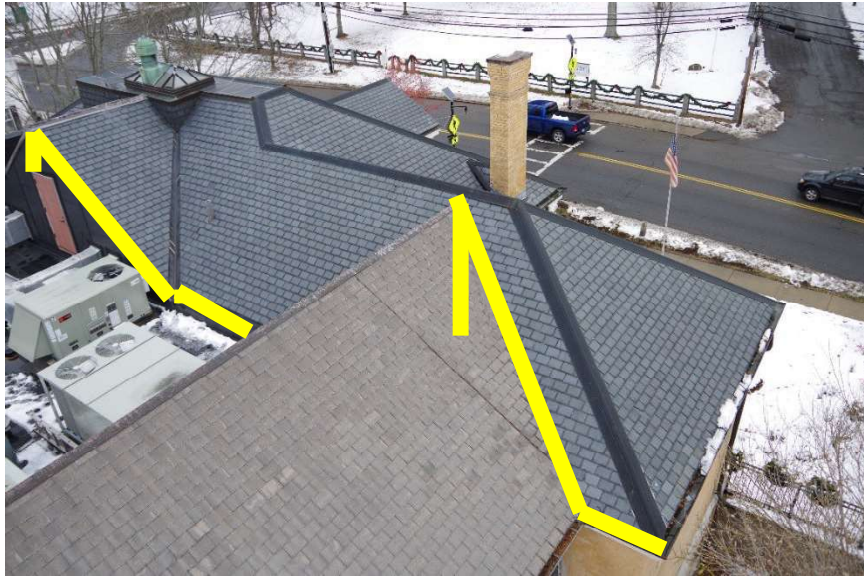
The slate roofing system at the original Groton Library Building is approximately 125 years old. In general, the existing slate roof system appears to be in fair condition; however, the slate shingles shown signs of age related deterioration including isolated cracked, broken, and missing shingles.

Partial view of the steep-slope, slate shingle roof system. The yellow line indicates the approximate limits of the slate roof area on the original library building. The roof system consists of gray slate shingles in a uniform pattern with open copper valleys and copper ridge and hip caps. Generally, the slate shingles appear to be in fair condition, however, cracked, broken, displaced, and missing slate shingles were observed throughout the roof.

Based on the conditions noted above, the removal of slate shingles at the roof eaves around the perimeter of the building and valleys is recommended to install ice and water shield membrane further up the roof slope (6'-0" minimum) to protect against moisture infiltration. Other repairs that should be considered include the removal and replacement of isolated cracked, missing, or otherwise deteriorated shingles. As this work will likely approach approximately 20% of the slate shingles, it is recommended that the slate roof system be considered for replacement. Removal and reinstallation of the slates could be considered, however, based on the advanced age of the shingles, the slates may become damaged upon removal or may not have enough service life remaining to make reinstallation cost effective as replacement can be expected to have a longer service life than reinstallation repairs.

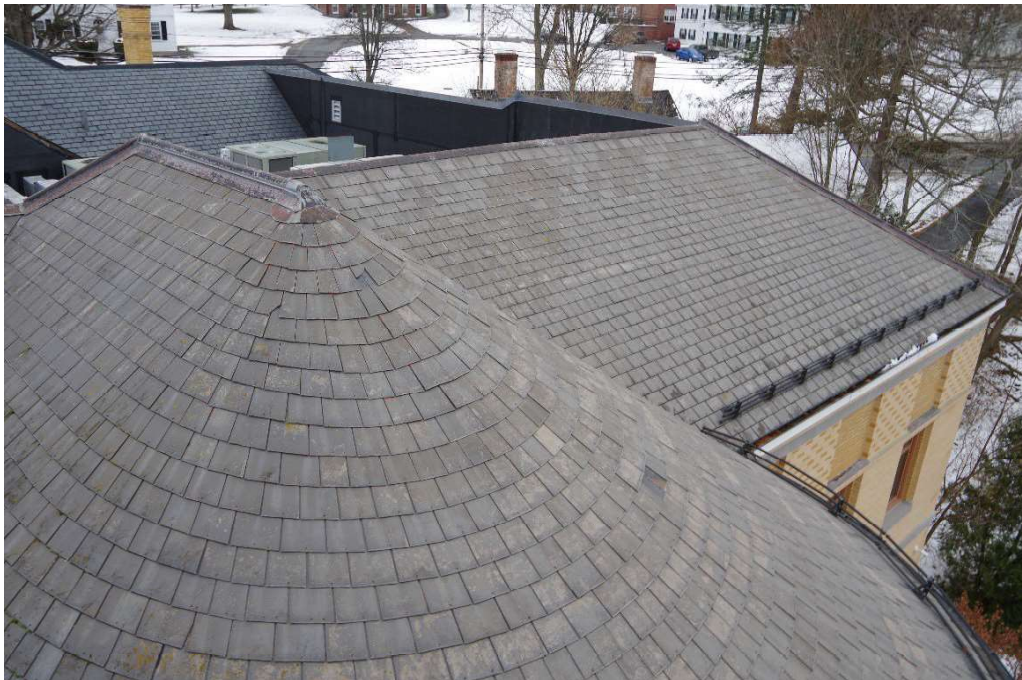
The existing sloped roof system on the 1999 library addition appears to consist of fiber cement based synthetic slate shingles. Although GPL reported no leaks below the synthetic slate roof system, the existing synthetic slate shingles appear to be in poor condition with large scale discoloration of the shingles, cracked and broken shingles, as well as large areas of vegetative growth on the shingles.

Partial view of the steep-slope, synthetic slate shingle roof system. Overall, the synthetic slate appears to have a fairly uniform size and exposure throughout the roof surface. Most of the color has faded or worn off, leaving the base material color exposed. Sheet metal flashings consist of lead coated copper and are installed at the hips and ridges. The roof has open sheet metal valleys and lead coated copper gutters. A three-rail, pipe-style, snow guard system is installed along the majority of the building perimeter of the addition.

GRLA recommends removal of the existing synthetic slate roofing system and replacement with a new steep slope roof system. Several roof system replacement options may be considered including, but not limited to slate shingles, synthetic slate shingles, asphalt shingles, or sheet metal roofing. Due to the historic designation of the attached original library building, replacement roof system options for the Library addition may fall under review by the local historical commission. In addition to aesthetic considerations for the replacement roof system, structural conditions may affect which replacement roof system is most desired as differences in dead load between the existing and new roof systems may affect structural dead load or wind uplift capacity of the roof system. As a preliminary recommendation, replacement with new slate shingles will be considered for the construction cost estimate.
