**CONSTRUCTION COMPLETION REPORT
SQUANNACOOK RIVER DAM
NID # MA00442
GROTON, MASSACHUSETTS**

**Haley & Aldrich, Inc.
Boston, Massachusetts**

Subject: Construction Completion Report
Squannacook River Dam
NID # MA00442
State Dam ID No. 4-9-115-1
Groton, Massachusetts

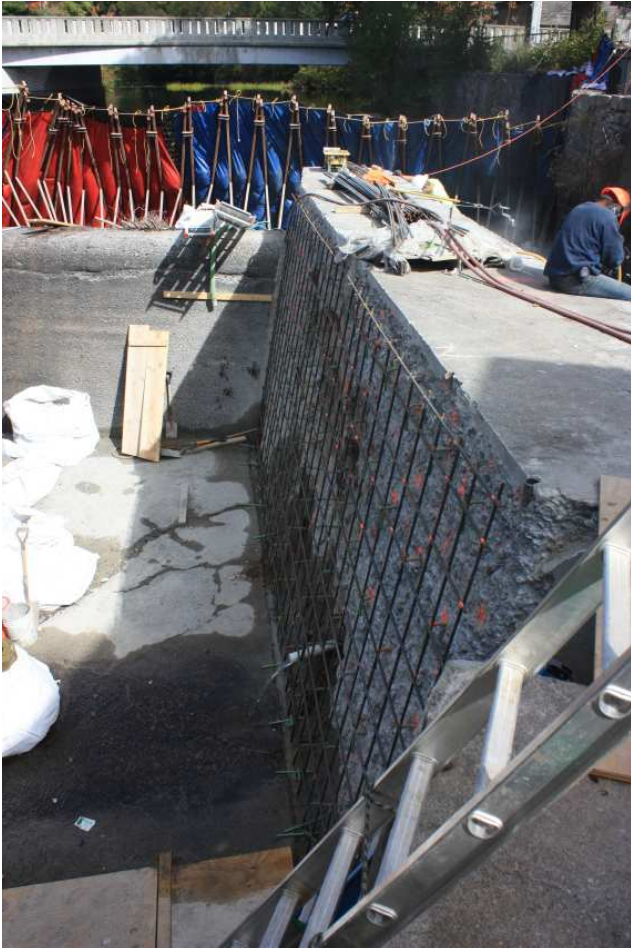
Removal of damaged concrete is ongoing on east side of sluiceway wall. Reinforcing layer and anchors already in place on west side wall. Nothing touched on apron.

West face – Sept 26, 2013

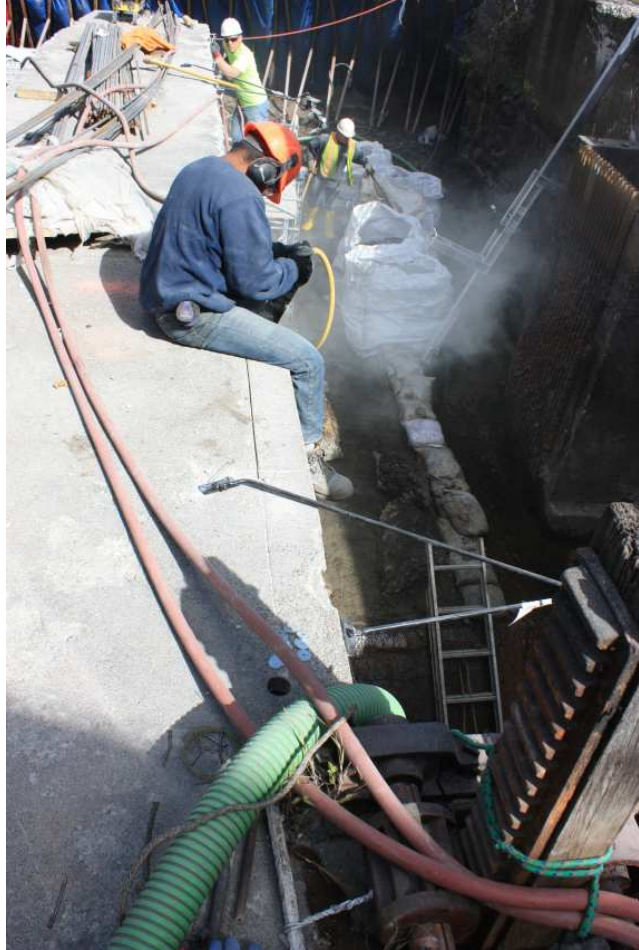
Top of east side – Sept. 26, 2013

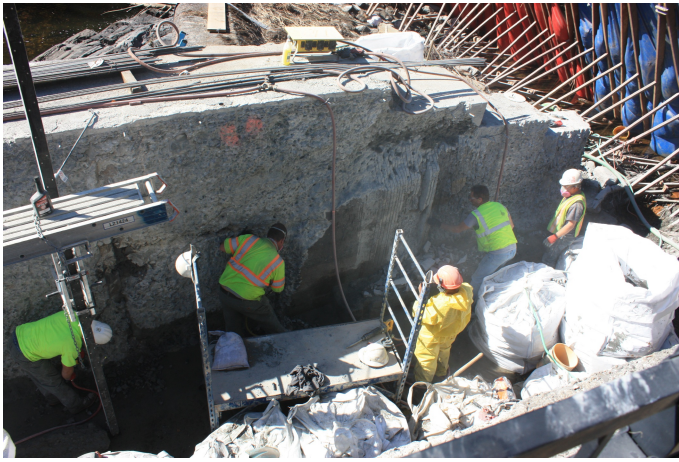
Removal of damaged concrete is ongoing on east side of sluiceway wall. Reinforcing layer and anchors already in place on west side wall. Nothing touched on apron.

Ongoing chipping on east side of wall

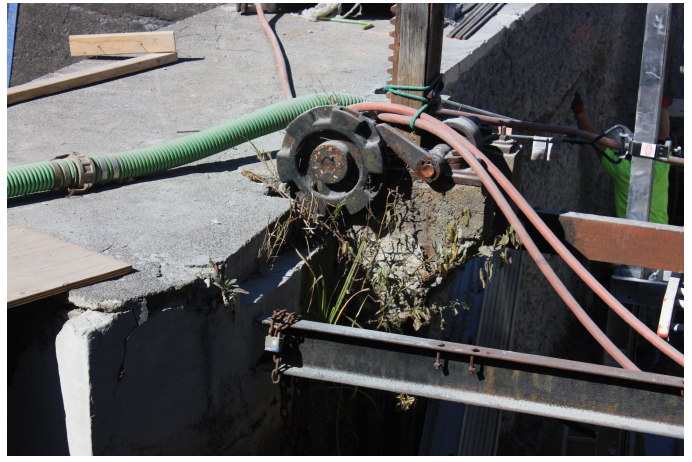
Concrete support for gearbox needs repair.

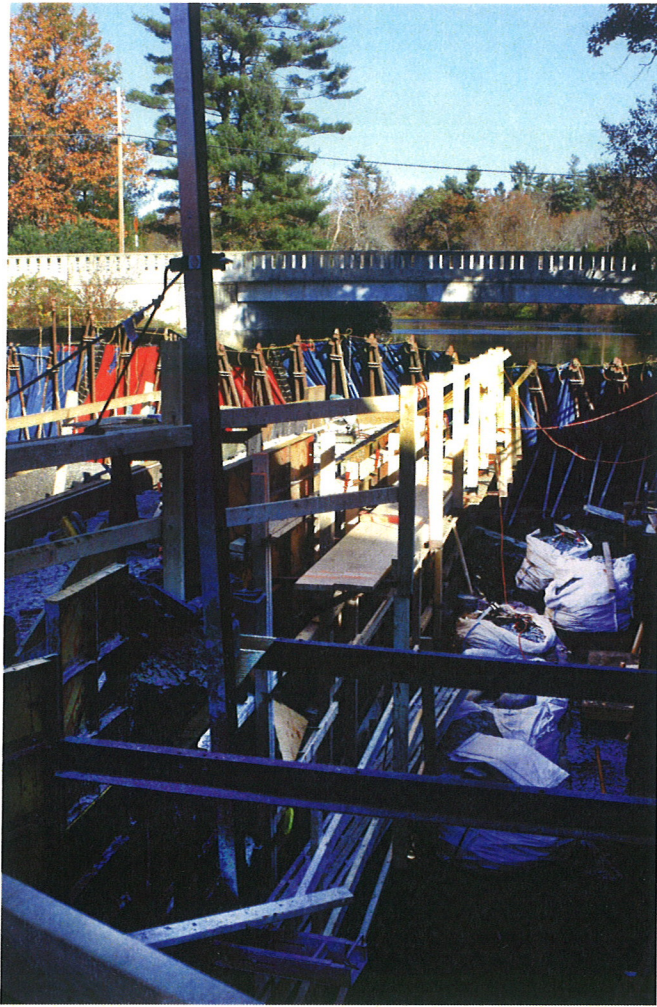
West Side Formwork in place.

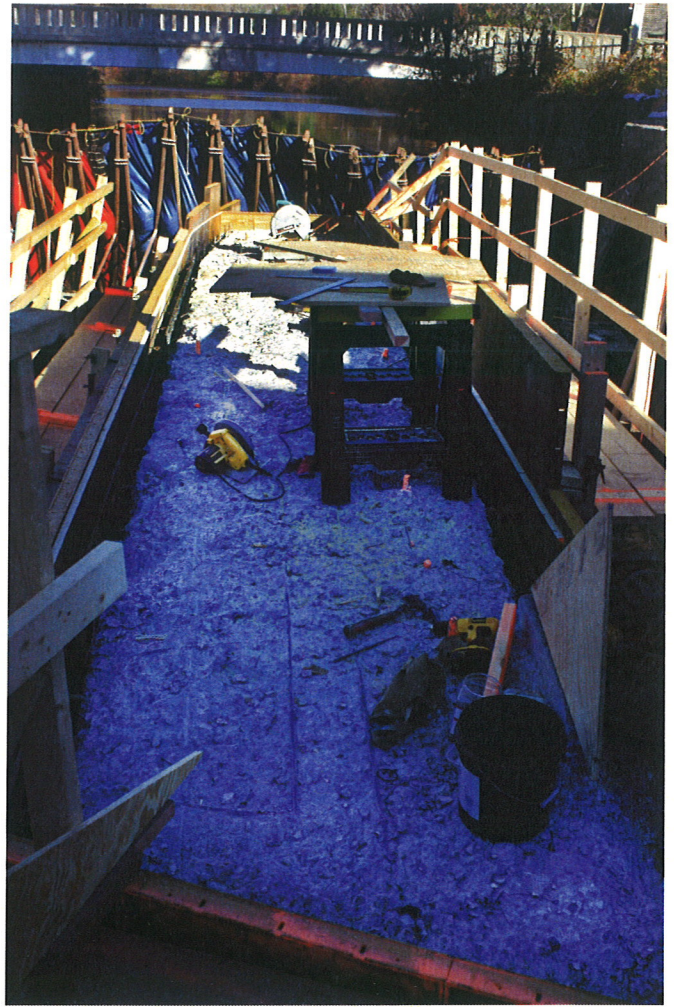
Top of Wall Prepped and Ready for Reinforcing
