# SQUANNACOOK RIVER DAM PHASE I INSPECTION / EVALUATION

**HALEY  
ALDRICH**

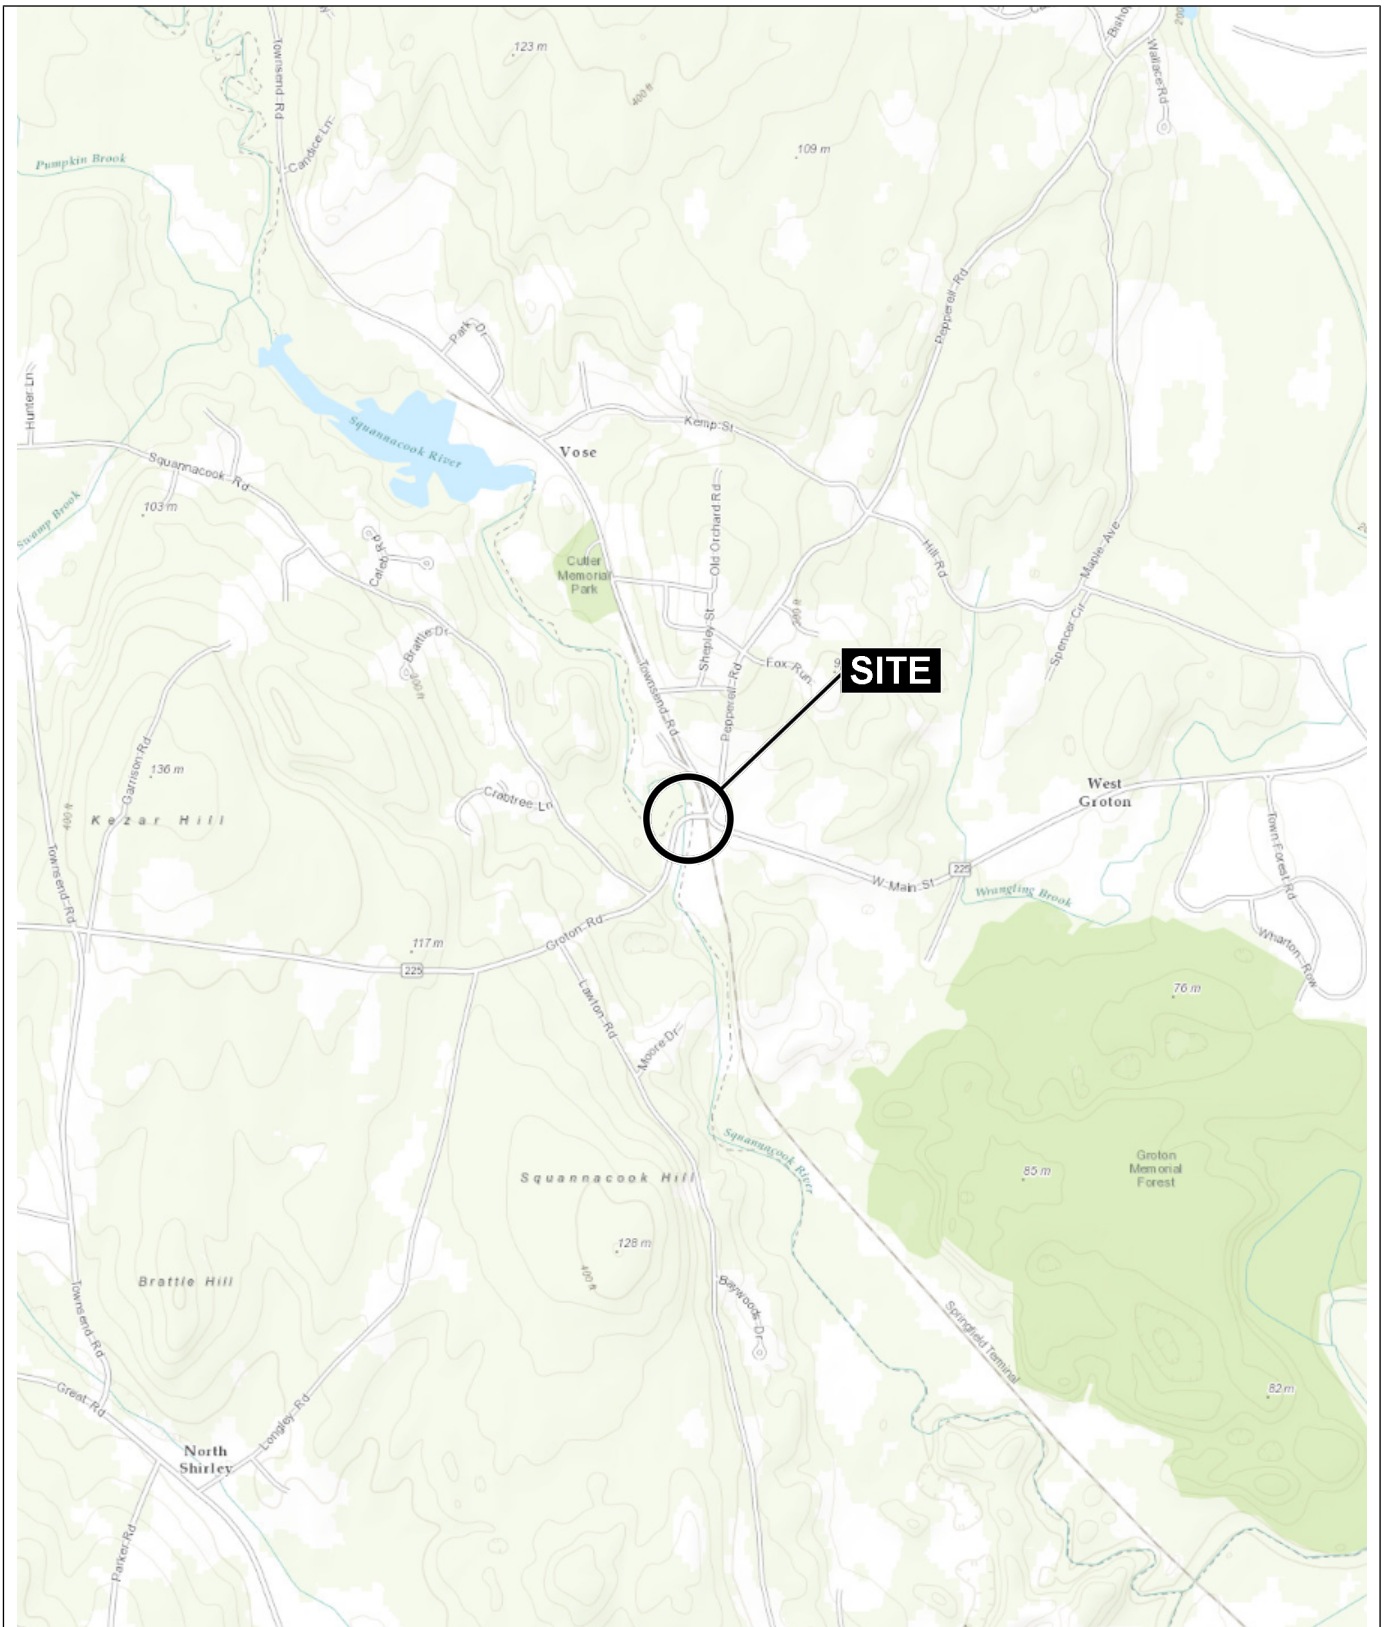
Total estimated repair cost for Squannacook River Dam is approximately \$306,000.
