TOWN OF GROTON, MASSACHUSETTS

SENIOR CENTER FEASIBILITY STUDY

FINAL STUDY REPORT

October 3, 2016

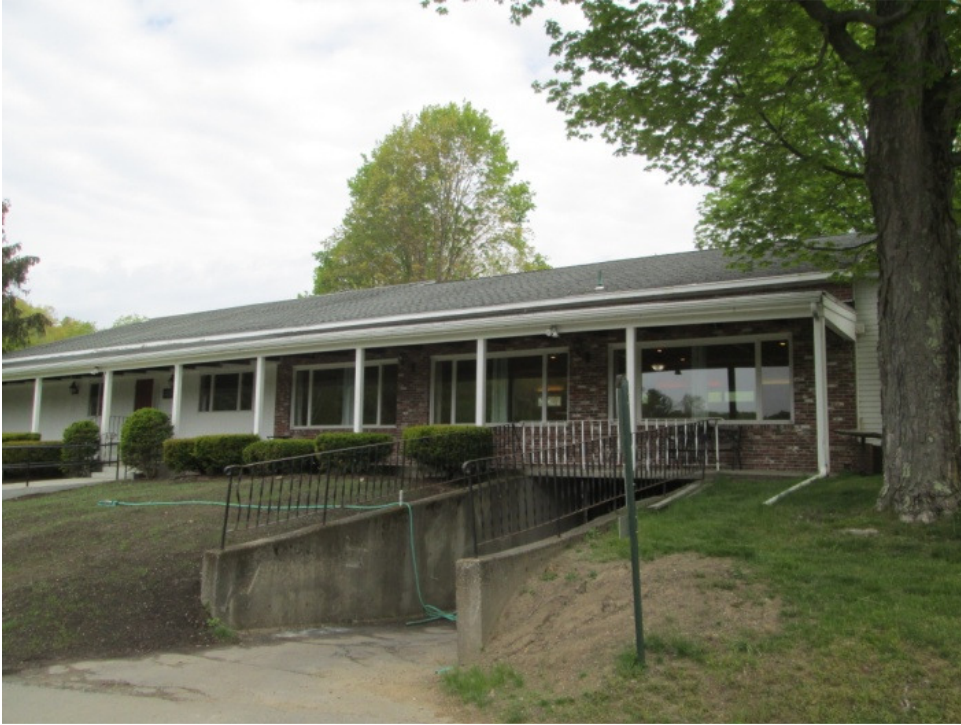
Photo CC4B: Main level is raised from surroundings and parking. The lower level is accessible through opening in foundation.

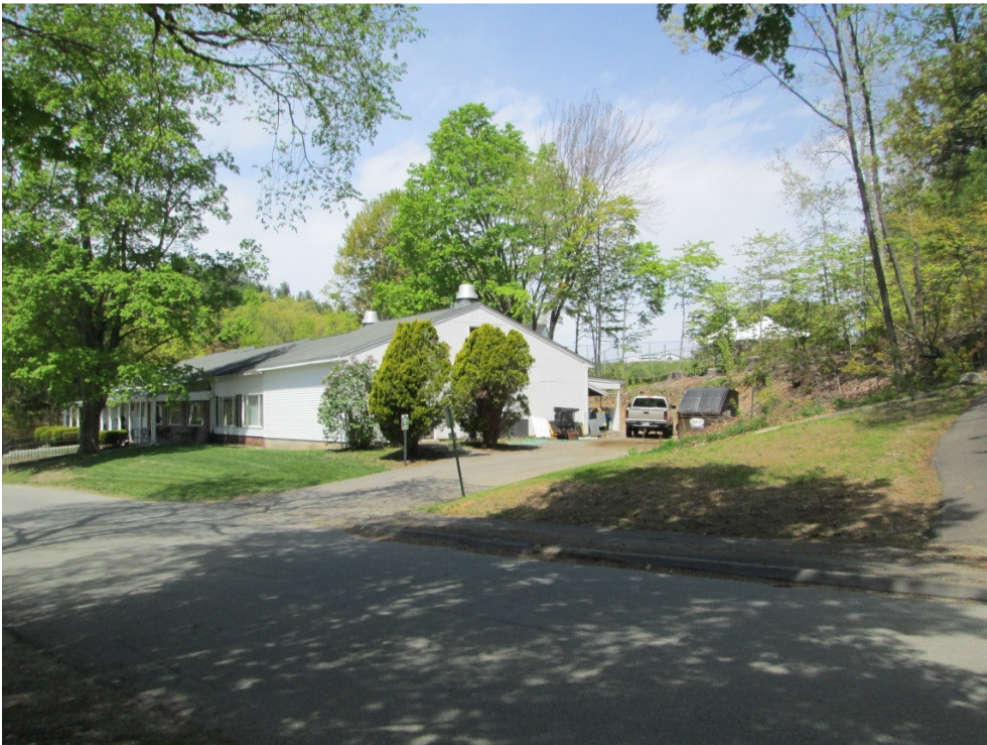
Photo CC4G: View from the 3 designated accessible parking spaces to the accessible entrance at the end of the building.

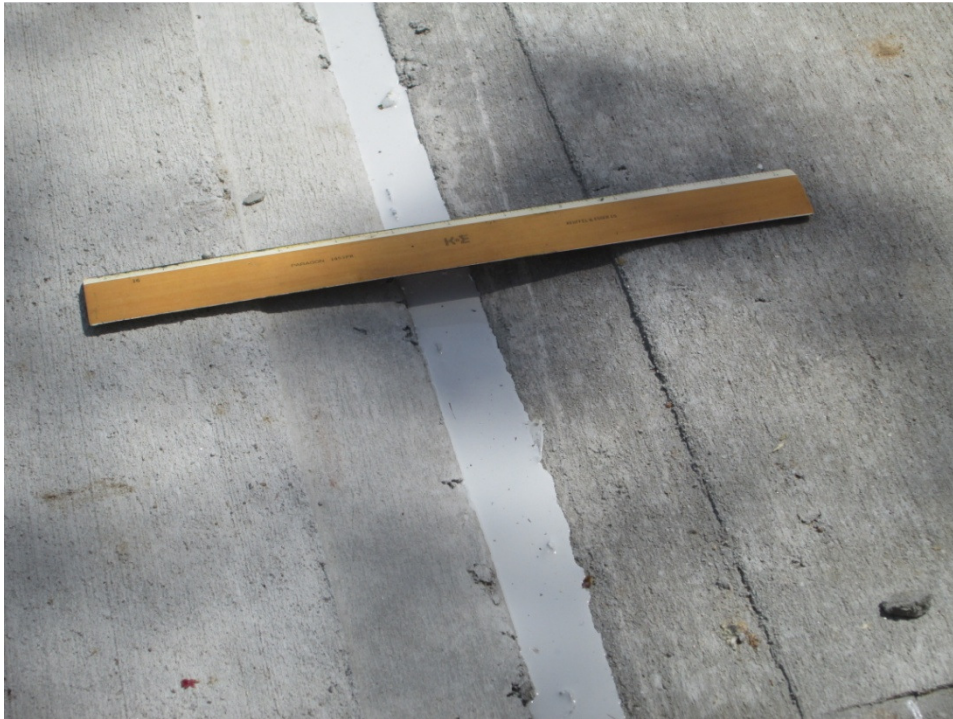
Photo CC2C: Tripping hazard near accessible entrance.

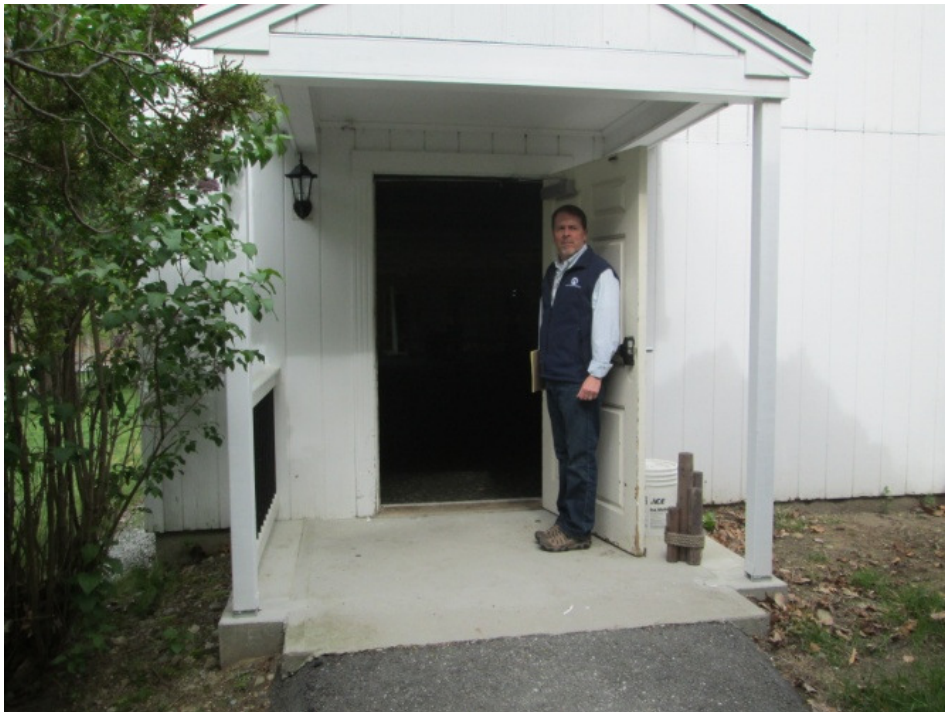
Photo CC4E: Accessible entrance is located at far end of building.

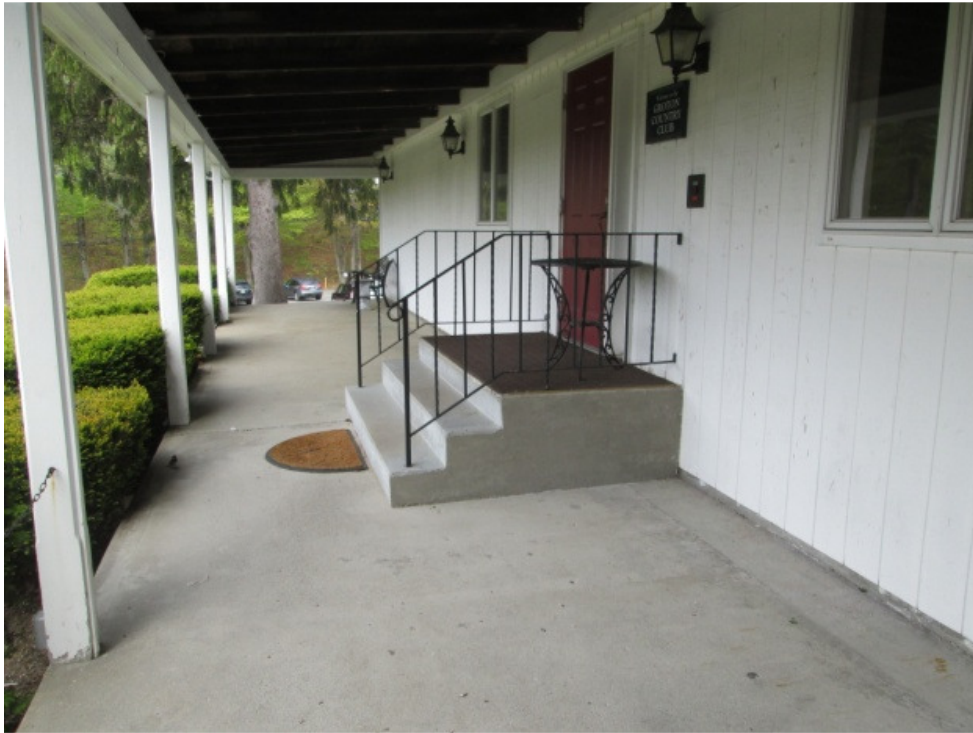
Photo CC4A: Primary entrance door to the building is not accessible.

- h) New accessible ramp to the primary entrance to the building. At current conditions, seniors wishing to enter the building through the primary entrance must climb a flight of stairs to reach the exterior covered patio. A remote accessible entrance already exists, but is located hundreds of feet away from the general parking area.

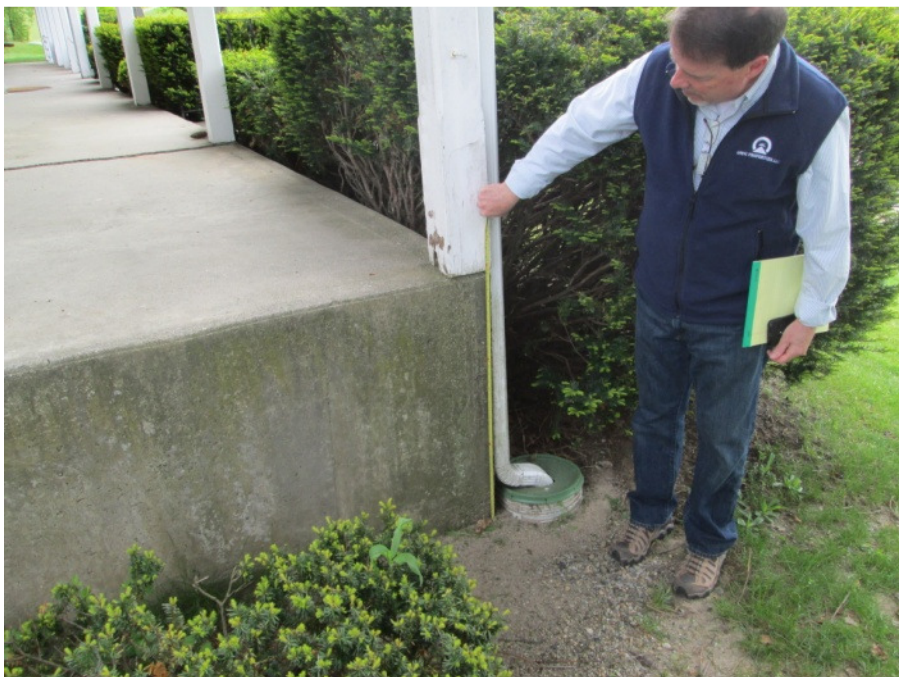
- a) The exterior steel guard railing allows passage of a 6-inch diameter sphere, is not code compliant, and represent a fall hazard for small children.
- b) Exterior covered patio lacks a guard railing at the end condition and represents fall hazard to persons.

Photo CC3A: Raised exterior patio lacks guard railing and represents fall hazard to users.

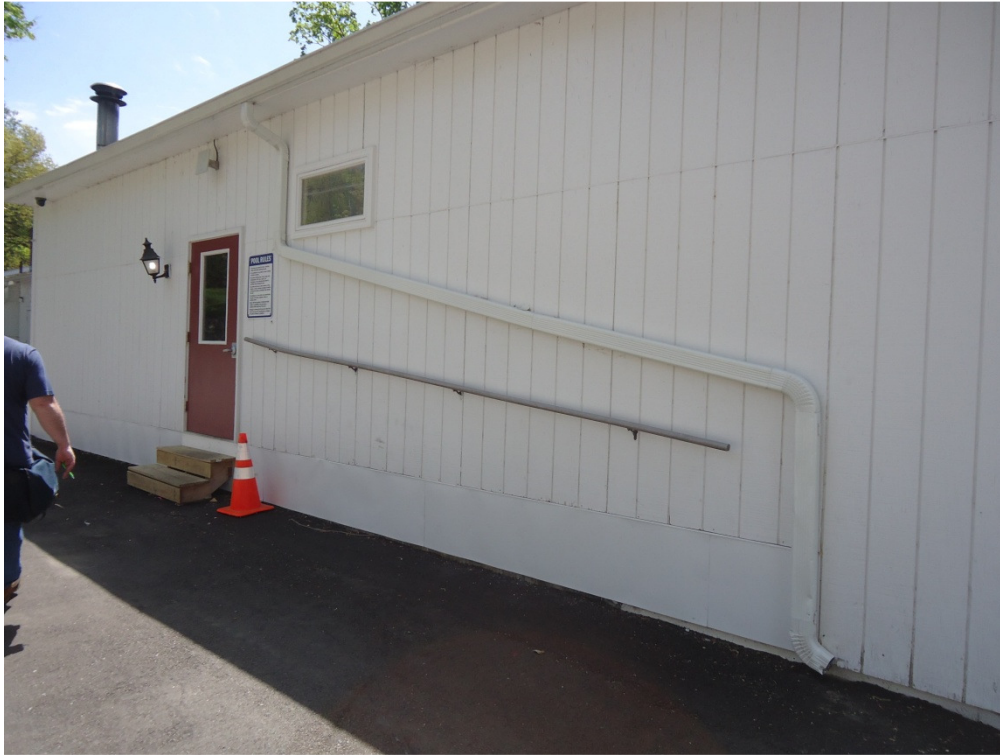
Photo CC7F: Where deteriorated wooden siding had occurred near the ground plane, current maintenance practice is to remove segments and replace with new panels.

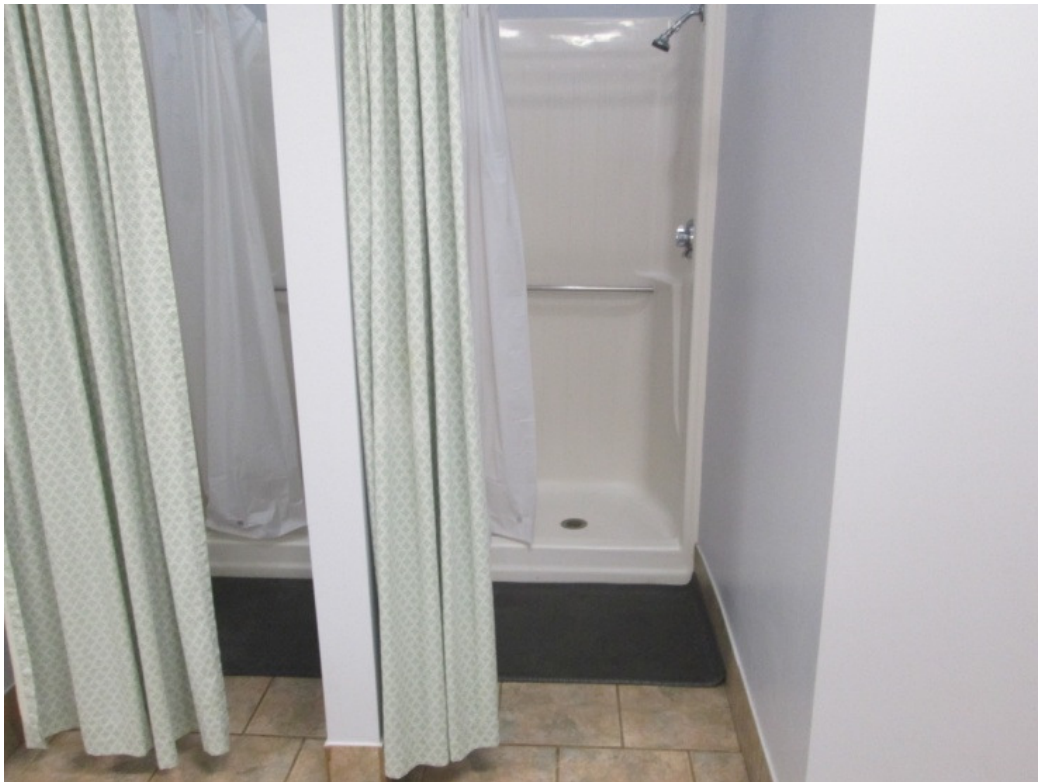
PhotoCC4D: Locker rooms lack numerous accessible features including accessible shower stalls and entrances.

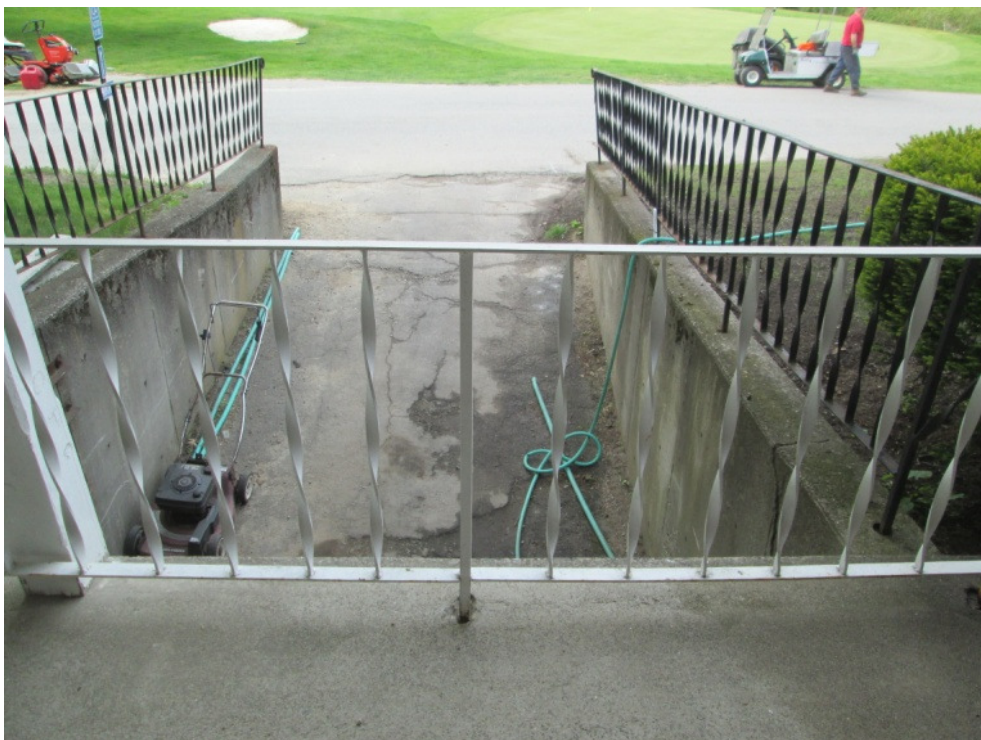
Photo CC3B: Fall hazards. Horizontal guard railing less than 42 inches in height. Spacing of vertical members exceeds 4 inches and allows passage of small child through railing.

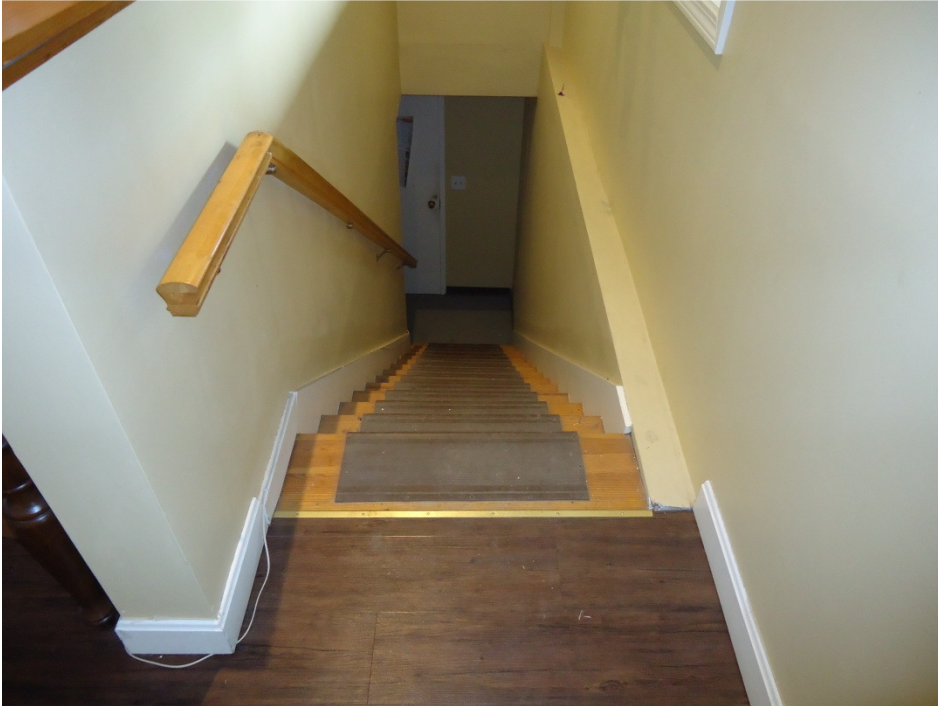
Photo CC10F: Existing stair to basement is 36 inches wide.

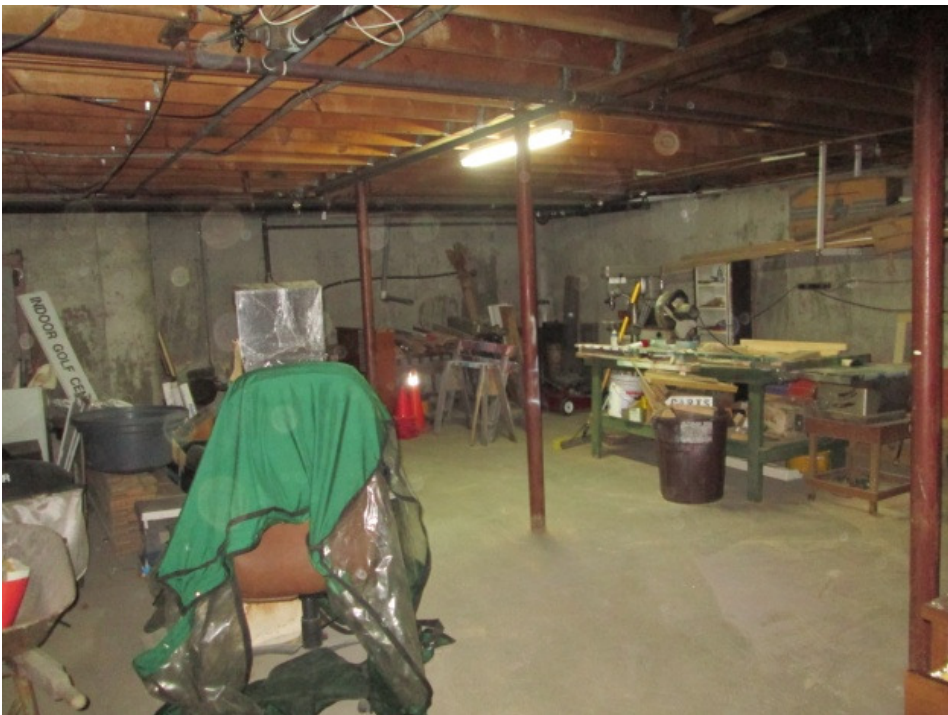
Photo CC5: Large, dry and open basement exists but space is windowless and lacks natural light.

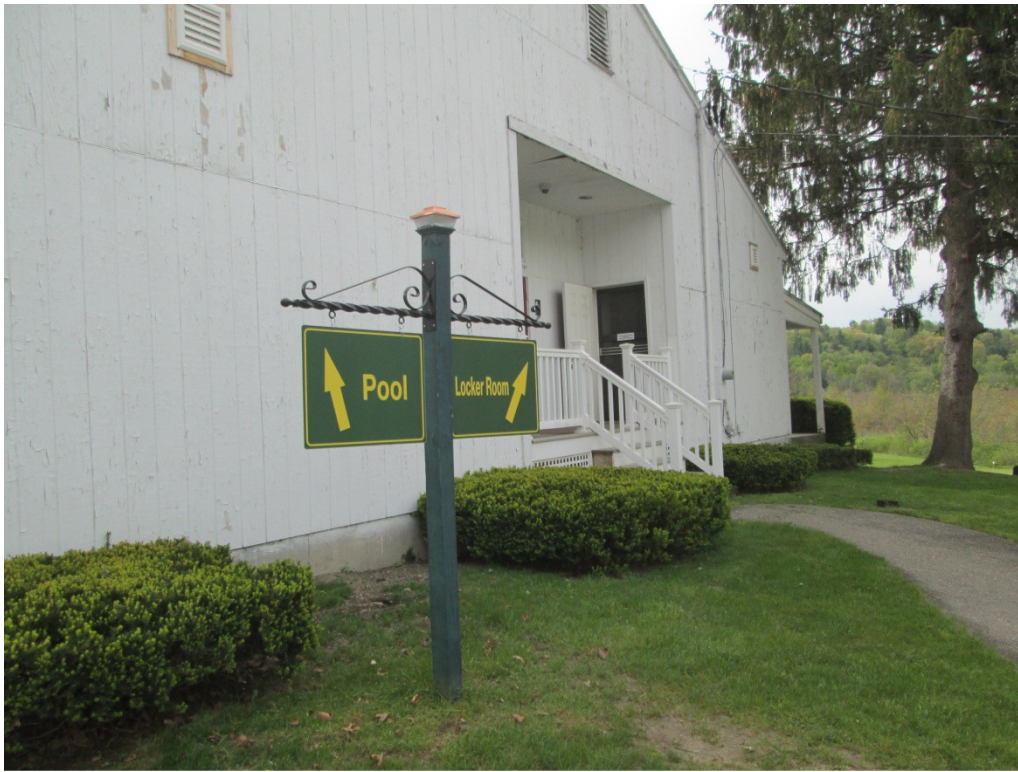
Photo CC4C: Inaccessible entrance to locker rooms.

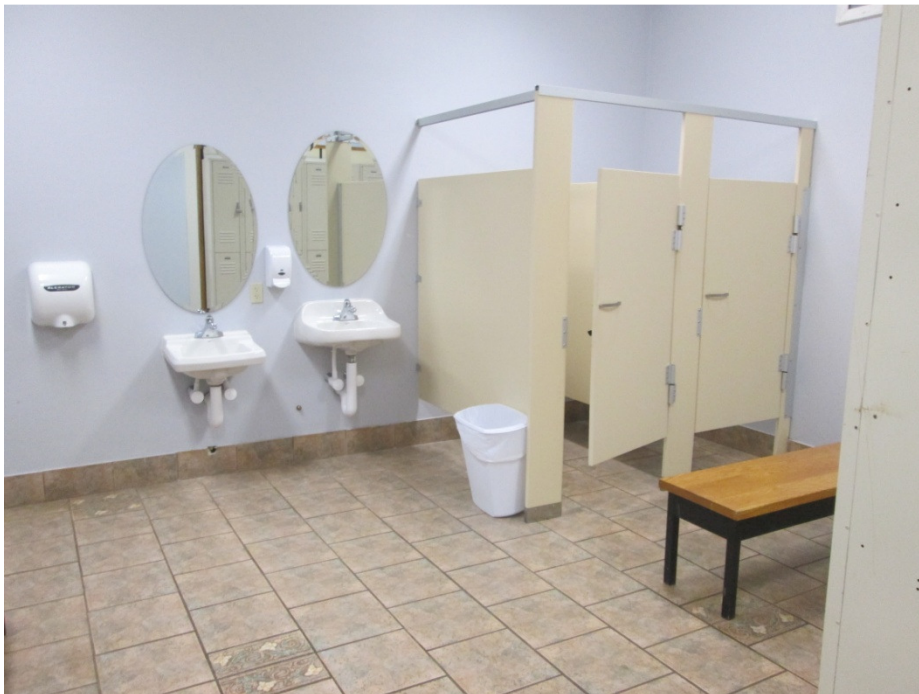
Photo CC4D: Locker room facilities at main level have received accessible upgrades since original date of construction. Conditions include non-accessible toilet stalls, mirrors at sinks not mounted at an angle to the user.

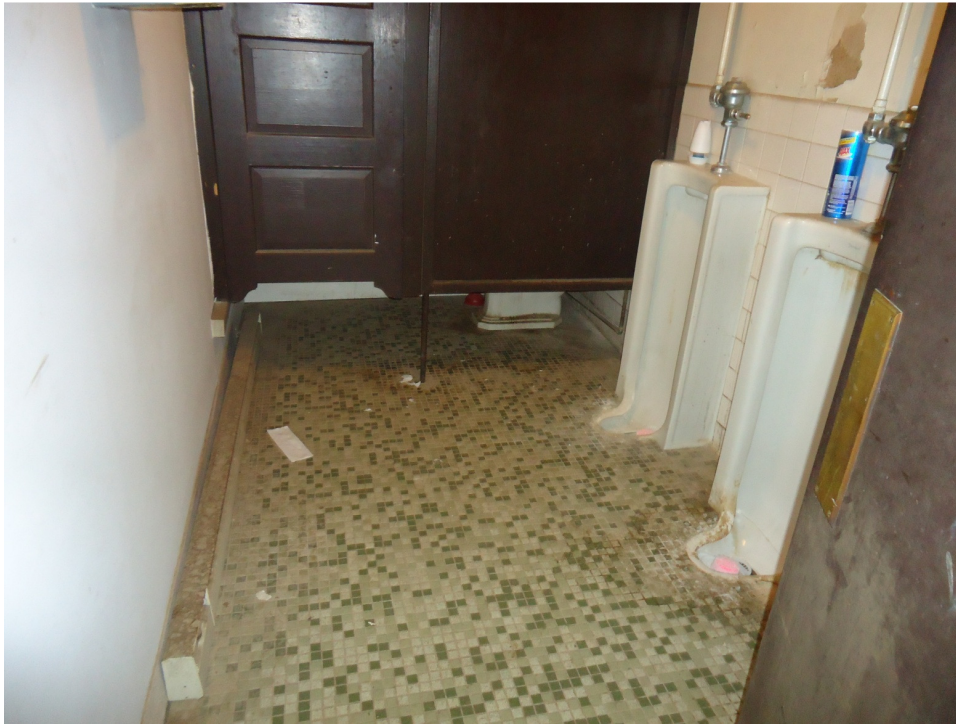
Photo CC4L: Toilet room facilities located at the basement level date to the original construction and have not received accessible upgrades.

- l) Renovate the basement toilet room facilities to current accessibility standards.
- m) Construct an entry vestibule to save energy costs.
- n) Add insulation in the attic to obtain R-40 for energy savings.

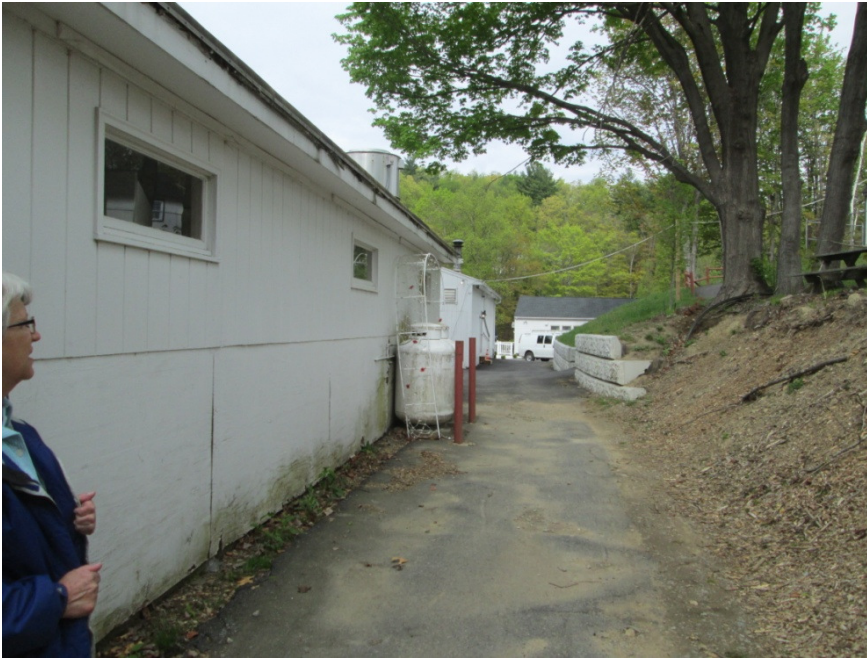
- c) Portions of brickwork are deteriorated at the front exterior elevation.
- d) Wooden siding panels at rear elevation are deteriorated and in poor condition. Siding is in near contact with adjacent ground surfaces. Wood siding then absorbs any standing surface water that may be present. Current condition is responsible for accelerating the deterioration of the siding materials.

Photo CC7D: Deteriorated wooden siding at rear elevation. Hillside at rear limits expansion possibilities.

- k) Correct the conditions leading to deteriorated siding at the rear elevation. Replace deteriorated siding. Where possible, ensure the grade adjacent to the building slopes away from the building.

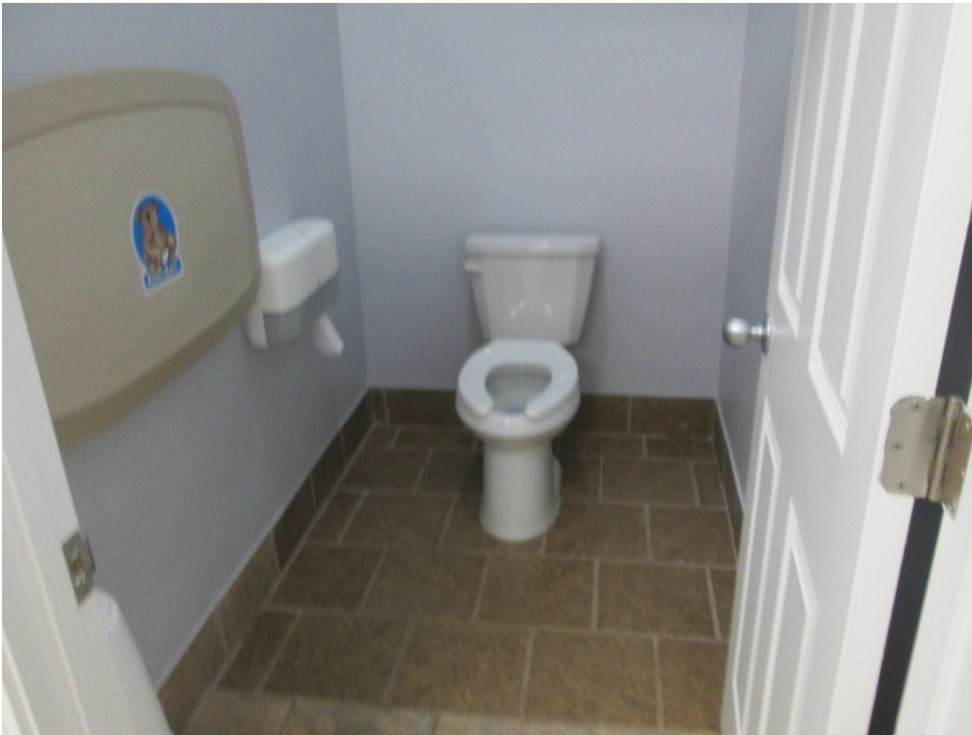
Photo CC4D: Toilet compartment lacks accessible grab bars and turning radius. Doors contain inaccessible knob hardware and lack lever handles.

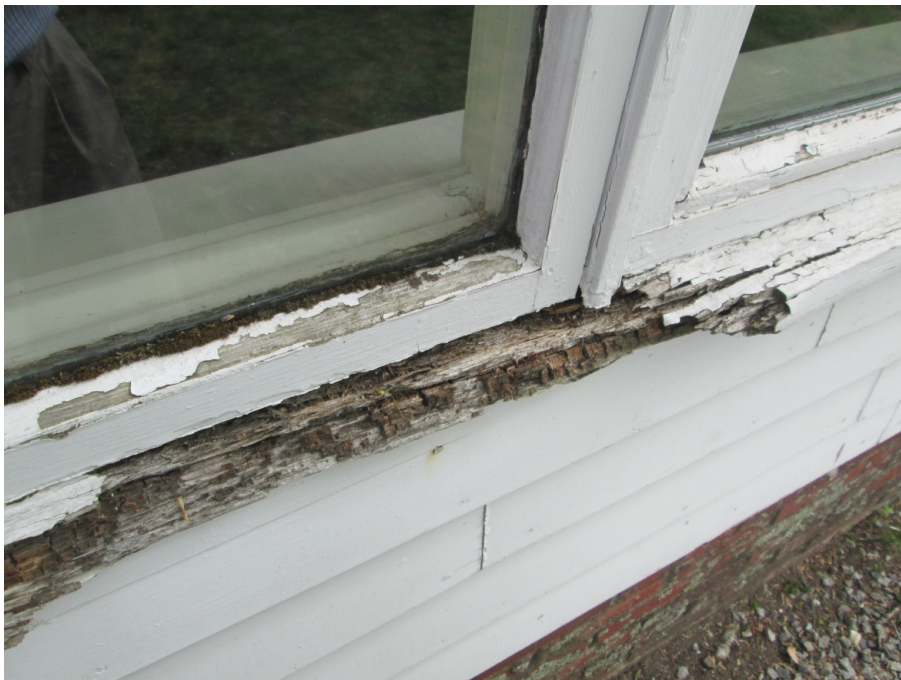
- a) At reportedly 30 years old, the shingle roofing has reached the end of its useful life and requires replacement.
- b) Several exterior window sills and wood trim are deteriorated.

Photo CC7B: Deteriorated wooden window, sill and associated trim.

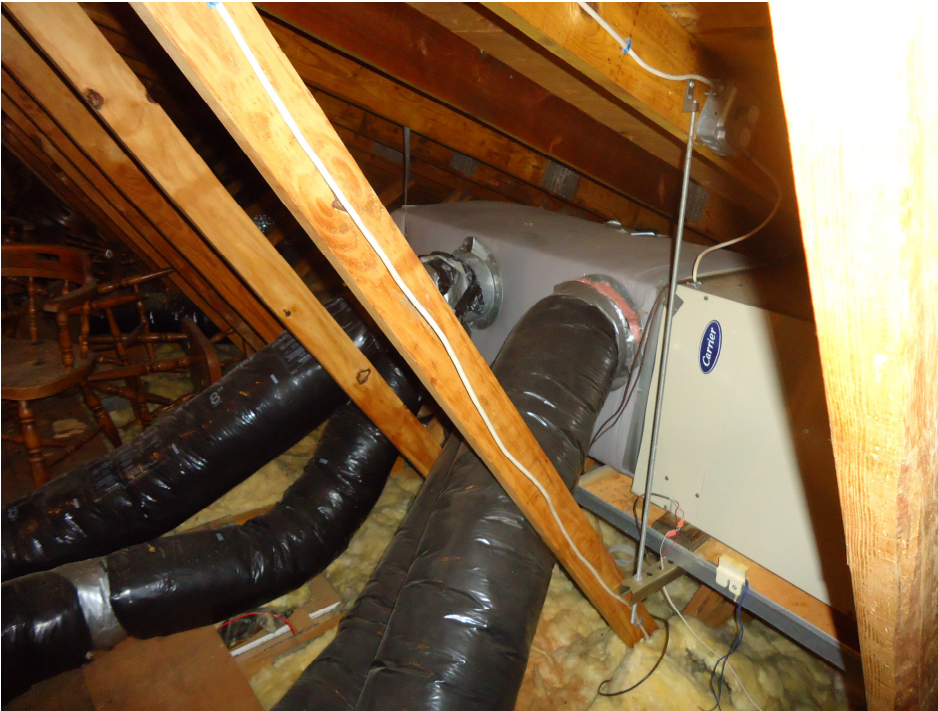
- e) Thermal insulation within the attic space and at the ceiling plane is approximately 8 inch and non-code compliant.
- f) Portions of exterior painted wooden siding at rear elevation have been repaired. It appears either the ground plane was installed too high in relation to the wooden wall, or, the wooden siding was extended downward to meet the ground plane. Current condition allows water absorption from the ground plane into the wooden siding, and accelerates deterioration.

Photo CC7E: Approximately 8 inches of fiberglass insulation at ceiling plane within attic space.

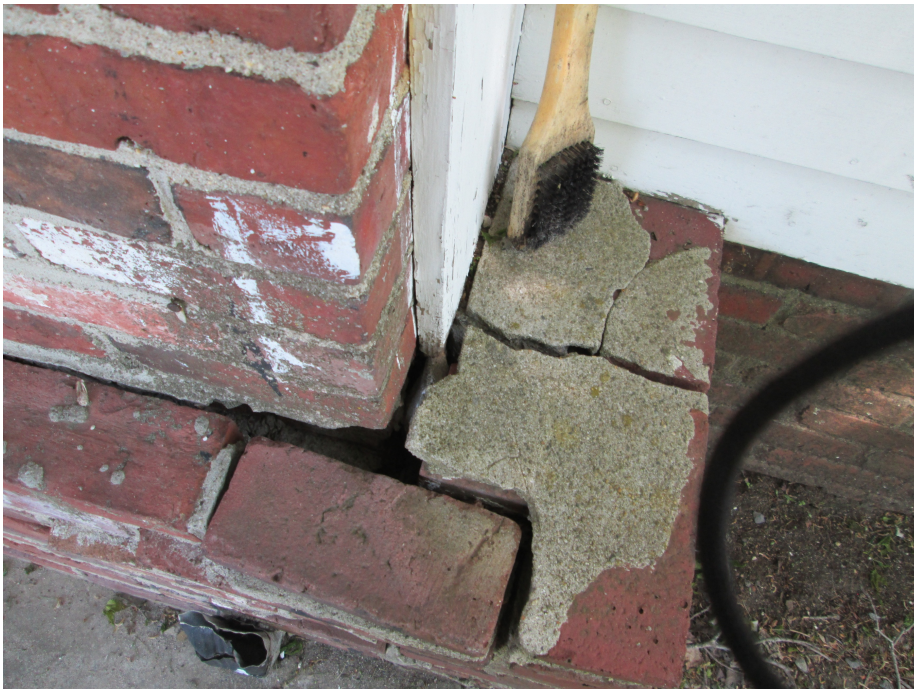
Photo CC7C: Portion of deteriorated brickwork at front elevation.

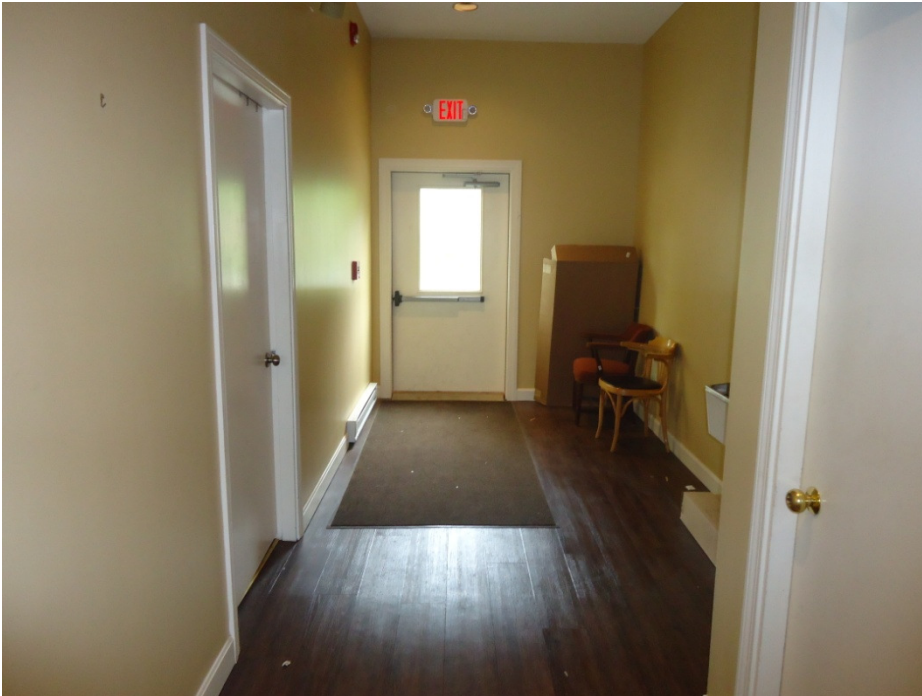
Photo CC4H: Raised threshold at exit door results in tripping hazard. Inaccessible knob door hardware is typical.

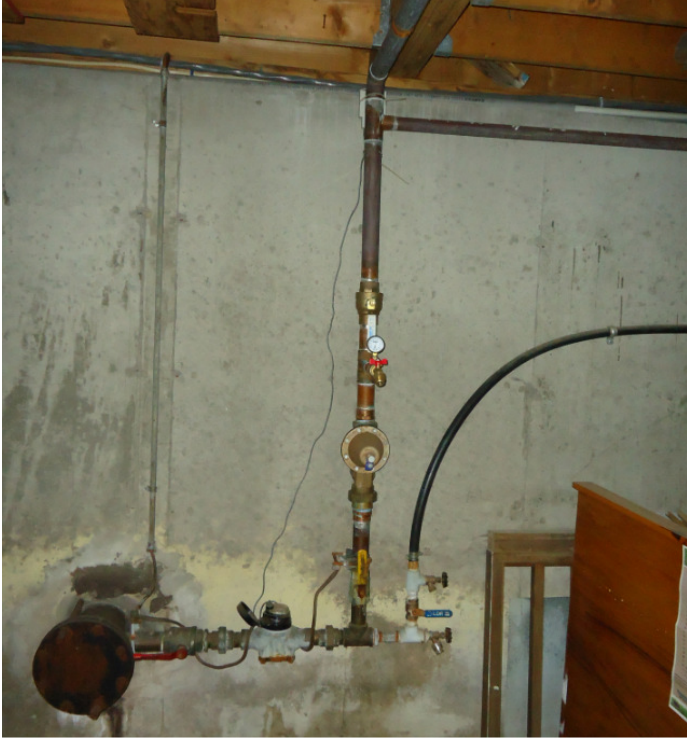
- a) The incoming water service and domestic water heating system are located in the ground floor of the building. (Photo CC3A)
- b) The incoming water service appears to have been brought in for future expansion and the addition of a fire protection system. A 6 inch steel pipe with flanged cap enters the ground floor of the building and a two inch potable water service is tapped off. From this 2" main water service the building appears to have been broken into sections including the rear locker rooms, the commercial kitchen/bar, an irrigation system tie in (for emergency use and priming of pumps only per onsite maintenance staff) and the 1st floor restrooms.

Photo CC3A: Existing water service to the building

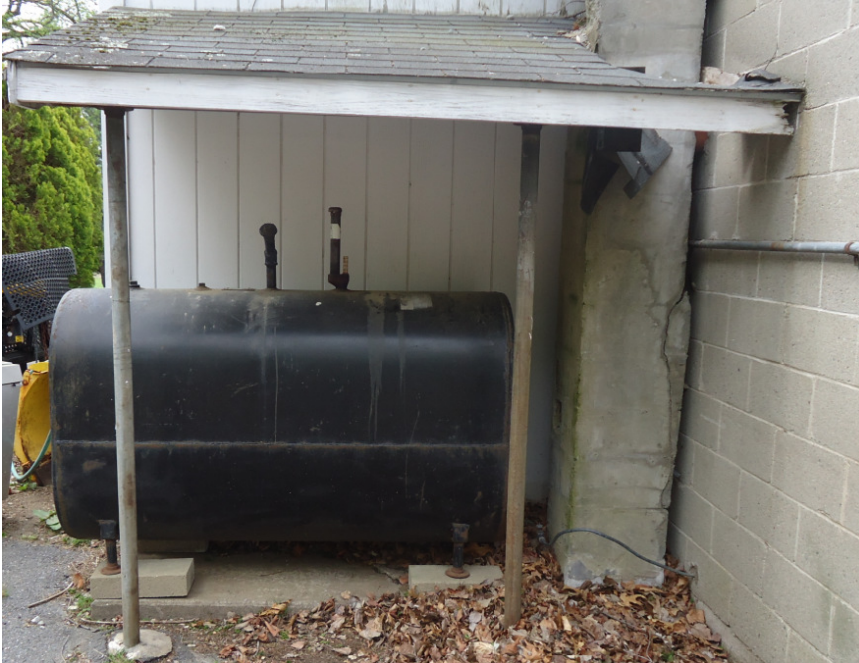
- c) Fuel/oil piping serving oil fired equipment is single wall with no containment. Under Chapter 453 of the Acts of 2008, as most recently amended in 2010, require the installation of either an oil safety valve or an oil supply line with protective sleeve on systems that do not currently have these devices. While this is typically enforced on residential appliances only, it is also typically at the discretion of the Authority Having Jurisdiction (AHJ) or in this case the local fire department. Any replacement of equipment, re-distribution or additional of equipment could trigger this requirement. (See Photo CC5I).

Photo CC5I: Existing Fuel/Oil Storage Tank with Supply Line. Also note the condition of the chimney directly adjacent.

- d) Existing chimneys serving oil fired equipment should be cleaned and inspected to determine current status/integrity and determine required repairs.

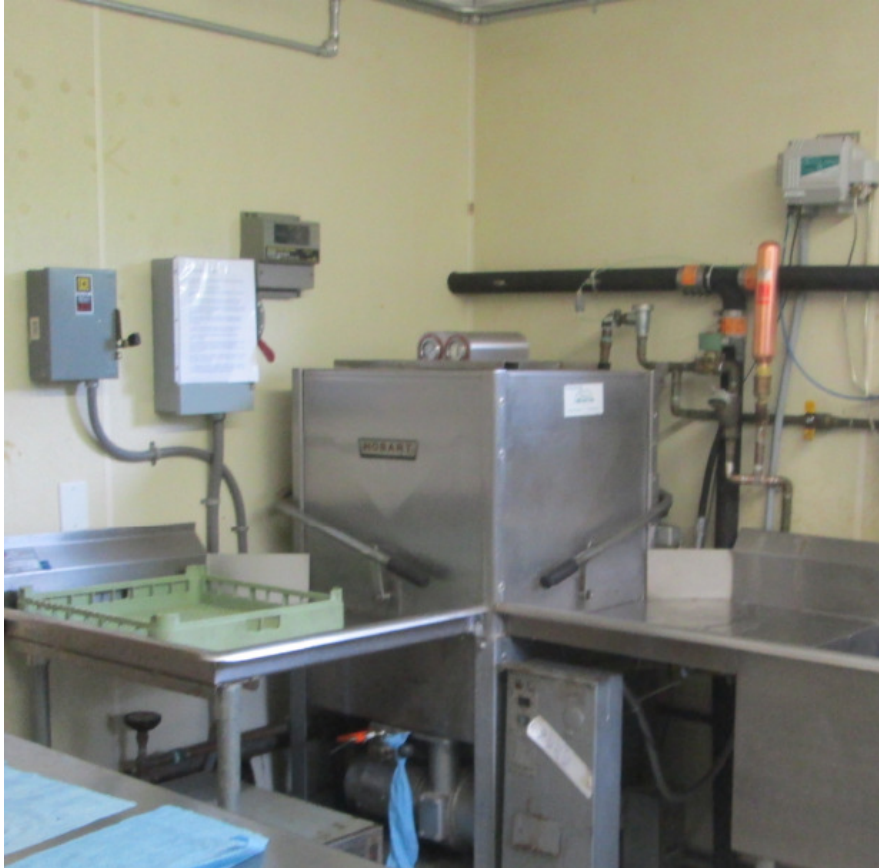
- b) The International Mechanical Code (IMC-2009) requires that Type II hoods be installed above dishwashers that produce heat and moisture and do not produce grease or smoke, except where the heat and moisture loads from such appliances are incorporated into the HVAC system design or into the design of a separate removal system. A Type II kitchen hood for the removal of heat and moisture from the space is not present and is required. (Photo CC7A)

Photo CC7A: Existing Dishwasher without Type II hood.

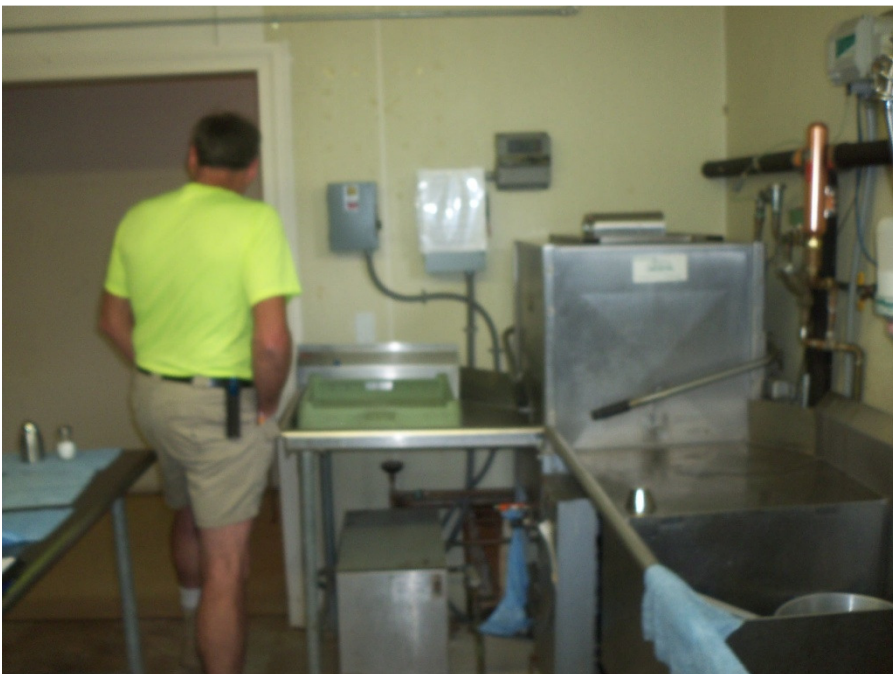
The improperly rated kitchen disconnects need to be replaced with NEMA 4X type.

Photo CC-2: Kitchen disconnect

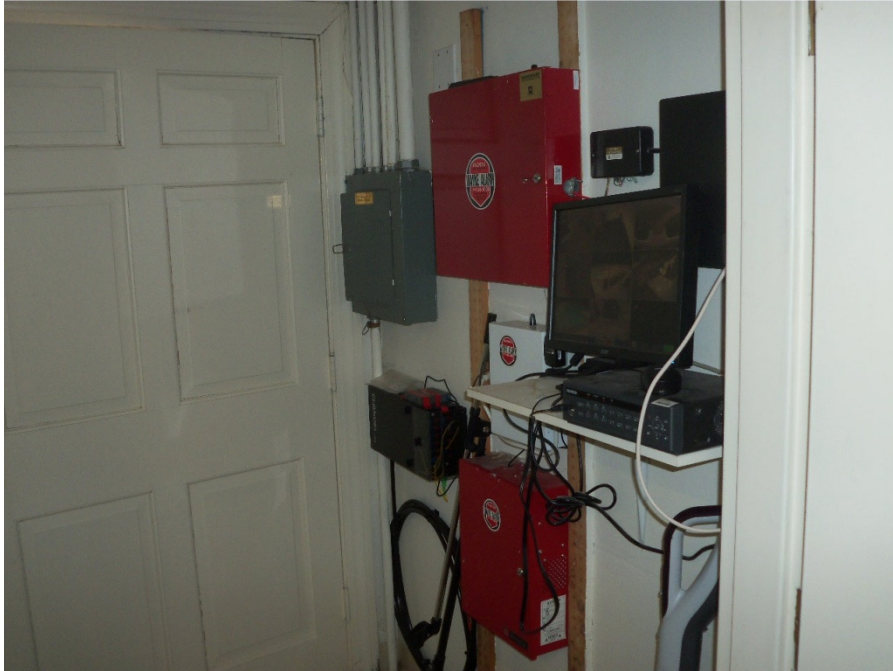
Photo CC-3: Improper placement of electrical equipment

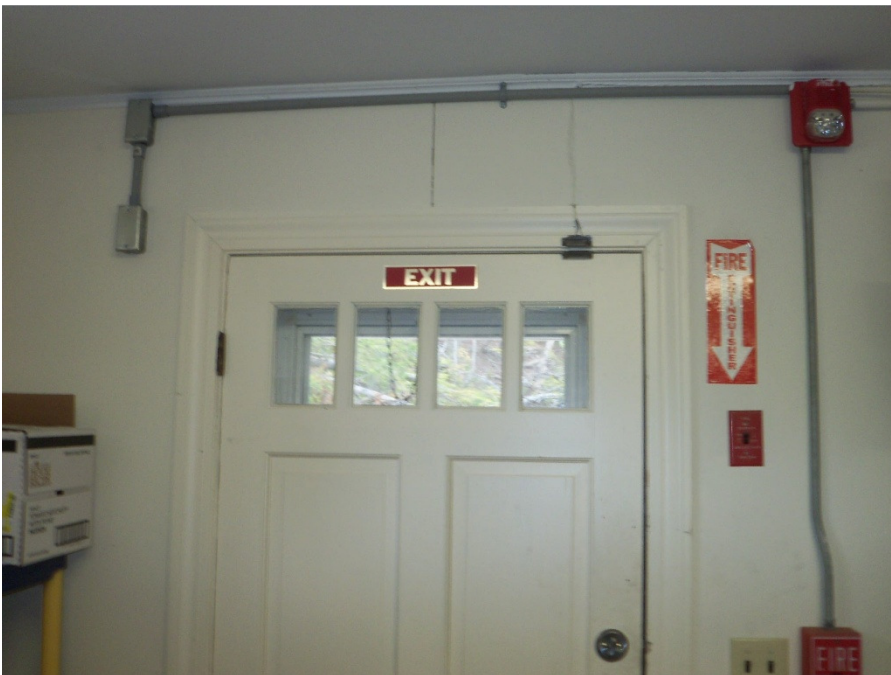
The existing Fire alarm system has had some upgrades, with the exception of the basement area. Audio/visual coverage seems to be lacking, mostly associated with the visual requirement needed to meet the present NFPA 72 Fire Alarm Code. Existing fire and smoke detection coverage, although adequate, may be approaching its replacement service life. (Photo CC-6)

Photo CC-6: Kitchen Egress Lighting and Fire Alarm example

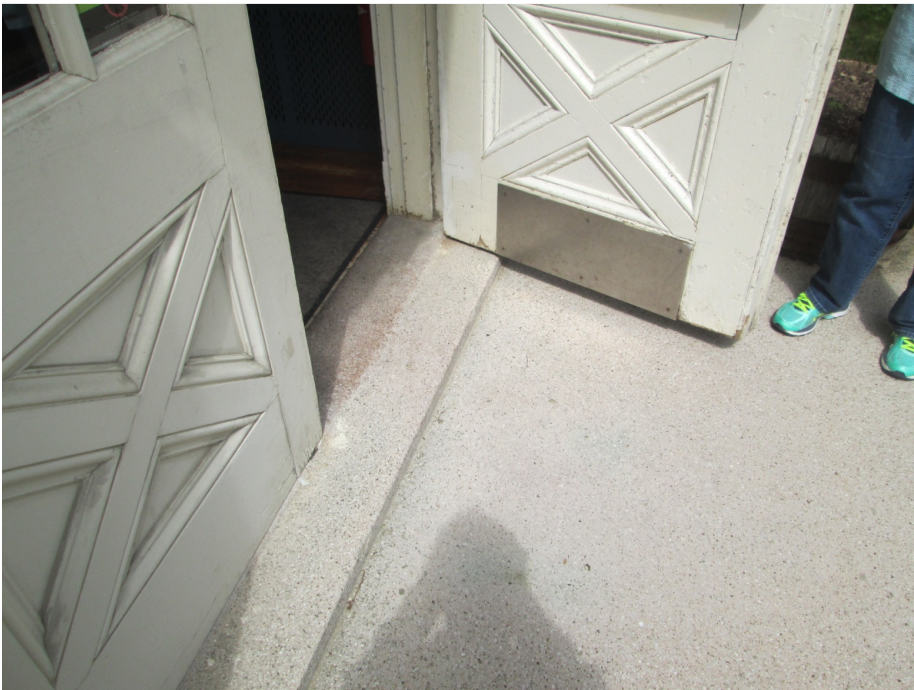
Photo PS4C: Designated accessible entrance door is heavy, lacks power assist, contains non-compliant threshold.

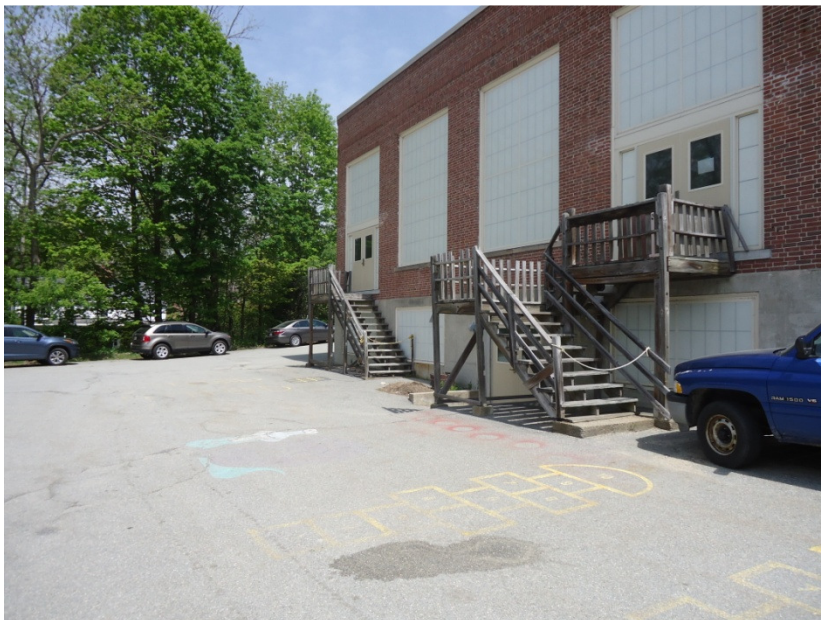
Photo PS3C: Exterior egress stairs at the rear of the building and serving the gymnasium are not code compliant.

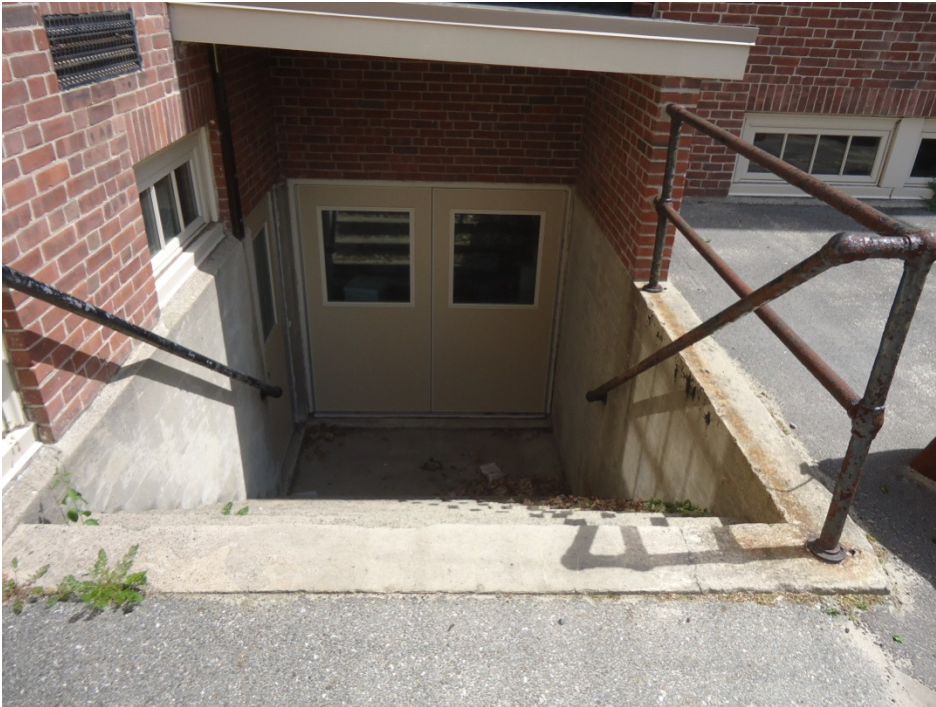
Photo PS3E: Non-compliant guard rails and handrails at stair.

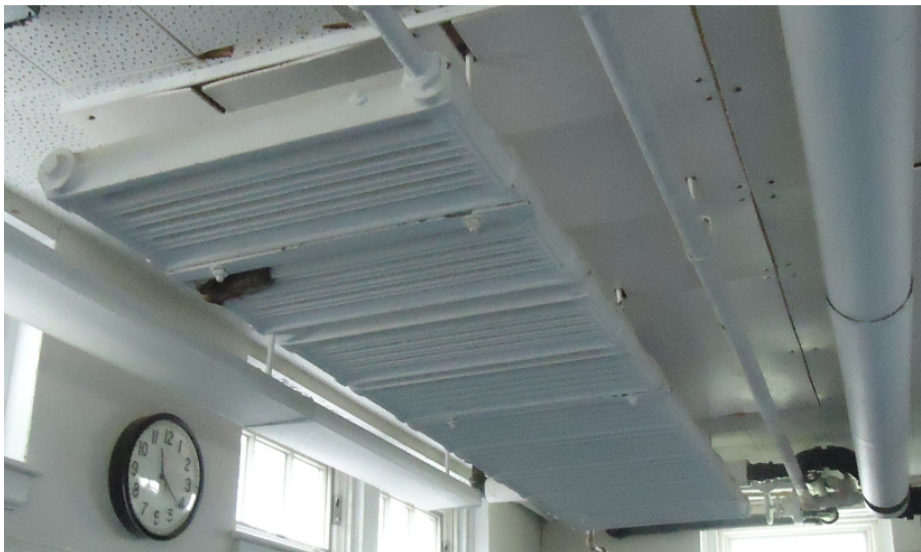
Photo PS4B: Existing Radiator Which Has Been Repaired.

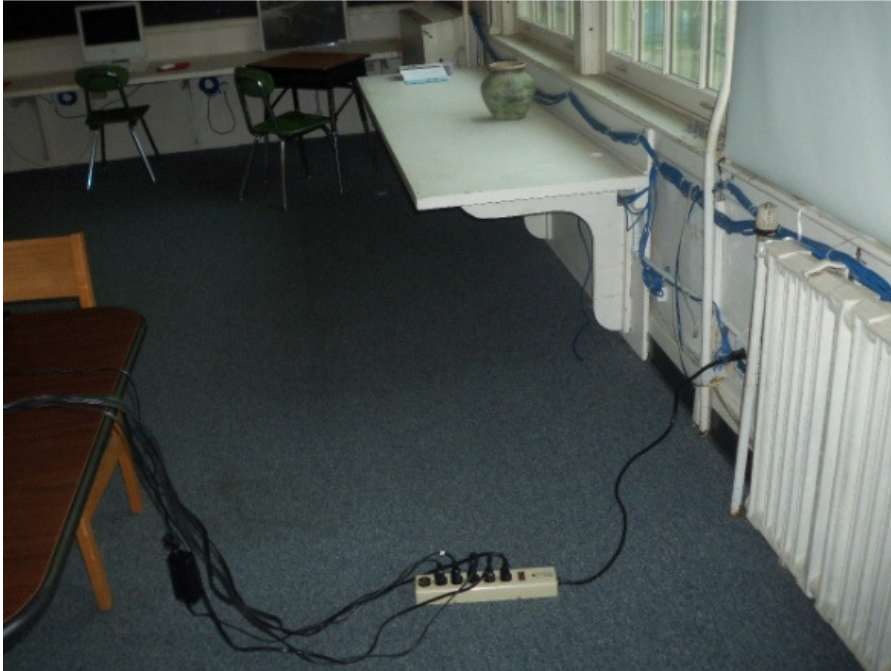
Photo PS-5: Exposed wiring and inadequate convenient general purpose outlets

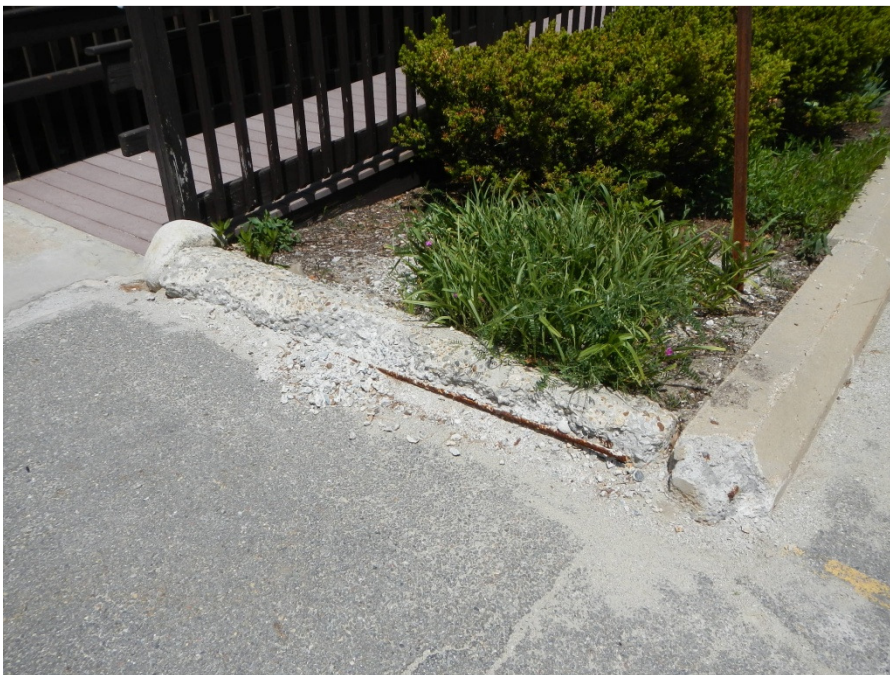
Photo GSC12: Deteriorated concrete curb near Main Entrance.
