TOWN OF GROTON, MASSACHUSETTS

SENIOR CENTER FEASIBILITY STUDY

FINAL STUDY REPORT

October 3, 2016

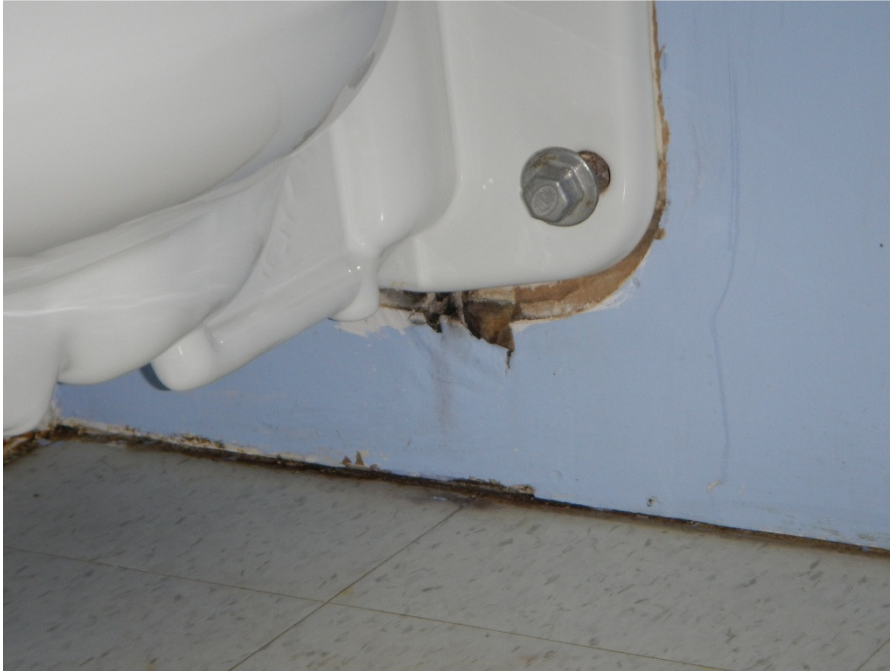
Photo GSC21: Water damaged gypsum board at Toilet

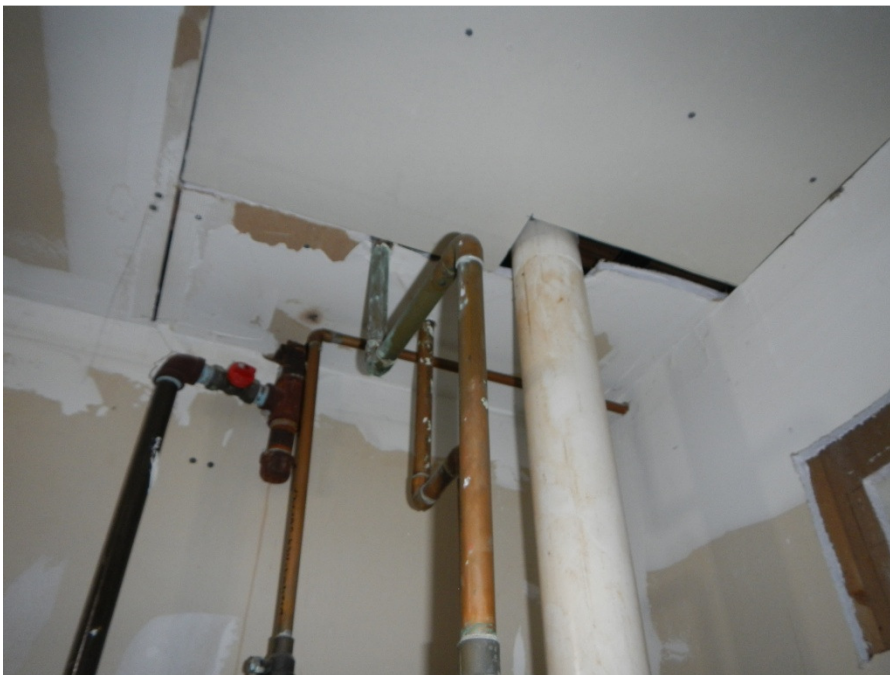
Photo GSC30: Unprotected openings in fire-rated ceiling construction

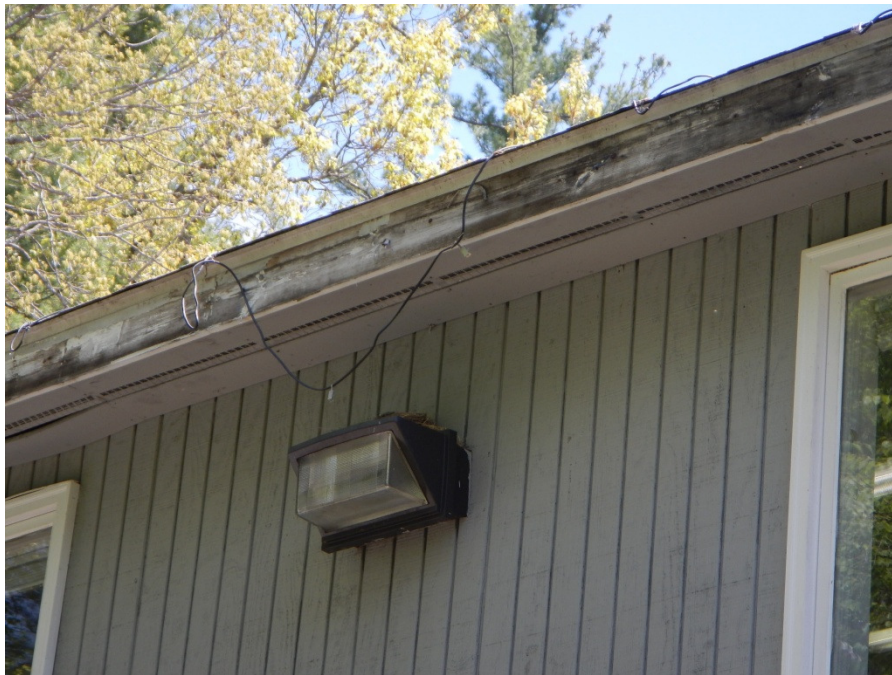
Photo GSC31: Deteriorated wood fascia trim and soffit
Loose snow melt wiring system

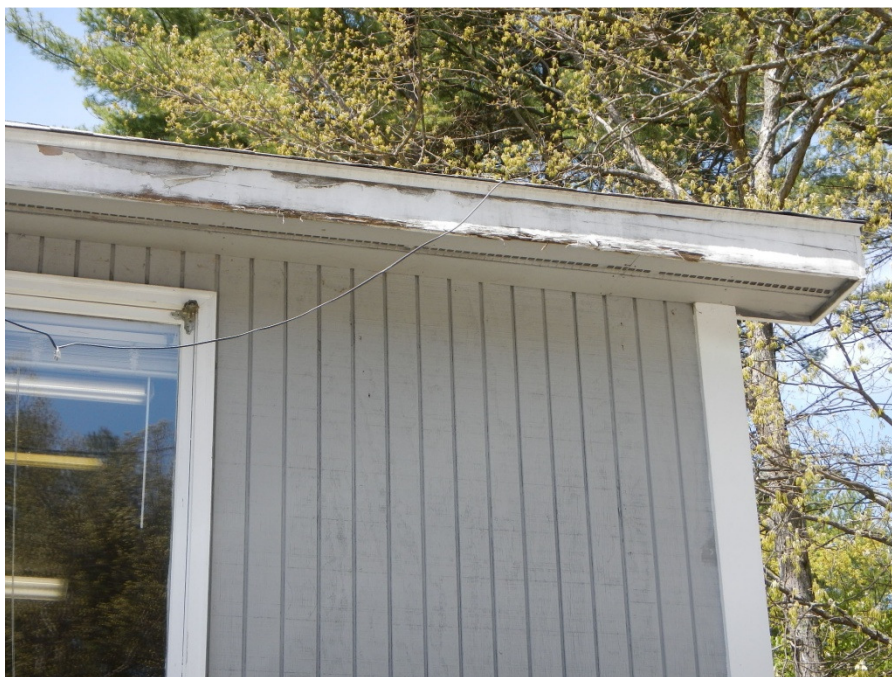
Photo GSC32: Deteriorated wood fascia trim
Loose snow melt wiring
