Groton Electric Light Department Groton, MA  
ADA Transition Plan

**Americans with Disabilities Act (ADA)  
Self-Evaluation/Site Access Survey for the Town of Groton**

**Groton Electric Light Department  
Address: 23 Station Avenue  
Manager Kevin Kelly  
978-448-1150  
Reviewed by the Commission on Accessibility  
December 10, 2018**

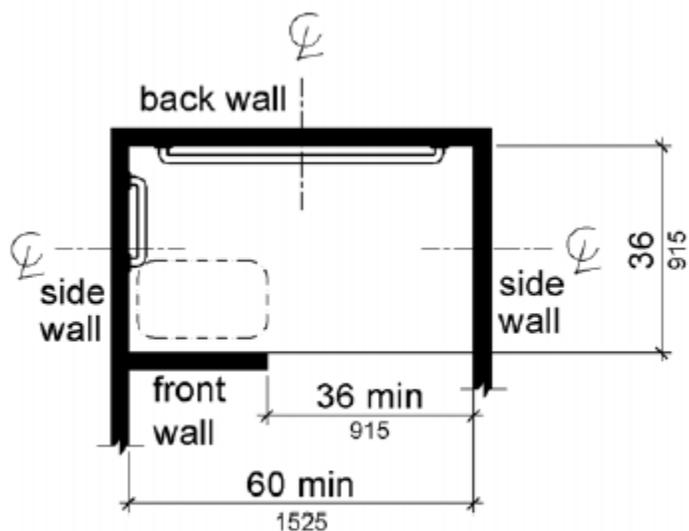
**Figure 608.2.3 Alternate Roll-In Type Shower Compartment Size and Clearance**

Note: inside finished dimensions measured at the center points of opposing sides

Also, pertinent: Section 608.2.3 Alternate Roll-In Type Shower Compartments. Alternate roll-in type shower compartments shall be 36 inches (915 mm) wide and 60 inches (1525 mm) deep minimum clear inside dimensions measured at center points of opposing sides. A 36 inch (915 mm) wide minimum entry shall be provided at one end of the long side of the compartment.

608.3 Grab Bars. Grab bars shall comply with 609 and shall be provided in accordance with 608.3. Where multiple grab bars are used, required horizontal grab bars shall be installed at the same height above the finish floor.

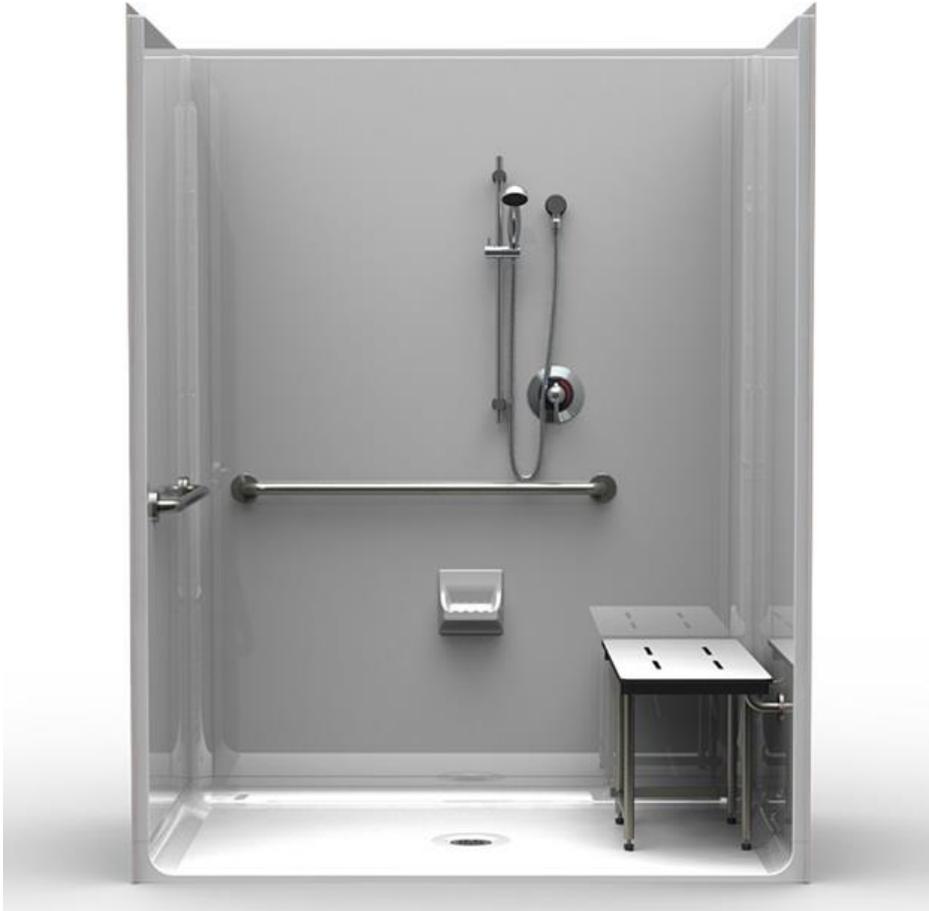
Photographic example of ADA accessible shower grab bars:

We also found in the shower room that there are no grab bars currently installed. We recommend those be installed to allow access for people with disabilities. The ADA 2010 standards call

for: "Horizontal grab bars shall be installed at the same height above the finish floor."

*We also found in the shower room that there are no grab bars currently installed. We recommend three such grab bars be installed to allow better access for people with disabilities.*

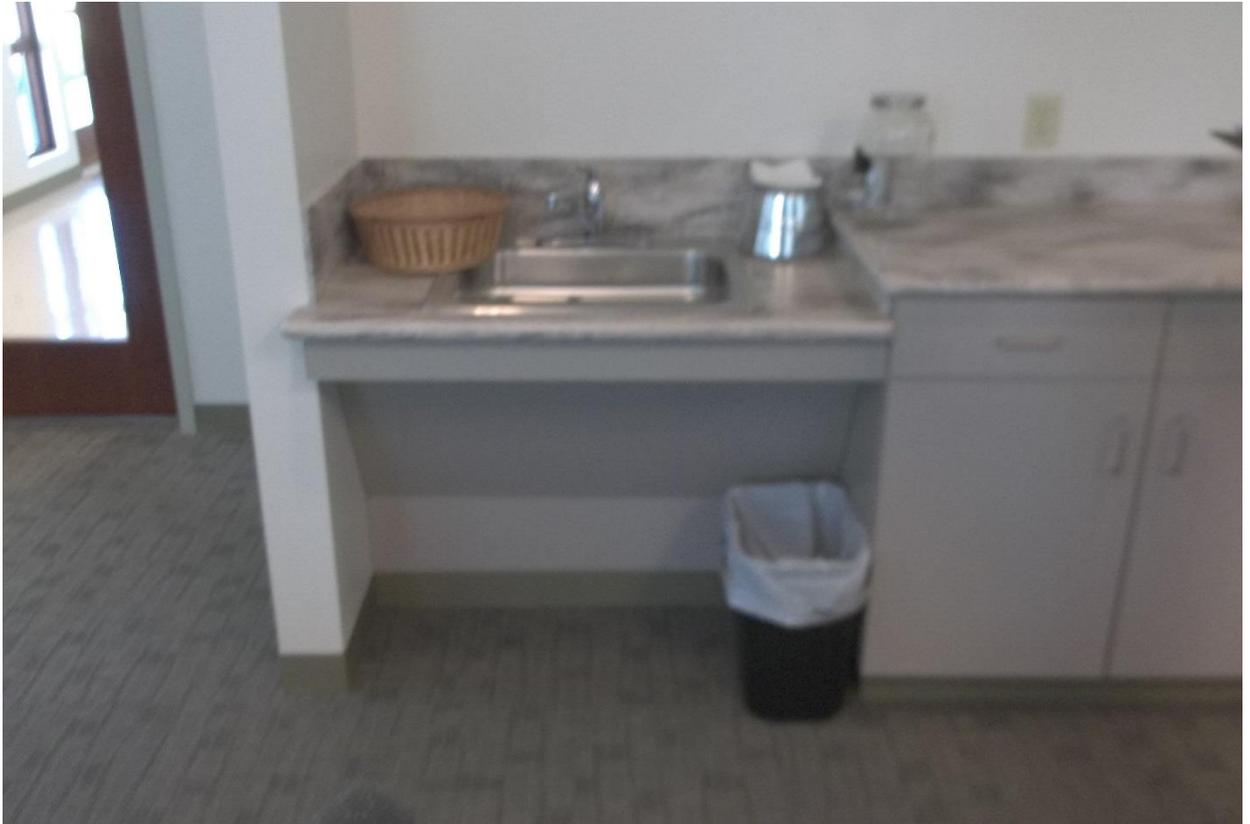
*The Team noted that the conference room tables, as well as sinks provided are all in compliance with the ADA. We suggested that the trash barrel be relocated to make room for people using a wheelchair to be able to use the sink with ease.*

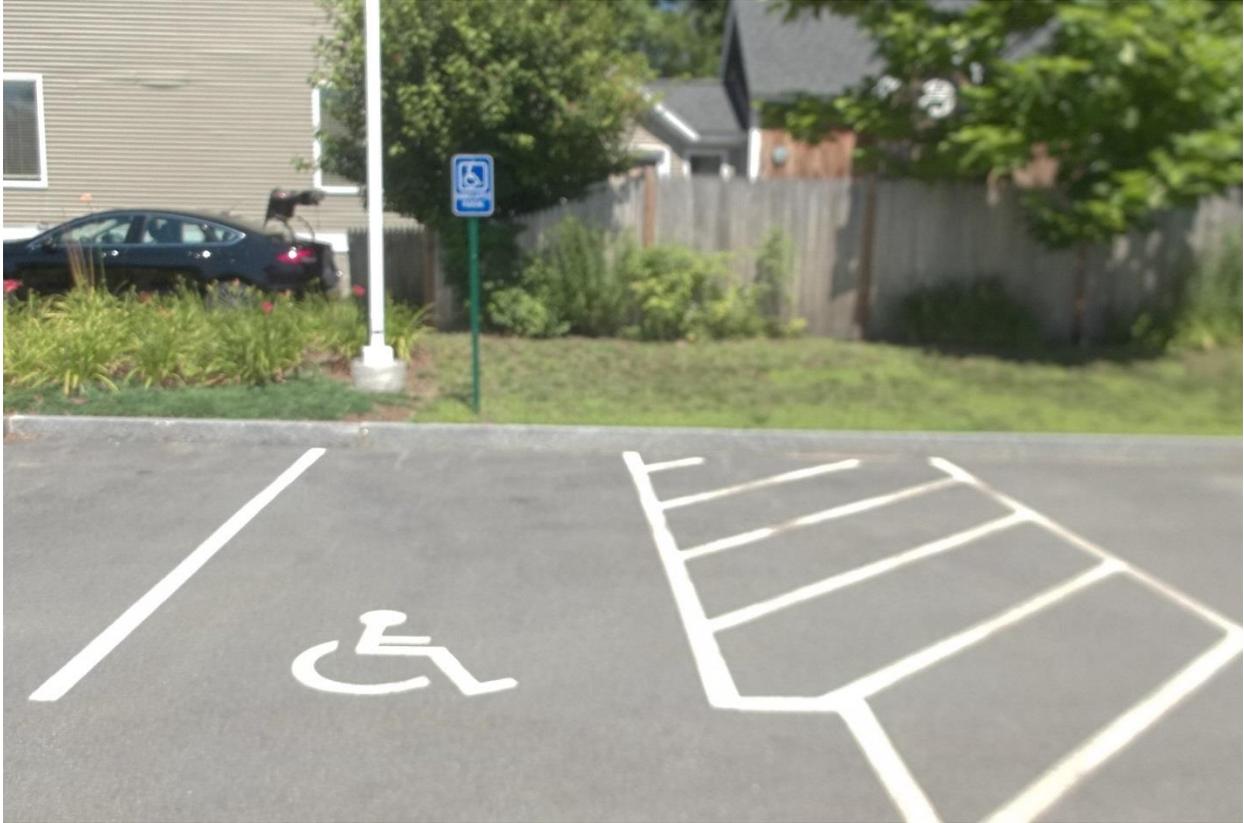
**Accessible Parking:** The team found that there is not a designated van accessible parking space at Groton Electric Light Department. We recommend a "Van Accessible" sign be mounted on the pole with the International Symbol of Access, due to the fact the ADA requires a designated HP van accessible parking space. This is required by The ADA section 4.6.4 that states, "the space shall have an additional sign "Van Accessible" mounted below the symbol of accessibility." Otherwise, the GELD has done an excellent job on the accessible parking lot.

*We recommend that a "Van Accessible" sign be mounted on the pole with the International Symbol of Access, due to the fact the ADA requires a designated HP van accessible parking space. This is required by The ADA section 4.6.4 that states, "the space shall have an additional sign "Van Accessible" mounted below the symbol of accessibility." Otherwise, kudos is to the GELD because they have done an excellent job on the accessible parking lot.*
