11. CPA PROJECT APPLICATION FORM

8. Project Name: Open space and Recreational Restoration of Knops Pond/Lost Lake

LOST LAKE AND KNOPS POND AQUATIC VEGETATION MANAGEMENT PROGRAM 2013 ANNUAL REPORT

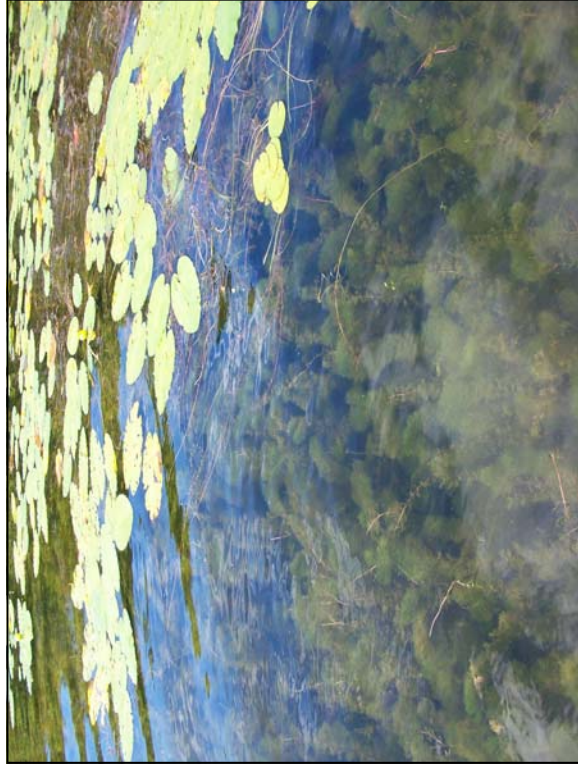
Dense Fanwort and Eurasian milfoil cover September 2011

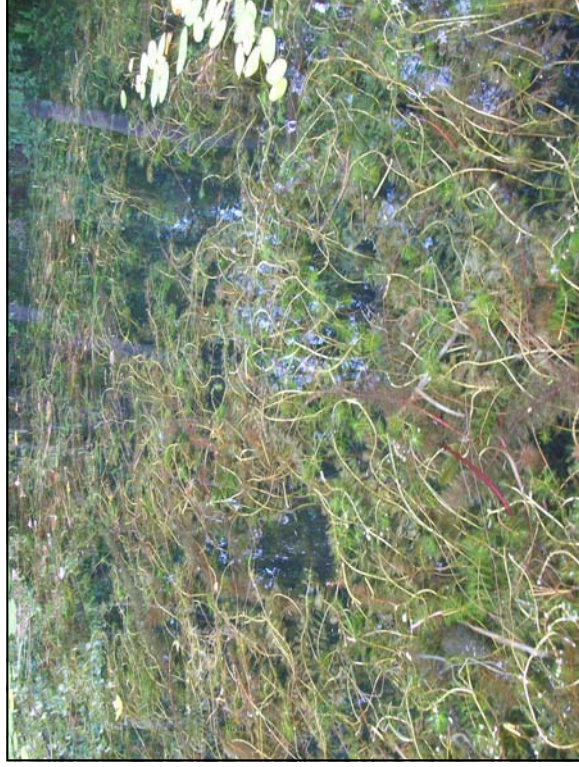
Dense Eurasian milfoil matted to the surface September 2011

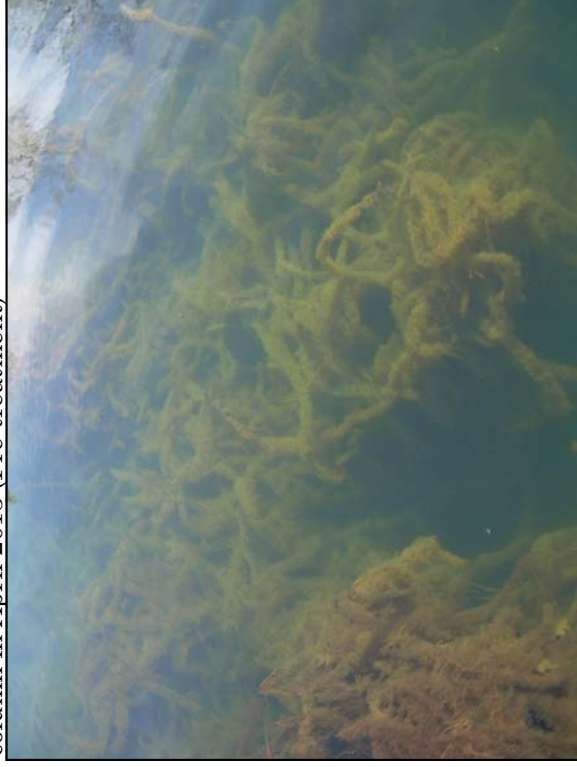
2012 growth of variable milfoil remaining in the water column in April 2013 (Pre-treatment)

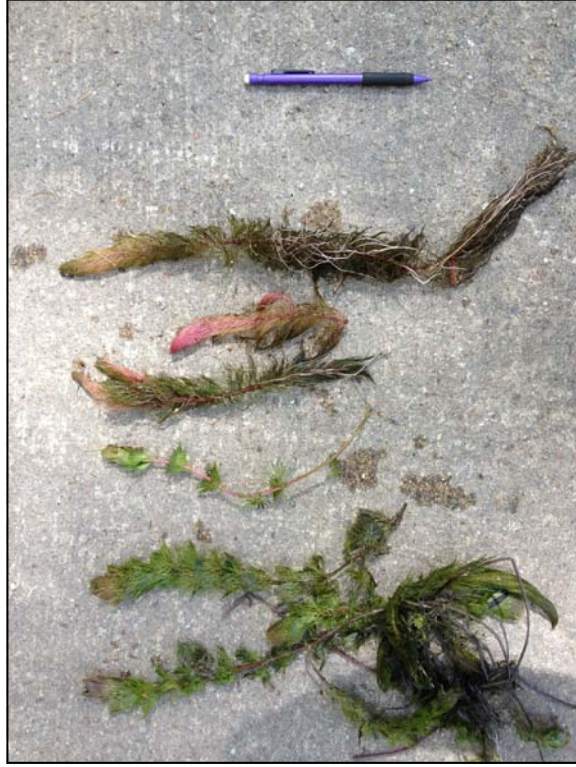
Progression of chlorosis in fanwort and variable milfoil on May 7, 2013

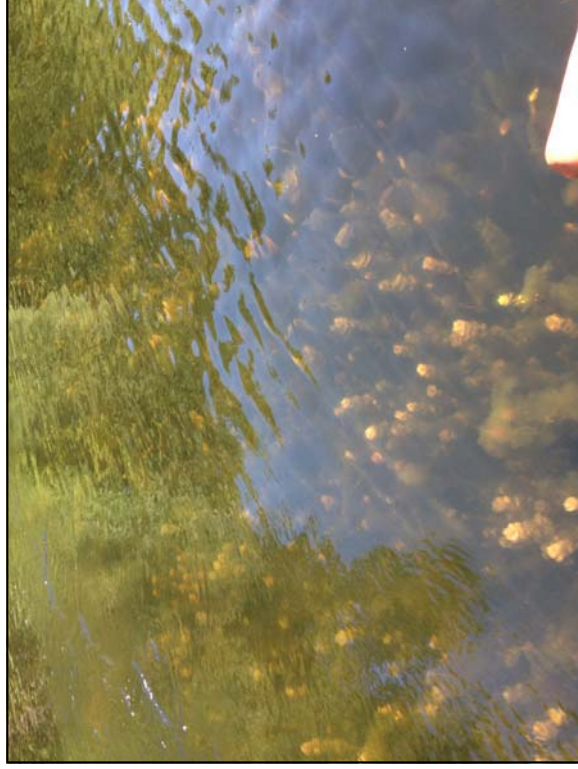
Chlorosis of Fanwort visible from the surface June 20 2013

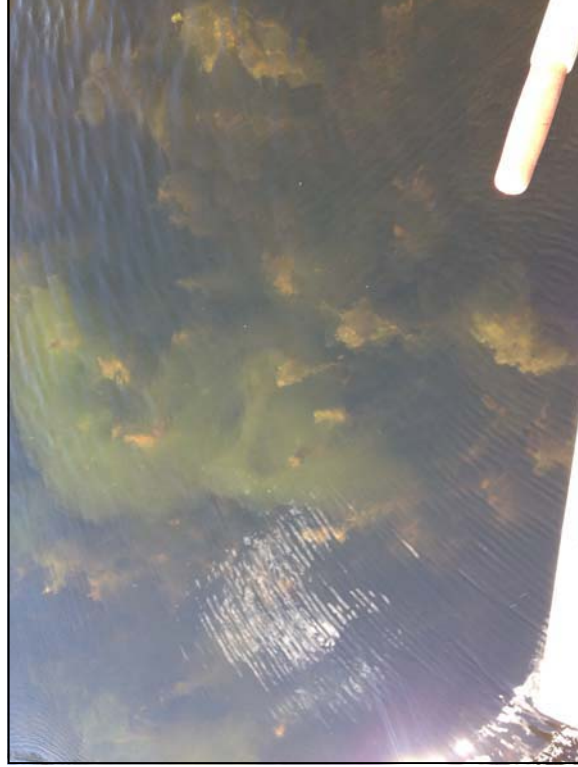
Dying Eurasian milfoil covered in periphytic algae

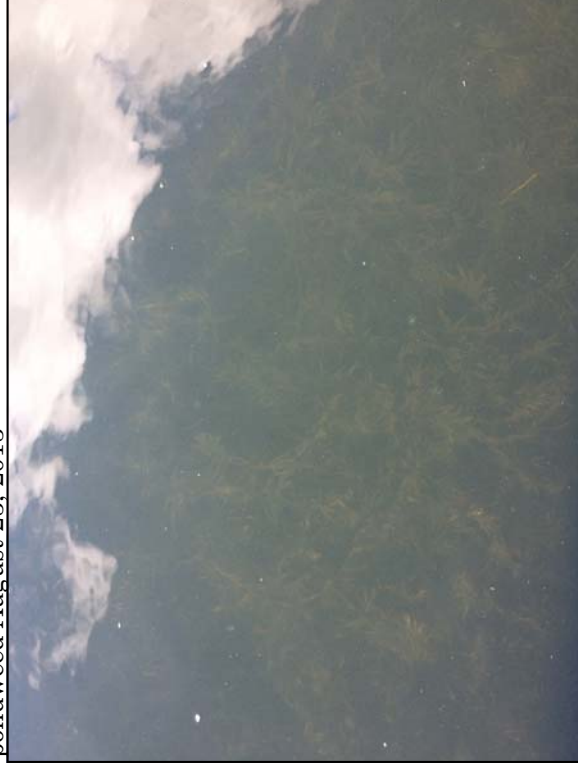
Healthy bottom cover of low growing native Robbins pondweed August 23, 2013
