Groton Community Preservation Plan 2017-18

11. CPA PROJECT APPLICATION FORM

1. a.) Applicant Name and Organization: Spiegelman, Bobbie
Organization(s) (if appropriate) Groton History Center
- b.) Regional Project: Yes ? or No? X If Yes, Town/Organization:
2. Submission Date: January 18, 2018
3. Applicant Address: PO Box 202, 172 Main Street, Groton, MA 01450
4. Ph. # 978-448-0092 Email: info@grotonhistoricalsociety.org
5. CPA Purpose. Check all that apply:
Community Housing (Affordable Housing:) Historic Preservation: ☒ Open Space: Recreation: ☐
6. Town Committee or boards participating:
7. Project Location/Address: Oliver Prescott House/Groton Inn, Groton, MA
8. Project Name: J.D. Poor Mural Preservation
9. Additional Responsible Parties (If applicable):

Paint Decorated walls: the Oliver Prescott, Jr. House, 170 Ayer Road, Groton, Mass.

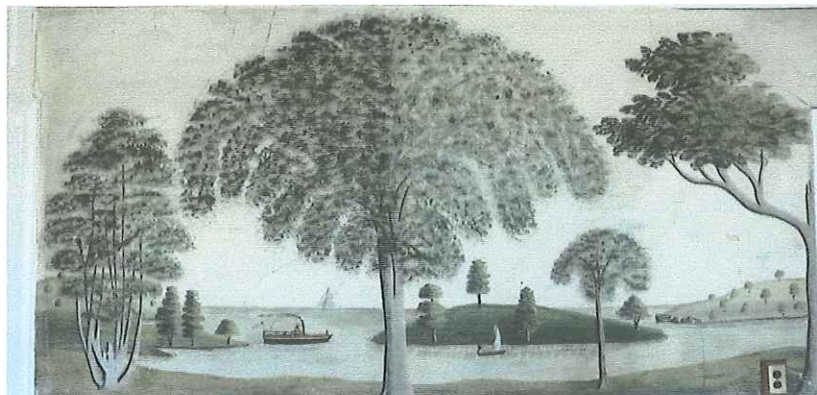
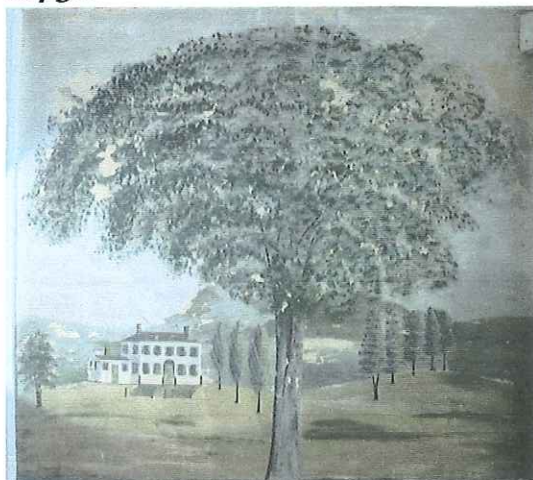
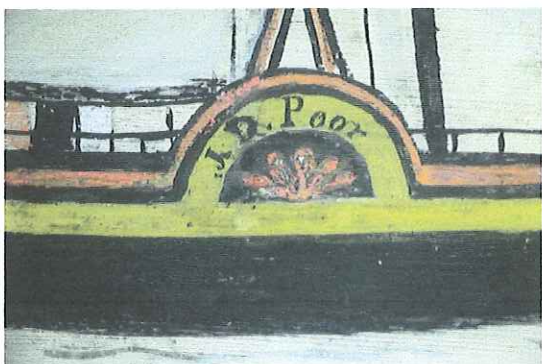
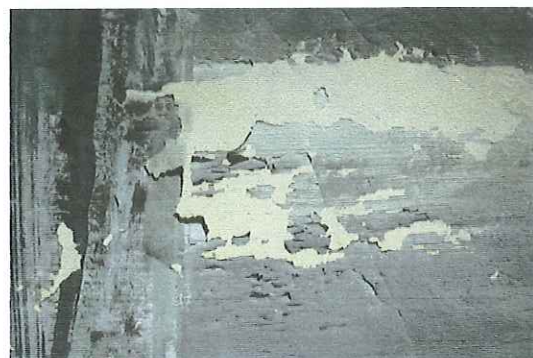
Inside wall "Water Scene": 114 1/4" x 57 1/2", outside wall "Landscape with House": 62" x 57 1/2"

Condition: The murals are executed on a plaster and lathe wall with a yellow ground. There is extensive cracking of the plaster throughout the larger "Water Scene" mural. There is a 1' x 1' area along the top on the right side where the plaster is failing and pulling away from the lathe. The paint is moderately thin with no impasto. It appears to be milk paint and is water-soluble. There is EXTENSIVE flaking throughout the "Landscape with House" and in scattered areas of the larger "Water Scene". There are numerous areas of overpaint throughout both murals, particularly in the "Landscape with House" mural, which also has numerous large areas of paint loss. The overpaint is more vibrant in these areas and is severely flaking. Numerous long stress cracks are visible throughout the surface of the larger mural. There is a big square nail in the center of the "Water Scene".

Treatment: Stage 1, (prior to removal of wall): Consolidate the flaking paint; surface clean; apply facing tissue to wall to prepare the mural for removal and transit.

Stage 2, (after reinstallation of mural to new location): Remove facing tissue; surface clean residual adhesive; fill losses and cracks; inpaint losses and readjust old discolored overpaint as necessary.
