11. CPA PROJECT APPLICATION FORM

1. a.) Applicant Name and Organization: Last Luening First James
Organization(s) (if appropriate) Great Ponds Advisory Com.
- b.) Regional Project: Yes X ? or No? If Yes, Town/Organization: Groton Water Depart., Weed Harvest Com.
Groton Lakes Association
2. Submission Date: 1/18/2018
3. Applicant Address: St. 711 Martins Pond Rd.
City/ State: Groton, MA ZIP: 01450
4. Ph. # 585-545-8344 Email: luening11@gmail.com
5. CPA Purpose. Check all that apply:
Community Housing (Affordable Housing:) Historic Preservation: Open Space: X
Recreation X
6. Town Committee or boards participating: Great Ponds Advisory Com., Groton Water Depart.,
Weed Harvest Com.,
7. Project Location/Address: Baddacook Pond, Groton MA
8. Project Name: Baddacook Pond Environmental Restoration – Year 3 (2019)
9. Additional Responsible Parties (If applicable):

Year-End Report for the 2017 Management of: **Baddacook Pond**

Groton, MA

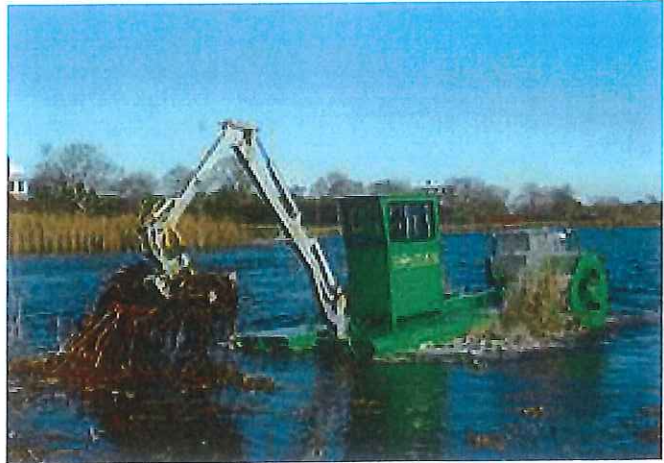
Hydro-Raking is basically a back hoe on a barge. Biomass is dredged up and placed onto a support barge which runs the debris back to shore. At the shore, debris is transferred to an appropriate composting location. In this case, the composting location is the town transfer station.

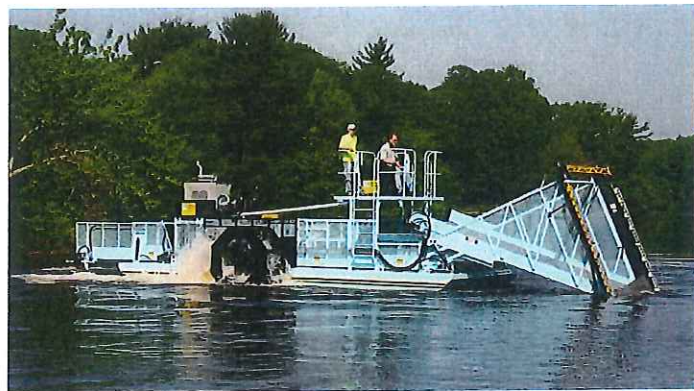
Weed Harvesting is accomplished using a Weed Harvester. A weed harvester is essentially a lawn mower. However does nothing to eradicate the weeds. The machine has three cutting blades, right, left and bottom, on the bow. These blades cut weeds onto a conveyor where they are move back, until the harvester is full. When full, the harvester transports the weeds to shore. The weeds are off loaded and moved to a composting location, the Groton transfer station.

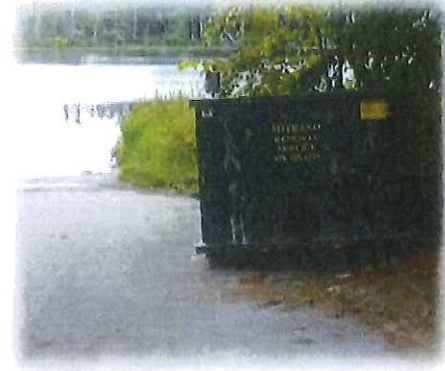
Image 1: Photo of the dumpster at the off-loading area

Seventeen (17) days of mechanical harvesting ensued, concluding on August 29. During operations, all collected material was off-loaded into a skid steer loader at the designated off-loading area. The plant material was then placed into a container to properly de-water (**Image 1**). Once full the containers were transported to the local landfill/composting site. During operations the harvester operator started south and then proceeded around the pond in a counter clockwise fashion, focusing on invasive species removal and recouping open water space. Please refer to **Figure 2** for a map of the harvested areas during this management period.

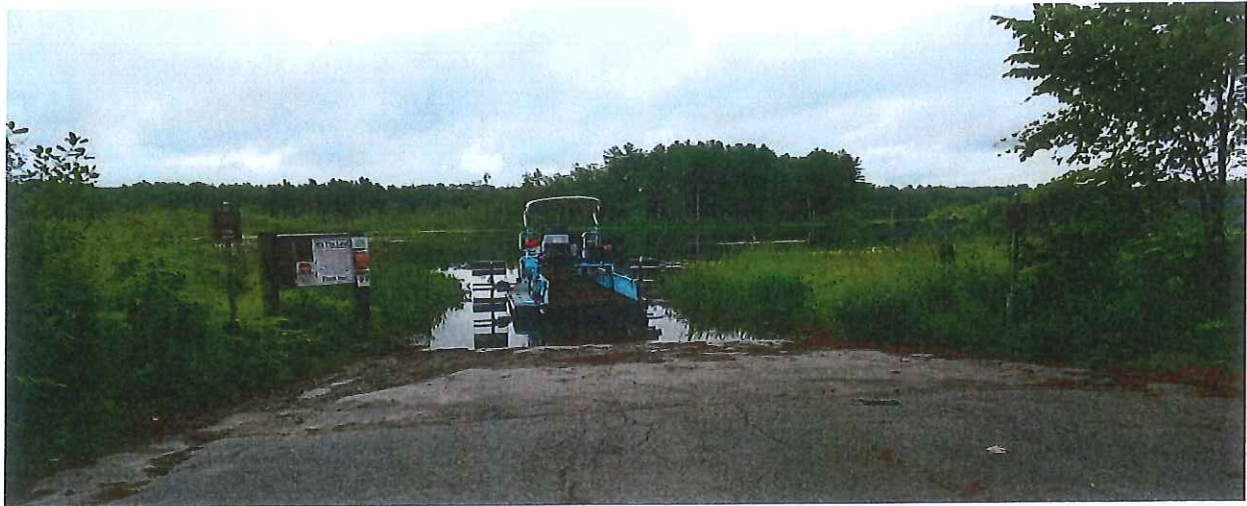
Image 1: Photo of the Baddacook Pond boat launch before the hydro-raking operation

matter. Please refer to **Image 1** and **2** for photos of before and after hydro-raking around the boat launch.

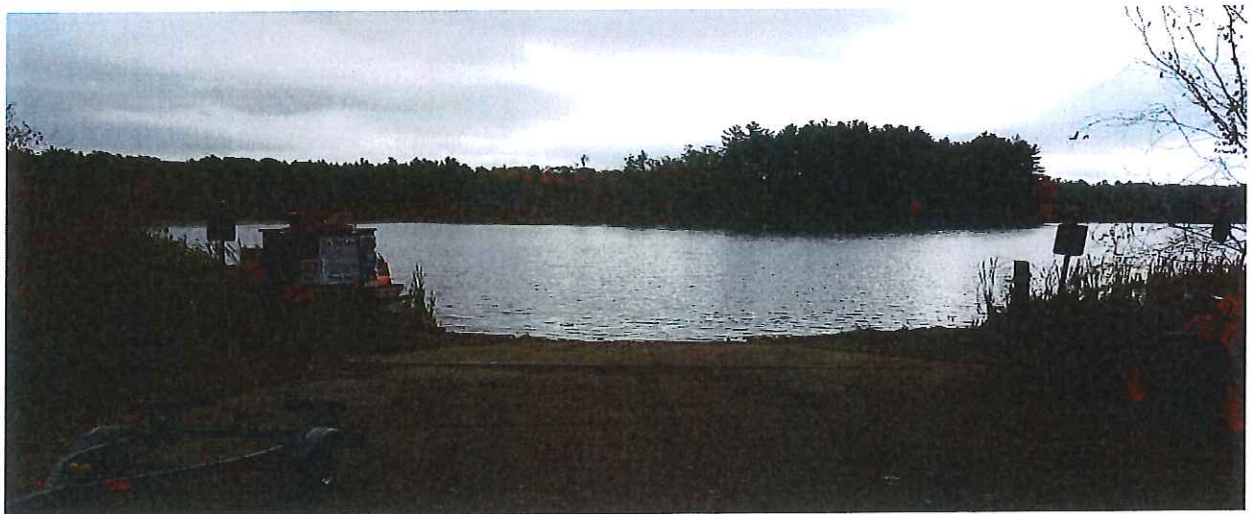
Image 2: Photo of the Baddacook Pond boat launch after the hydro-raking operation
