11. CPA PROJECT APPLICATION FORM

18. Project description and explanation (attach additional sheets as needed): This is a funding for the third year of a 3 year environmental restoration program. Year 1 has already been successfully completed. Year 2 will be this summer (2018). See Baddacook Pond Environmental Restoration – Year 3 description description.

Year-End Report for the 2017 Management of:
Baddacook Pond

Groton, MA

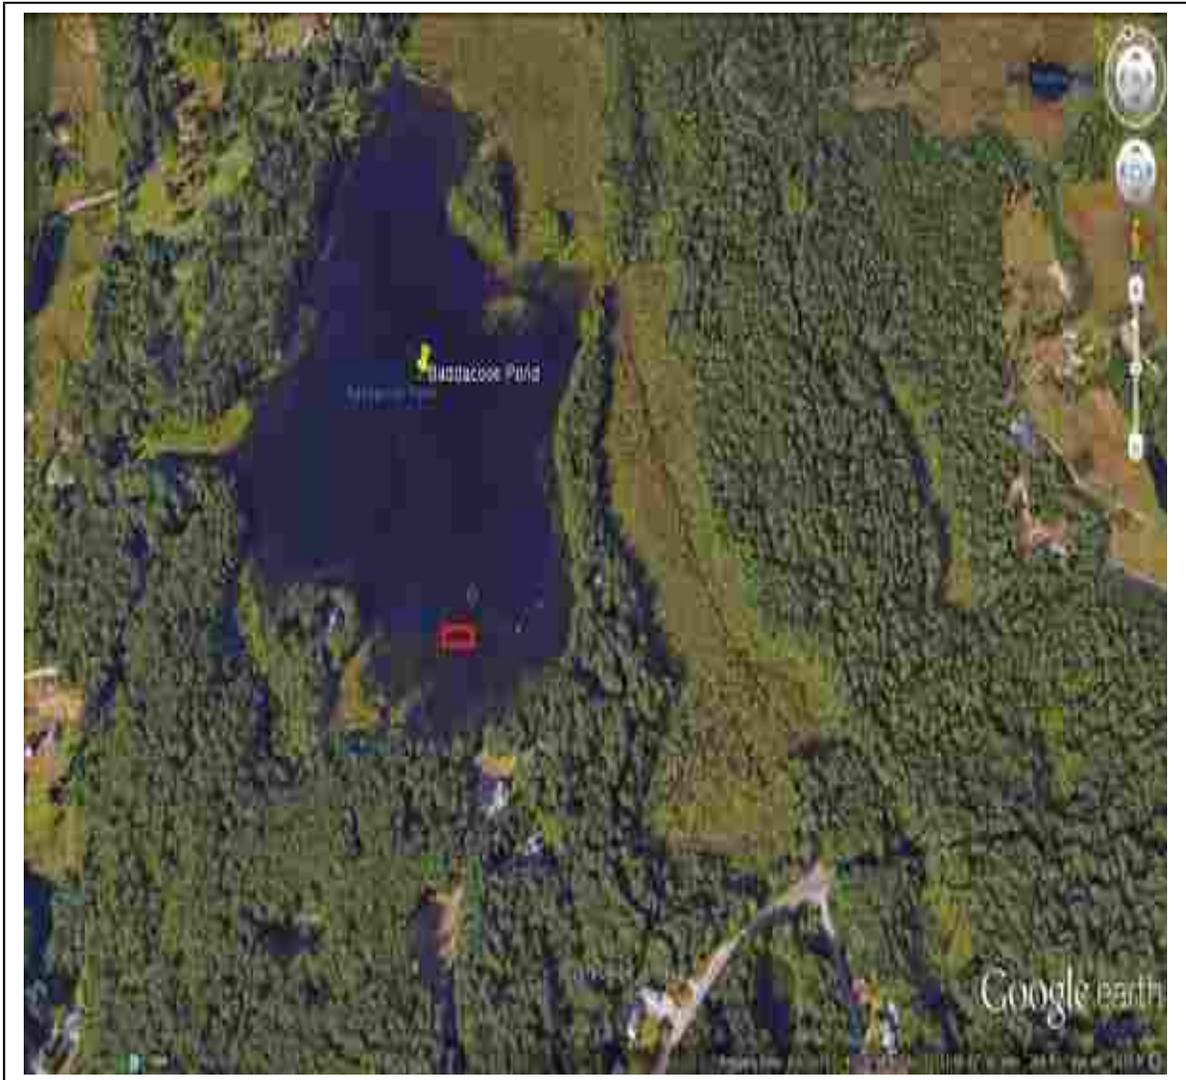
2-2 Baddacook Pond from Google earth showing weed growth 8-24-2015

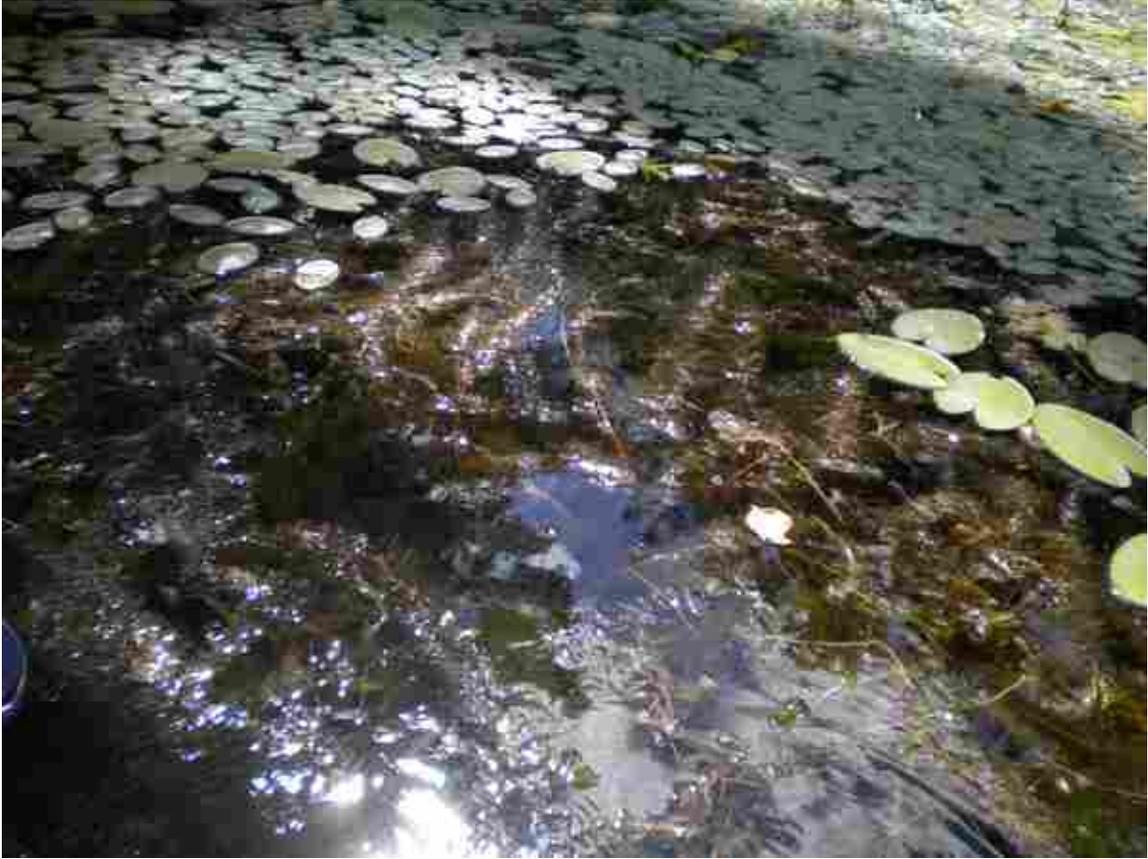
2-3 Fanwort invasive taking over noninvasive floating heart

Cabomba caroliniana (Fanwort) and *myrophyllum heterophyllum* (variable milfoil) are the two invasive aquatic species which have spread to the point of impacting the current health and long term viability of Baddacook. For boaters, the weeds are navigational impediment and fowl their propellers. For fishermen, the weeds destroy the fish habitat and snag their lines. For swimmers, the weeds over grow access areas and present a risk of drowning, especially for young children. For the town and home owners, the value of the abutting property drops as the lake deteriorates.

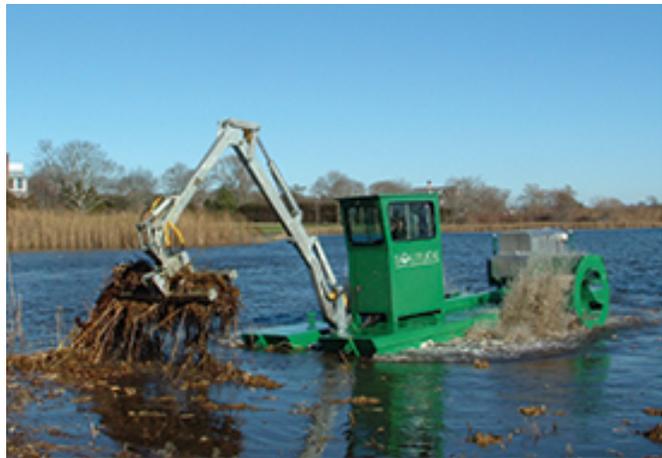
Hydro-Raking is basically a back hoe on a barge. Biomass is dredged up and placed onto a support barge which runs the debris back to shore. At the shore, debris is transferred to an appropriate composting location. In this case, the composting location is the town transfer station.

Many areas of Baddacook's littoral zone have filled in with debris from internal as well as external sources. Internal sources include weeds, root mass and floating islands. External sources include branches and leaves. The hydro-rake will address all areas that are too dense for the weed harvester to manage. After initially clearing the areas with the hydro-rake, the weed harvester will be used to maintain them, year after year.

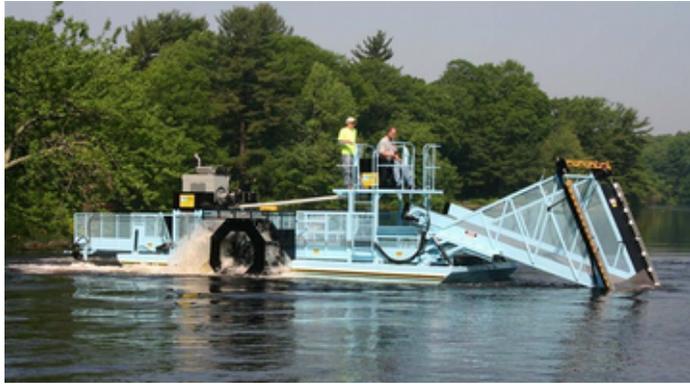
Weed Harvesting is accomplished using a Weed Harvester. A weed harvester is essentially a lawn mower. However, it does nothing to eradicate the weeds. The machine has three cutting blades, right, left and bottom, on the bow. These blades cut weeds onto a conveyor where they are moved back, until the harvester is full. When full, the harvester transports the weeds to shore. The weeds are off loaded and moved to a composting location, the Groton transfer station.

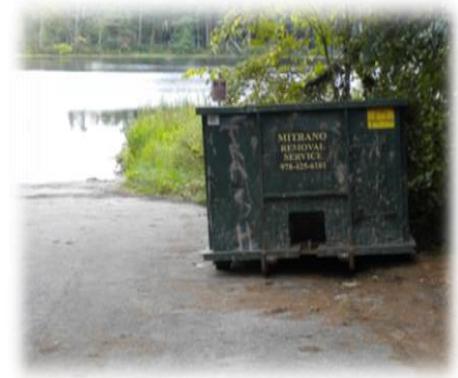
Image 1: Photo of the dumpster at the off-loading area

Seventeen (17) days of mechanical harvesting ensued, concluding on August 29. During operations, all collected material was off-loaded into a skid steer loader at the designated off-loading area. The plant material was then placed into a container to properly de-water (**Image 1**). Once full the containers were transported to the local landfill/composting site. During operations the harvester operator started south and then proceeded around the pond in a counter clockwise fashion, focusing on invasive species removal and recouping open water space. Please refer to **Figure 2** for a map of the harvested areas during this management period.

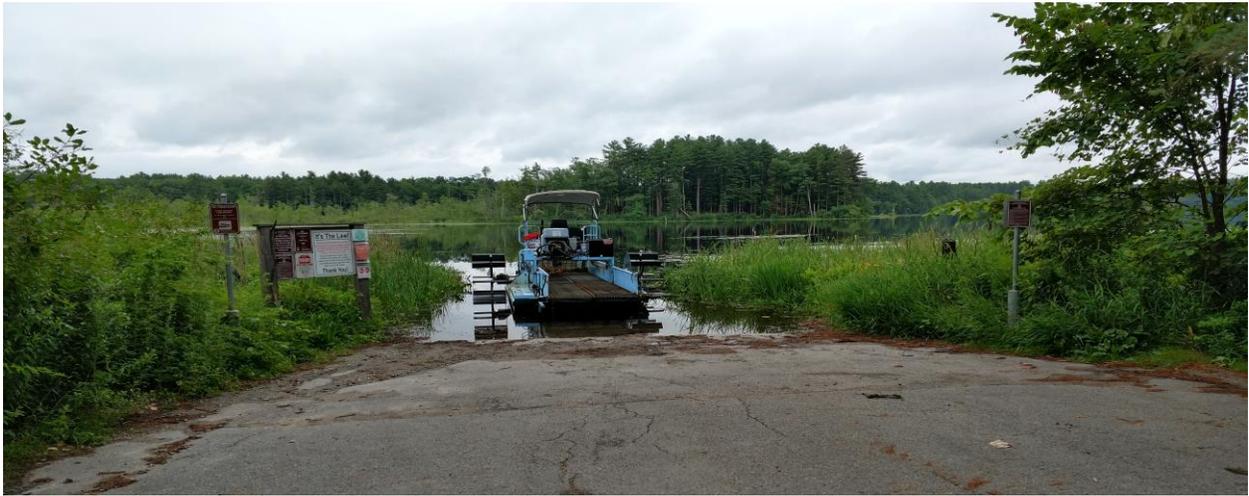
Image 1: Photo of the Baddacook Pond boat launch before the hydro-raking operation

matter. Please refer to **Image 1** and **2** for photos of before and after hydro-raking around the boat launch.

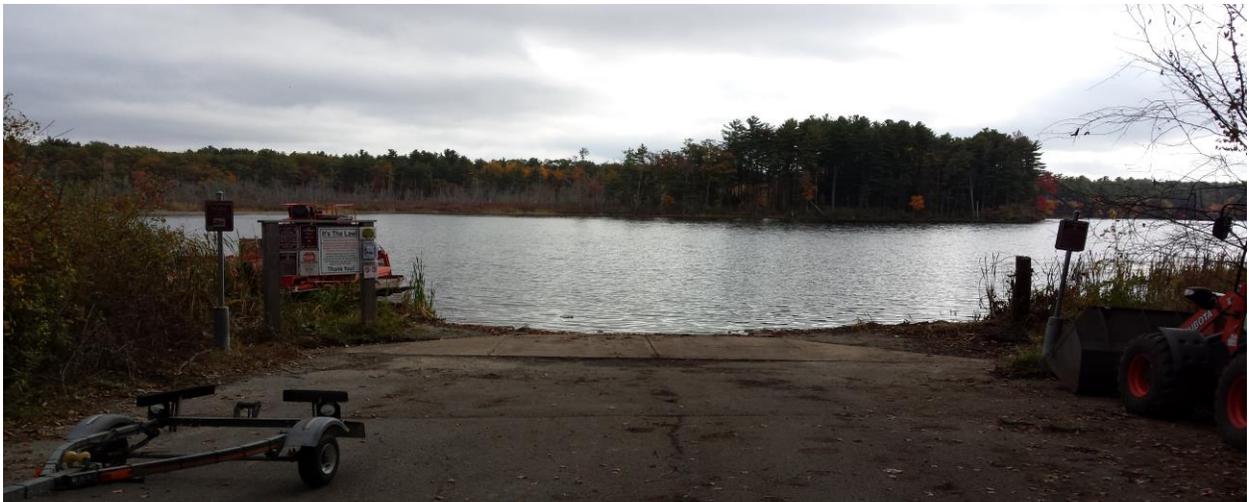
Image 2: Photo of the Baddacook Pond boat launch after the hydro-raking operation
