Appendix B - CPA Project Application Proposal

7. Project Address/Property Owner Name: 160 Chicopee Row, Groton, MA 01450

8. Project Name: FY26 Williams Barn Restoration

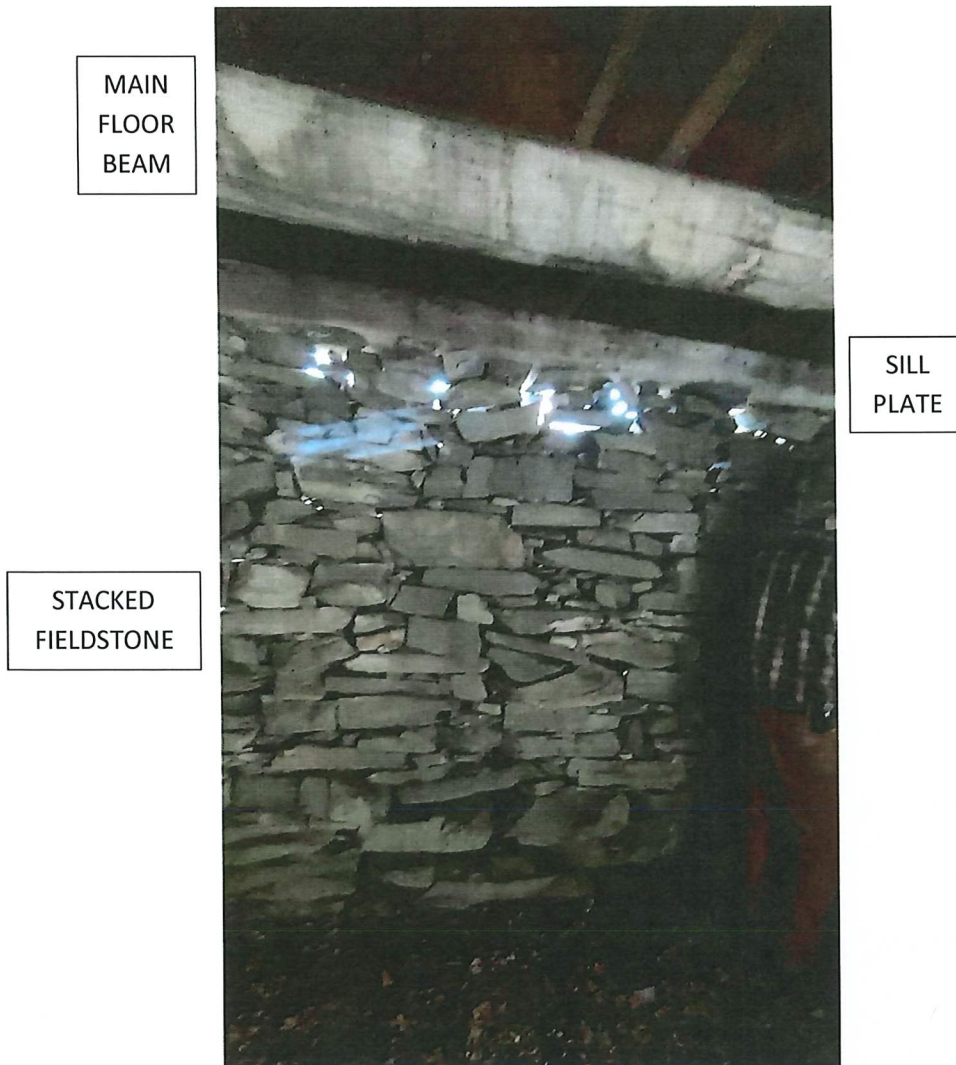
Figure 3: Foundation Wall Fieldstone, Sill Plate and Main Floor Beam

1. *Foundation wall restoration:* The barn foundation is composed of granite blocks and stacked fieldstone to create a basement wall upon which the barn structure itself sits. Over time, the pressure exerted on the wall by the surrounding soil causes the wall to fail inward and necessitates that the wall be periodically disassembled and rebuilt. Some estimate that foundation rebuilding is required about every 100 years. The foundation wall repair task involves jacking the barn up about two inches, just enough to take the weight off the foundation. The fieldstones are removed by hand and then re-stacked vertically to create a new stable wall using the original materials. A few new larger pieces of granite will be added to give the wall additional stability. After completion, the foundation wall will look like the original. Figure 3 shows the fieldstone foundation wall, the sill sitting atop the wall and one of the beams supporting the main floor of the barn.

2. *Sill Plate Replacement:* The sill plates are wooded horizontal members that sit atop the stone foundation and distribute the weight of the building onto and along the stacked stones. Over time, these members rot due to their exposure to water and the weather. The sill plates are made of hand hewn hard wood and will be replaced with new hand hewn hardwood. The sill plate replacement will occur while the barn is still jacked up off the foundation as described in Task 1. Only the sill plates along the northeast wall and southeast corner need replacement.

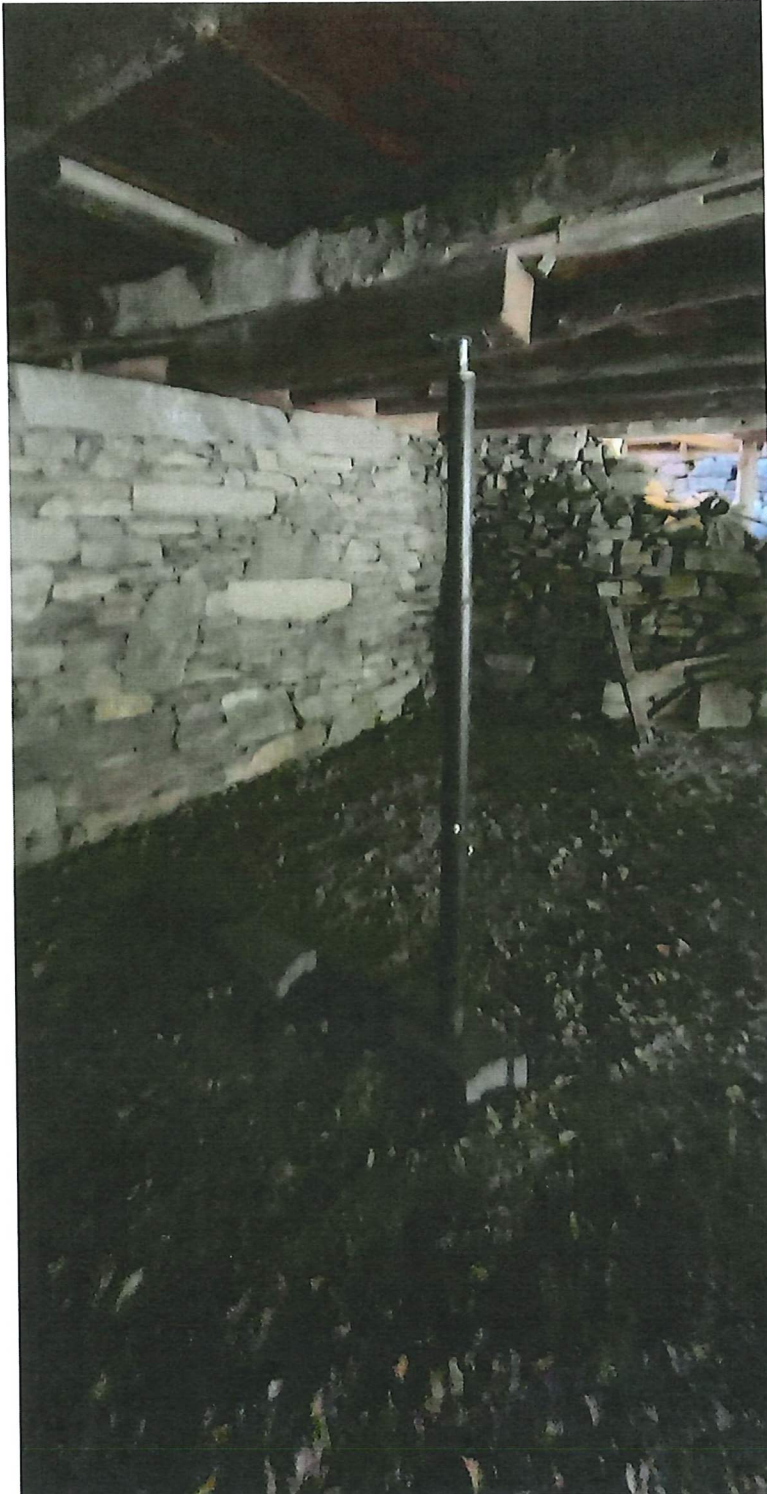
Figure 4: Cracked Main Floor Beam with Installed Stabilizing Jack

3. *Cracked Beam Replacement:* There are two cracked beams in the barn that need to be replaced. The first supports the main floor planking and is currently being stabilized with a jack as shown in Figure 4. The beam is made from hand hewn hardwood and will be replaced with hand hewn hardwood. Interestingly, Figure 4 shows unused mortise holes and wooded peg holes in the failed beam suggesting it may have originally been used in a previous barn. Beam replacement will require the floor above the beam to be supported on jacks while the old beam is removed and the new hand hewn beam is installed. The old beam will be retained as an example of the original construction.

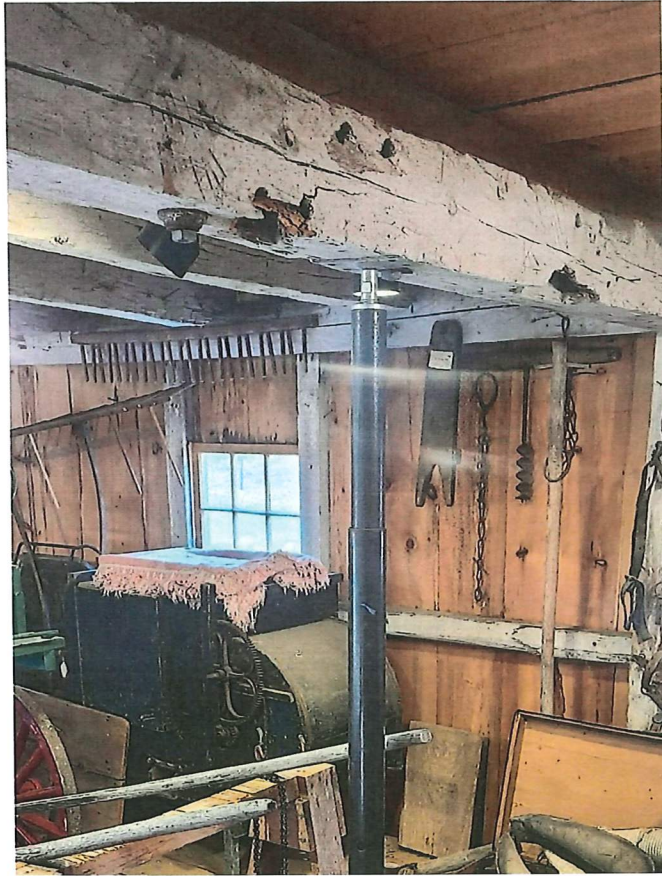
Figure 5: Cracked Beam Under Hayloft with Temporary Stabilizing Jack

The second beam needing replacement supports the hayloft above the main floor on the northeast side of the barn. See Figure 5 below. The beam there is cracked and is also being stabilized with a jack. Here too, the load above the beam will be supported on jacks, the wooden pins removed and the beam slid out of its connecting mortise. The new hand hewn beam will be inserted, pinned and the jacks removed.

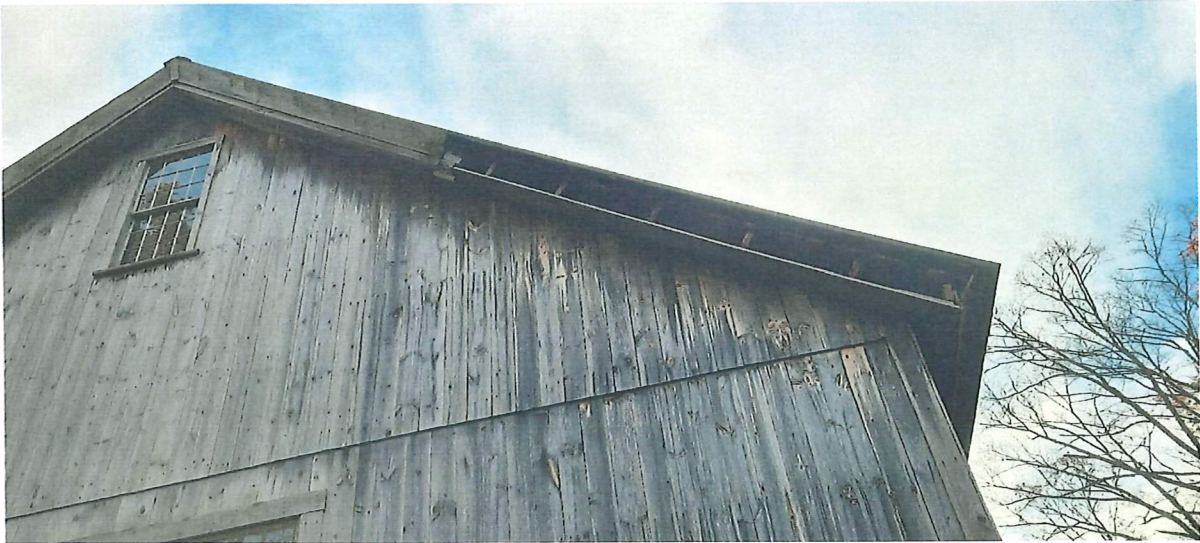
Figure 6: Missing Gable End Fascia from Northeast End of the Barn

4. *Gable End Fascia and Soffit Repair:* A section of fascia has fallen from the barn's northeastern gable. See Figure 6 below. Inspection from the ground suggests both the fascia and soffit have come loose because the members to which they were attached have rotted. Repairs involve installing scaffolding to gain access to the area, removing the rotted members and reinstalling the fascia and soffit boards if they are in good enough condition to be reused. If not, the boards will be replaced using boards of the same species and dimensions.

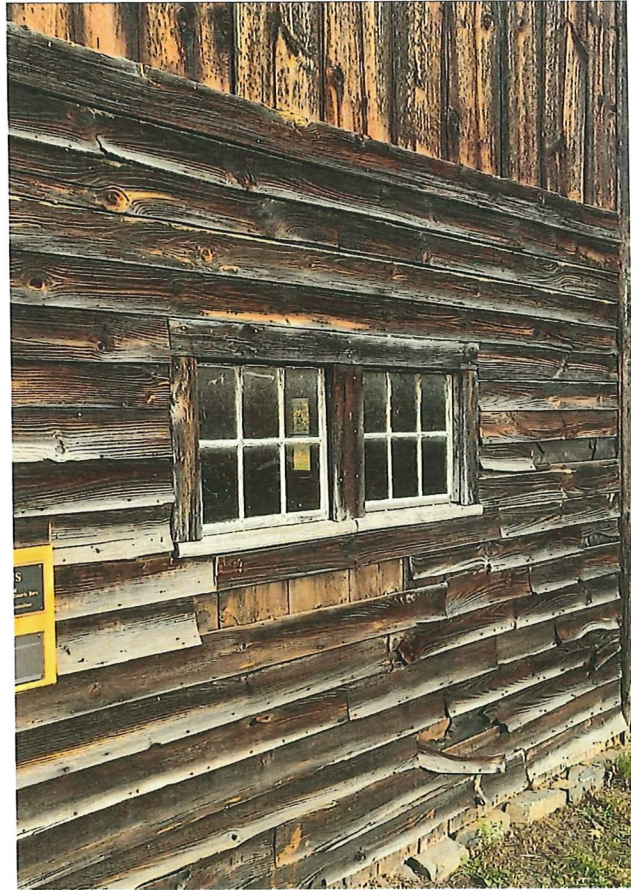
Figure 7: Sheathing on South West Gable has Come Loose

5. *Re-nailing Gable End Boards:* The sheathing on the two gable ends has come loose and needs to be reattached to the underlying wall boards. See Figure 7. The sheathing will be reused and re attached with cut nails as were used during original construction.
