# SQUANNACOOK RIVER DAM REMOVAL FEASIBILITY STUDY

June 2024

## Preliminary Design Assessment Report

### Groton, Massachusetts

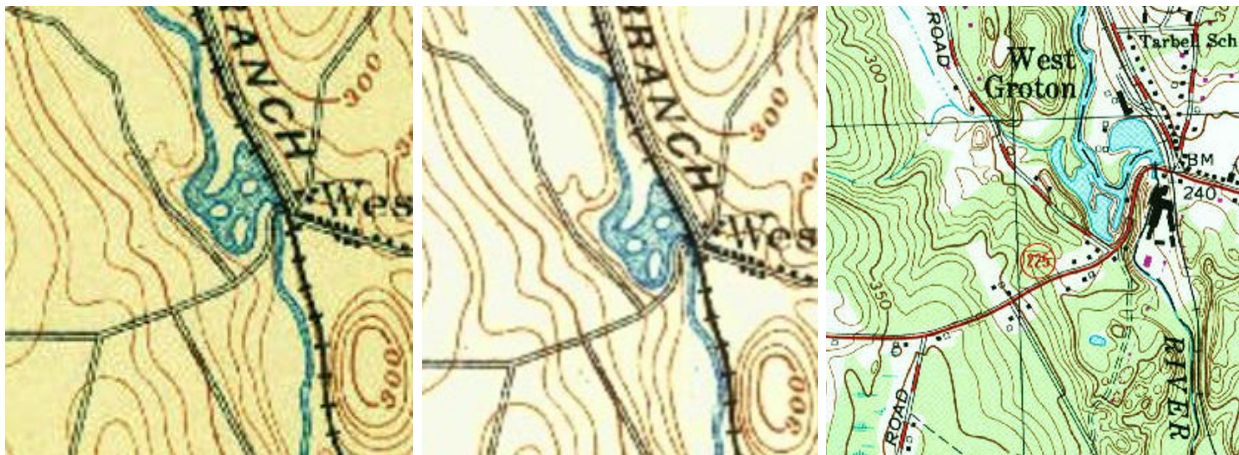
Figure 2. USGS Topographic Maps of Groton (left two, 1893 and 1935) and Shirley (right, 1965)

original construction date. The earliest available USGS maps, dated 1893 (**Figure 2**) show a dam impoundment at the site and there is little evident change in the size of the impoundment behind the dam comparing that oldest map to current conditions. In *Groton at 350*, Murray, Kulesz, and Johnson write that a sawmill was established at the site of the dam prior to 1744. According to the Massachusetts Historical Commission (MHC) Form A prepared by Sanford Johnson (Background Document #3), the area around West Groton was sparsely populated until 1847, at which time railroad services expanded into the area. Around this time a grist-and-saw mill was constructed by Thomas Tarbell at the current location of the RiverCourt Residences. By 1875, the Tarbell Mill was replaced by E.H. Sampson's Groton Leatherboard factory, which quickly became the primary industrial center in West Groton. Groton Historical Commission researchers have claimed that the Groton Leatherboard factory was the first leatherboard factory in the nation.

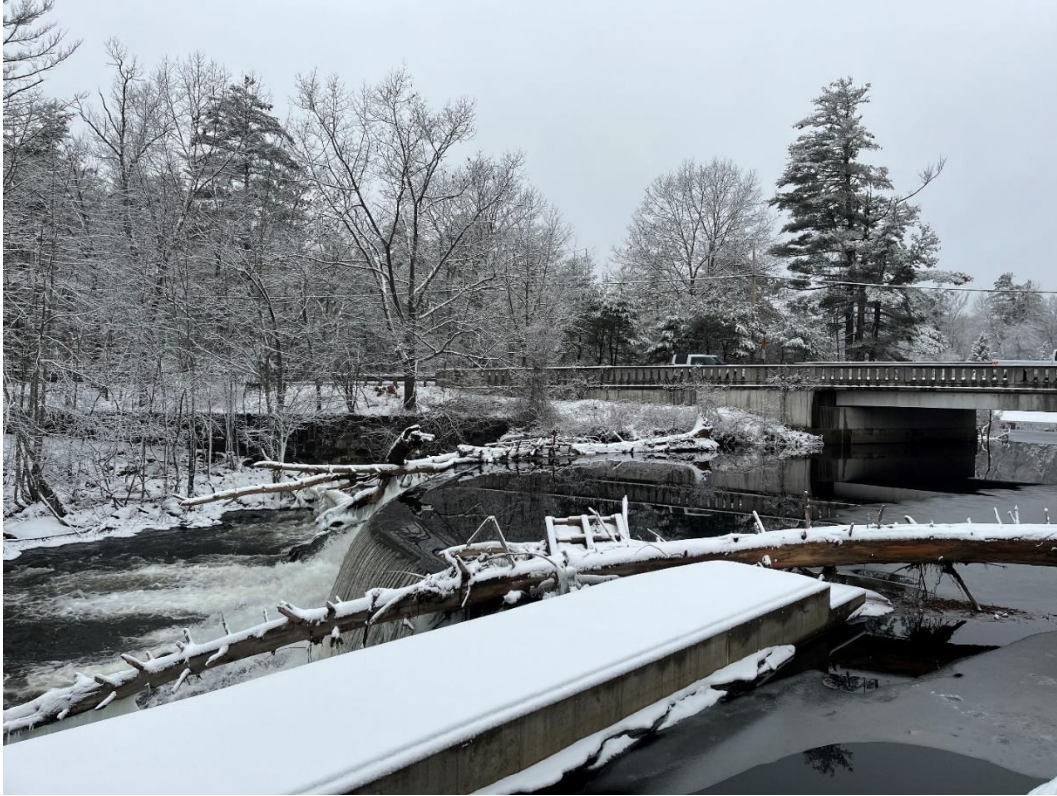
Figure 4. The Squannacook River Dam looking west, from the penstock (left bank) to Groton Road (Route 225) (right bank)

The current dam is a run-of-the-river, stone masonry and concrete structure, approximately 150 feet long with a structural height of 18 feet and crest elevation of 228.15 feet. On the river right side of the dam, a masonry training wall meets the dam at approximately the dam elevation. This training wall provides structural support to Groton Road in Shirley (Route 225).

On the river left side of the dam, a 10-foot-high masonry training wall extends from the dam parallel to the riverbank, forming a penstock. An overflow spillway at elevation 225.85 is located along this penstock, and a low level outlet structure consisting of a square wooded gate about 40 inches wide and tall is located at the bottom of the training wall. According to the DPW, the low level outlet is rarely used except in dry periods (typically in summer) when flow in the Squannacook River is insufficient out of the overflow spillway and the upstream impoundment becomes stagnant. During these times, the low level outlet is opened by one foot.

At the base of the dam, a concrete splashpad dissipates water that flows out of the overflow spillway along the penstock. Bedrock outcrop is located along the base of the main spillway of the dam.

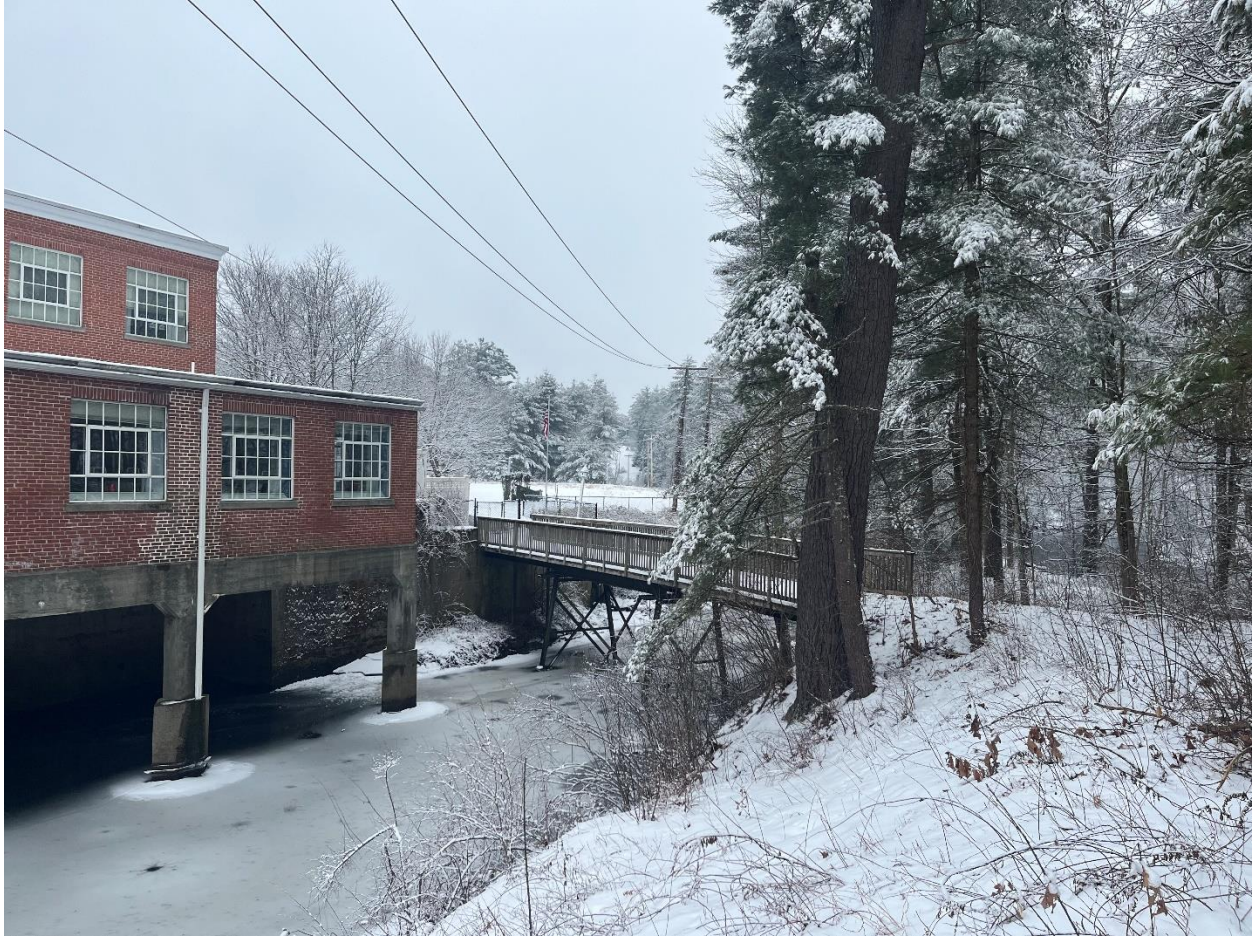
Figure 5. Looking east from the peninsula to the former mill building and parking lot

A 6-foot diameter pipe runs from the penstock approximately 100 to 150 feet along the former mill building – previously used to generate power at the mill. The pipe was plugged with concrete at some point between 1999 and 2006. A discharge channel from the former mill building runs between the legacy bank of the Squannacook River and the parking lot of the RiverCourt Residences, forming a peninsula in the river. A wooden pedestrian bridge on steel trusses connects the peninsula to the parking lot (**Figure 5**).

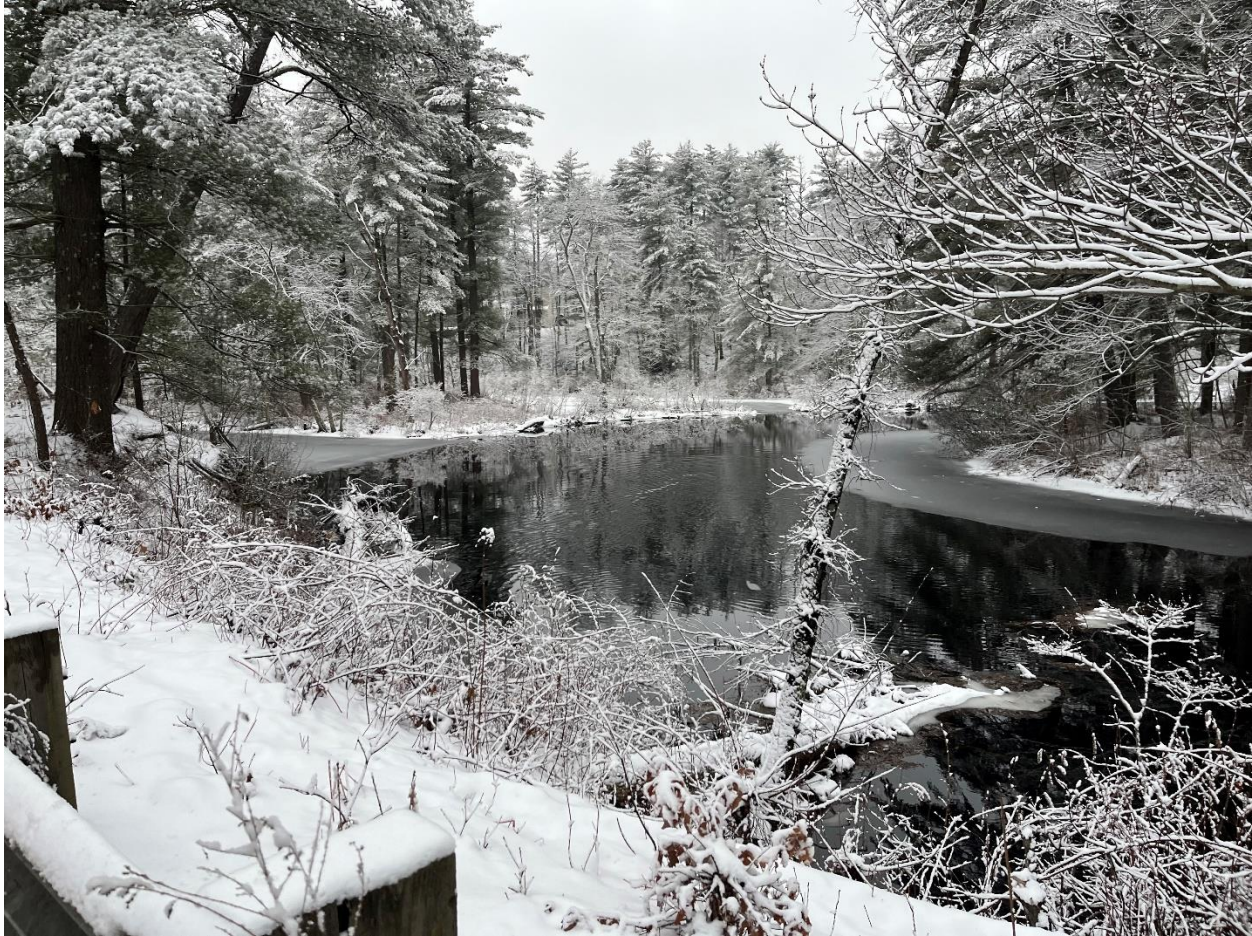
Figure 8. Reach of Squannacook River Upstream of West Groton Bridge

The upstream reach of the Squannacook River (**Figure 8**) is characterized by a relatively gentle channel slope (0.8%)<sup>1</sup>, and an overwidened width measured by HW to be around 95 feet (influenced by dam impoundment effects). A number of side channels and inlets are present along the upstream reach, also possibly influenced by the impoundment tailwater elevation. Vegetation on both sides of the river upstream of the dam consists of an open mix of native tree species as well as both native and invasive shrub and vine species. Evidence of beaver activity was observed on the right bank of the upstream reach.

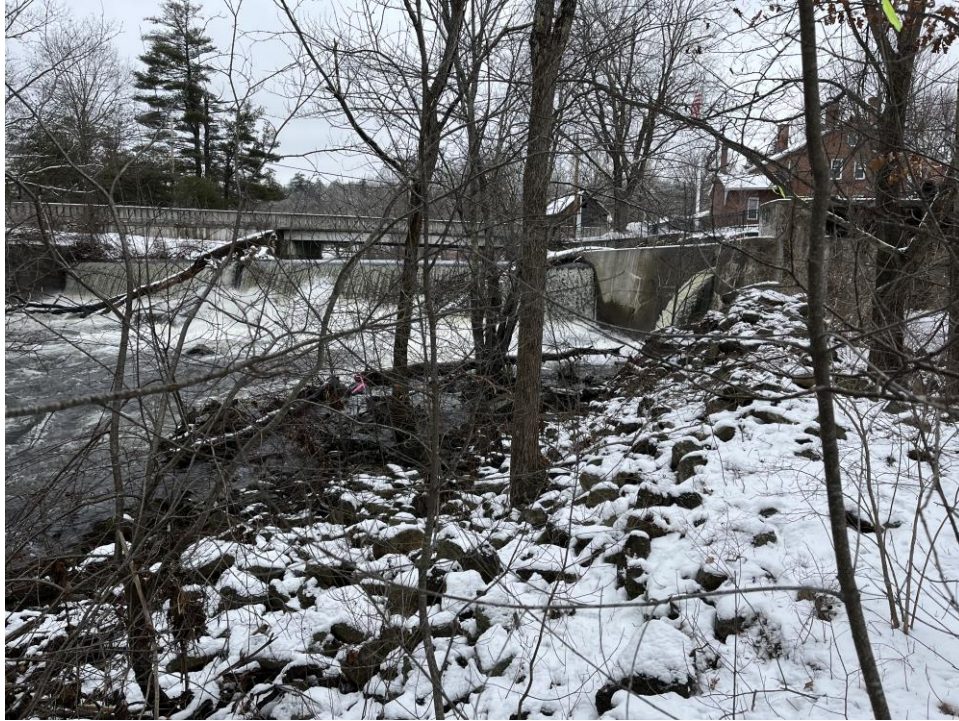
Along the eastern side of the Squannacook River, south of the dam structure, within the jurisdiction of the Town of Groton, the Bank consists primarily of a sparsely vegetated rock revetment, which rises steeply to the east from the edge of the river and then flattens out to a vegetated strip adjacent to the former mill building at the RiverCourt Residences property (**Figure 11**). Vegetation observed on the bank includes slippery elm (*Ulmus rubra*), red maple (*Acer rubrum*), glossy buckthorn (*Frangula alnus*), silky dogwood (*Cornus amomum*), alder (*Alnus sp.*), poison ivy (*Toxicodendron radicans*), and grape (*Vitis sp.*). Additional species observed directly adjacent to the Bank includes red oak (*Quercus rubra*), white pine (*Pinus strobus*), black cherry (*Prunus serotina*), cherry birch (*Betula lenta*), shrub honeysuckle (*Lonicera sp.*), glossy buckthorn, Japanese barberry (*Berberis thunbergia*), staghorn sumac (*Rhus typhina*), steplebush (*Spiraea tomentosa*), poison ivy, grape, and Asian bittersweet (*Celastrus orbiculatus*). Along this extent of the river, the locally-defined (Town of Groton) upper boundary of Bank is distinct from the upper boundary of Bank as defined by the Massachusetts Wetlands Protection Act at 310 CMR 10.54(2)(a). HW delineated the upper boundary of the locally-defined Bank at the first break in slope with consecutive bright green flagging stations labeled BANK 100 to BANK 102. HW delineated the upper boundary of the state-defined Bank at the mean annual flood level with consecutive pink flagging stations labeled MA BANK 100 to MA BANK 102.

Figure 11. Looking upstream at the Bank south of the dam, on the eastern side of the river.

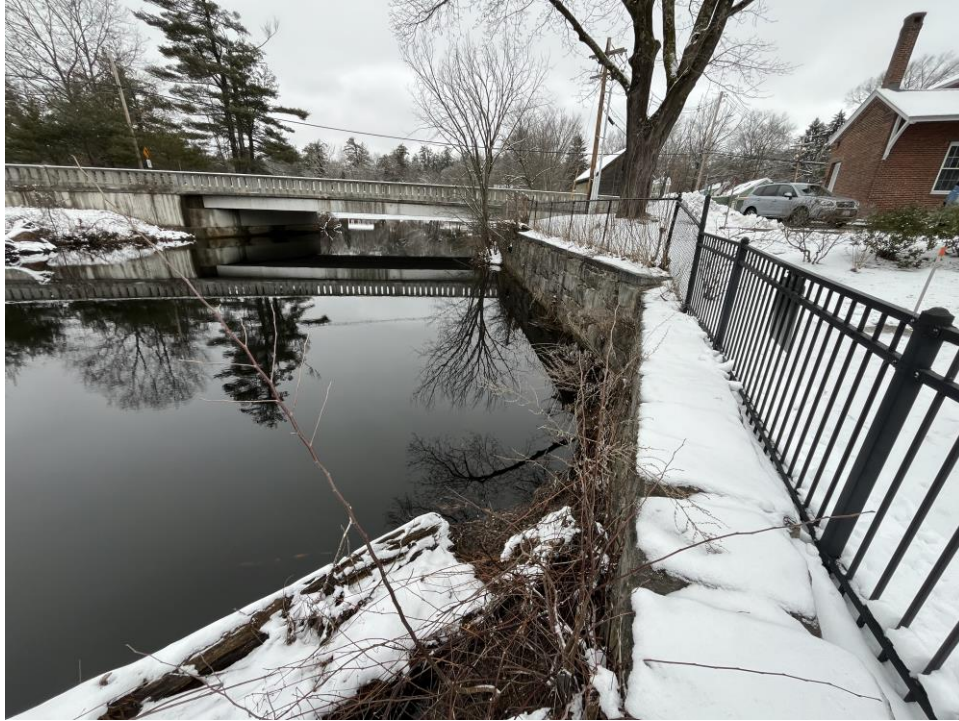
Along the eastern side of the Squannacook River, between the dam structure and the West Groton Bridge, within the jurisdiction of the Town of Groton, the Bank is primarily defined by a vertical stone wall that confines the river along the west side of the RiverCourt Residences property (**Figure 12**). The adjacent upland area consists of lawn, landscaping, walkway, and parking lot features associated with the RiverCourt Residences. There is a small section of vegetated Bank at the base of the stone wall along this extent, which consists of slippery elm, red maple, common buckthorn (*Rhamnus cathartica*), highbush blueberry (*Vaccinium corymbosum*), Japanese barberry, silky dogwood, poison ivy, and grape. Along this extent of the river, the locally-defined (Town of Groton) upper boundary of Bank coincides with the upper boundary of Bank as defined by the Massachusetts Wetlands Protection Act at 310 CMR 10.54(2)(a), due to the presence of the stone wall. HW delineated the upper boundary of the Bank with consecutive pink flagging stations labeled BANK 103 to BANK 106.

Figure 12. Looking upstream at the Bank along the eastern side of the river, between the dam and bridge.

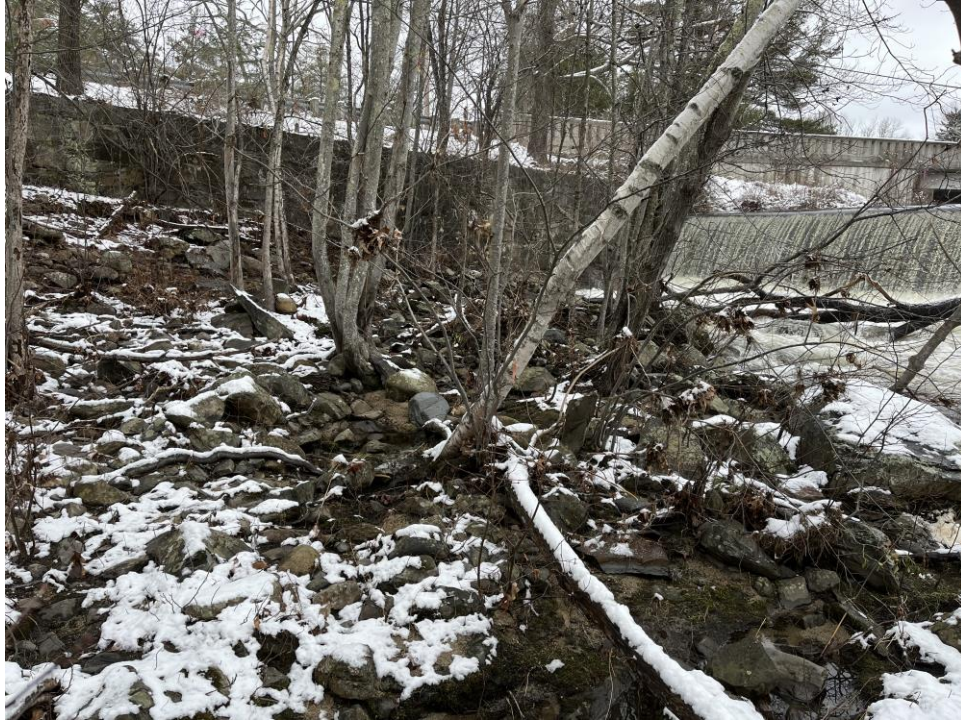
Along the western side of the Squannacook River, south of the dam structure, within the jurisdiction of the Town of Shirley, the Bank is vegetated with a mix of trees and shrubs and represents the edge of an alluvial hardwood flat community present along the low-lying area adjacent to the river (**Figure 13** and **Figure 14**). The slope then rises steeply up to the right of way of West Groton Road and is vegetated with a white pine-oak forest community. From the downstream side of the dam, a stone wall extends to the south, approximately parallel to West Groton Road. The eastern face of this wall is exposed along the northern section and confines the river at the mean annual flood level; therefore, the wall represents the upper boundary of the Bank along this section. Further to the south, the wall becomes embedded into the slope downgradient of West Groton Road, where the mean annual flood level occurs further to the east, downgradient from the wall. Vegetation observed on the bank includes slippery elm, red maple, river birch (*Betula nigra*), gray birch (*Betula populifolia*), and silky dogwood. Commonly observed species directly adjacent to the Bank includes red oak, cherry birch, white pine, ash (*Fraxinus sp.*), slippery elm, and common buckthorn. The extent of the Bank in the section closest to the dam was delineated along the mean annual flood elevation, where there is no distinct break in slope between the river and the mean annual flood elevation. Further to the south, the slope between the river and the mean annual flood elevation rises steeply from the river's edge before breaking sharply and transitioning into the alluvial hardwood flat community; therefore, the upper boundary of the Bank was delineated at the break in slope along this extent. HW delineated the upper boundary of the Bank with consecutive pink flagging stations labeled BANK 202 to BANK 207.

Figure 13. Looking upstream at the Bank along the western side of river, directly south of the dam.

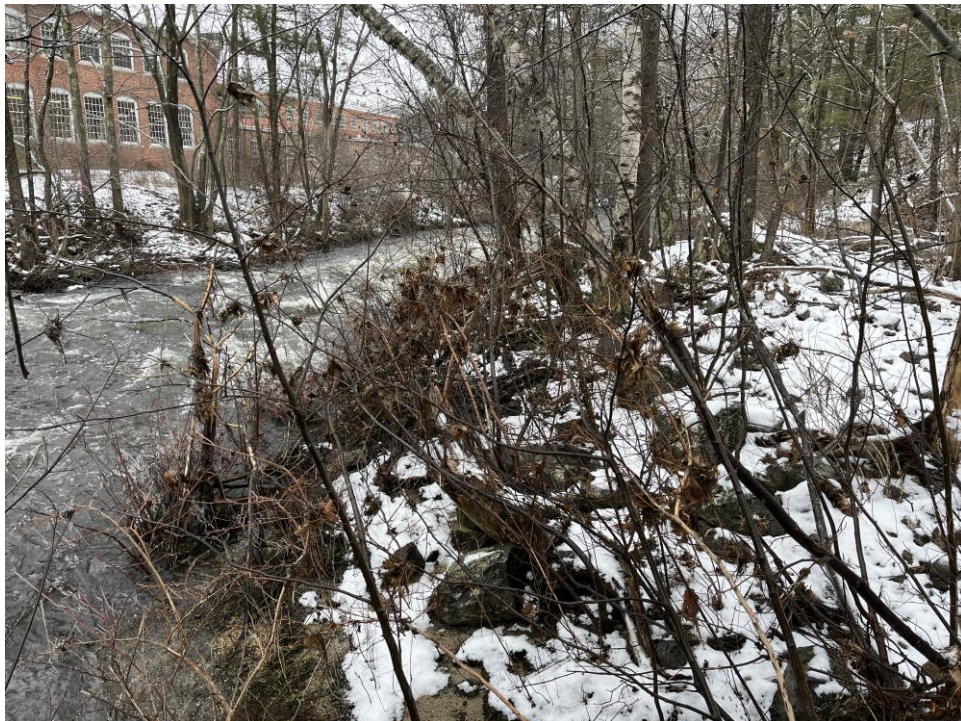
Figure 14. Looking downstream at the Bank along the western side of the river, where the upper boundary occurs at the first break in slope.

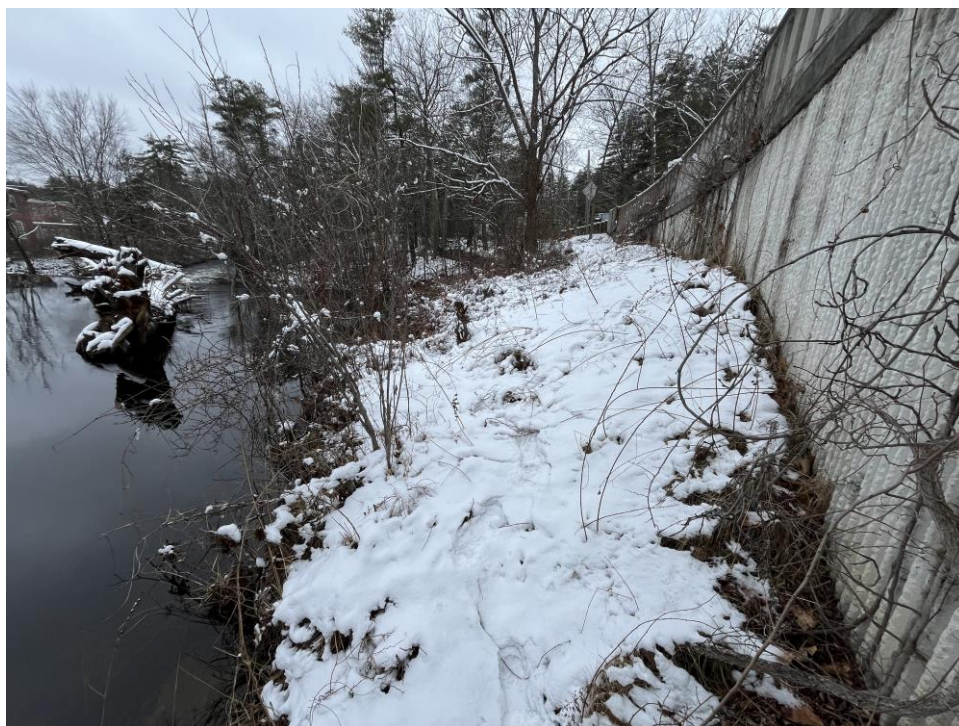
Along the western side of the Squannacook River, between the dam structure and the West Groton Bridge, within the jurisdiction of the Town of Shirley, the Bank consists of an open mix of shrub and vine species and is defined by the mean annual flood level. The slope rises steeply between the Bank and the bridge and consists primarily of vines and herbaceous species (**Figure 15**). Commonly observed vegetation along the Bank includes slippery elm, glossy buckthorn, silky dogwood, and Asian bittersweet. Commonly observed species directly upgradient of the Bank include poison ivy, Asian bittersweet, and bush clover (*Lespedeza sp.*). HW delineated the upper boundary of the Bank with consecutive pink flagging stations labeled BANK 200 to BANK 202.

Figure 15. Looking downstream at the Bank between the bridge and dam.

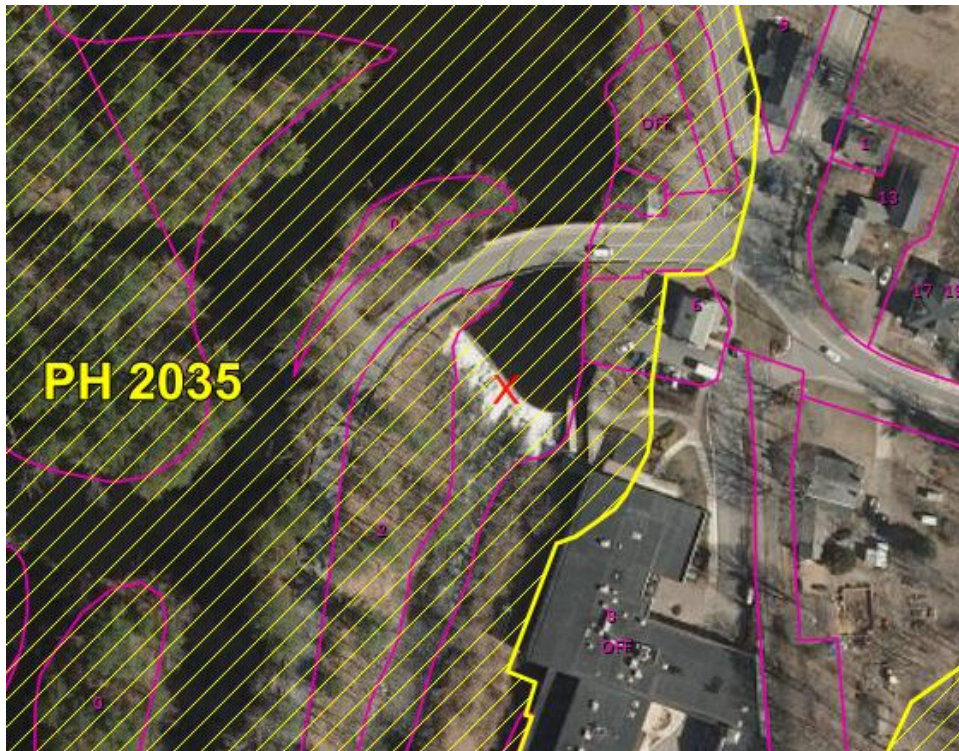
According to the most recent version of the *Massachusetts Natural Heritage Atlas* (15<sup>th</sup> Edition, August 1, 2021), the site is located within areas mapped as *Estimated Habitat of Rare Wildlife* (EH 1300) and *Priority Habitat of Rare Species* (PH 2035) as designated by the Massachusetts Natural Heritage and Endangered Species Program (NHESP) (**Figure 19**). There are no *Certified Vernal Pools* or *Potential Vernal Pools* mapped within the vicinity of the project.

Figure 19. Rare species habitat (Source: MassMapper 2024)

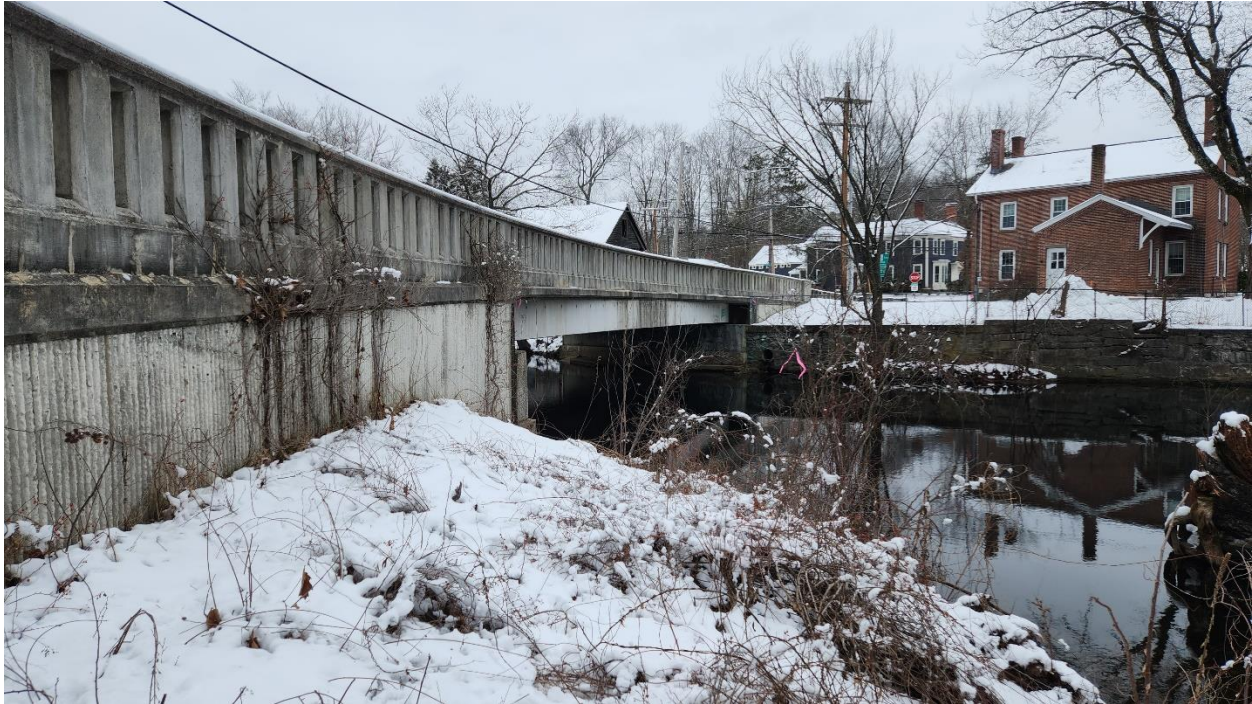
Figure 20. West Groton Bridge (Viewed from Downstream)

The West Groton Bridge (**Figure 20**) is a 20-foot-wide bridge that spans 65 feet of the Squannacook River along Groton Road. The bridge is comprised of concrete and stone masonry. The bridge deck is approximately 19 feet higher than the channel bottom of the Squannacook River at the thalweg, 6 feet higher than the ordinary high water elevation, and 8 feet higher than the dam spillway. Proposed Bridge Replacement Plans by Luchs Associates, Inc. (Background Document #1) show that prestressed concrete box beams support the bridge under the deck. During the January 31, 2024 site visit, 6 feet of separation was present between the water level and the bridge deck.

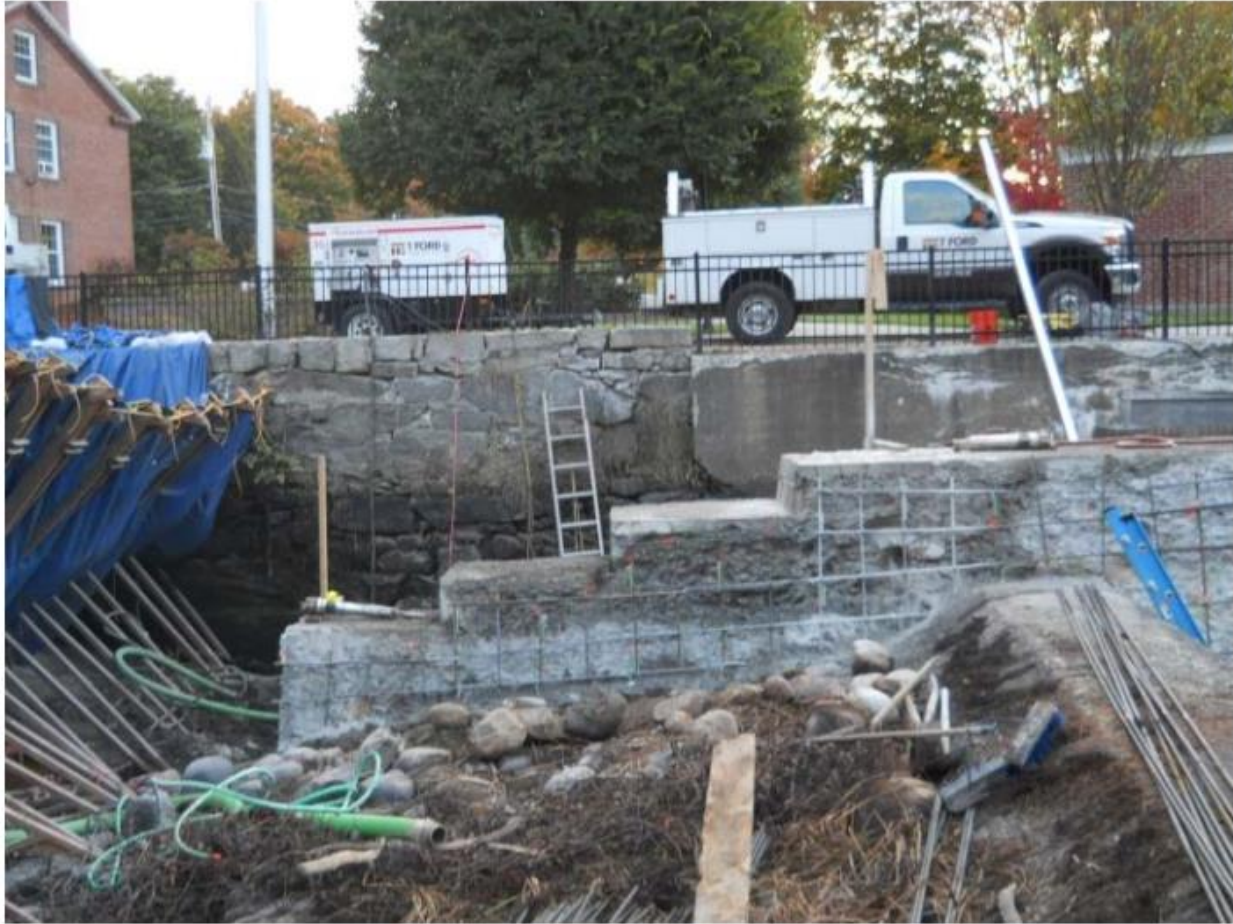
As discussed further below, construction access to the Squannacook River Dam would likely be achieved through the northern driveway on the RiverCourt Residences property. This was the access route used during the 2013 repairs to the Groton side of the dam (**Figure 21**). During the 2013 repairs, cofferdams were used to control water flow and create areas to work in the dry, and ladders were used to enter and exit the work area.

Figure 21. Access to Squannacook River Dam from RiverCourt Residences
