# SQUANNACOOK RIVER DAM REMOVAL BASIS OF DESIGN

November 2025

## Basis of Design Report

### Groton & Shirley, Massachusetts

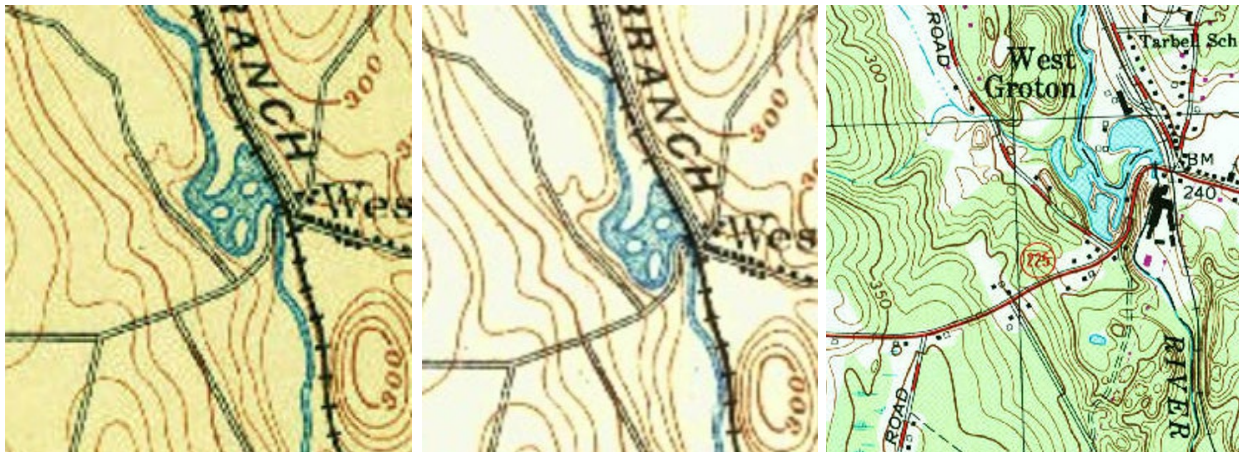
Figure 4. USGS Topographic Maps of Groton (left two, 1893 and 1935) and Shirley (right, 1965)

No construction records are available for the original Dam, although the year 1926 is imprinted in concrete on the Dam. This date likely represents a major reconstruction rather than the original construction date. The earliest available USGS maps, dated 1893 (**Figure 4**) show a dam impoundment at the site, and there is little evident change in the size of the impoundment behind the Dam when comparing that oldest map to current conditions. In *Groton at 350*, Murray, Kulesz, and Johnson write that a sawmill was established at the site of the Dam prior to 1744. According to the Massachusetts Historical Commission (MHC) Form A prepared by Sanford Johnson (Background Document #3), the area around West Groton was sparsely populated until 1847, at which time railroad services expanded into the area. Around this time a grist-and-saw mill was constructed by Thomas Tarbell at the current location of the RiverCourt Residences. By 1875, the Tarbell Mill was replaced by E.H. Sampson's Groton Leatherboard factory, which quickly became the primary industrial center in West Groton. The Groton Historical Commission researchers have claimed that the Groton Leatherboard factory was the first factory in the nation to produce leatherboard, an artificial leather product made of scrap leather, waste paper, and wood pulp.

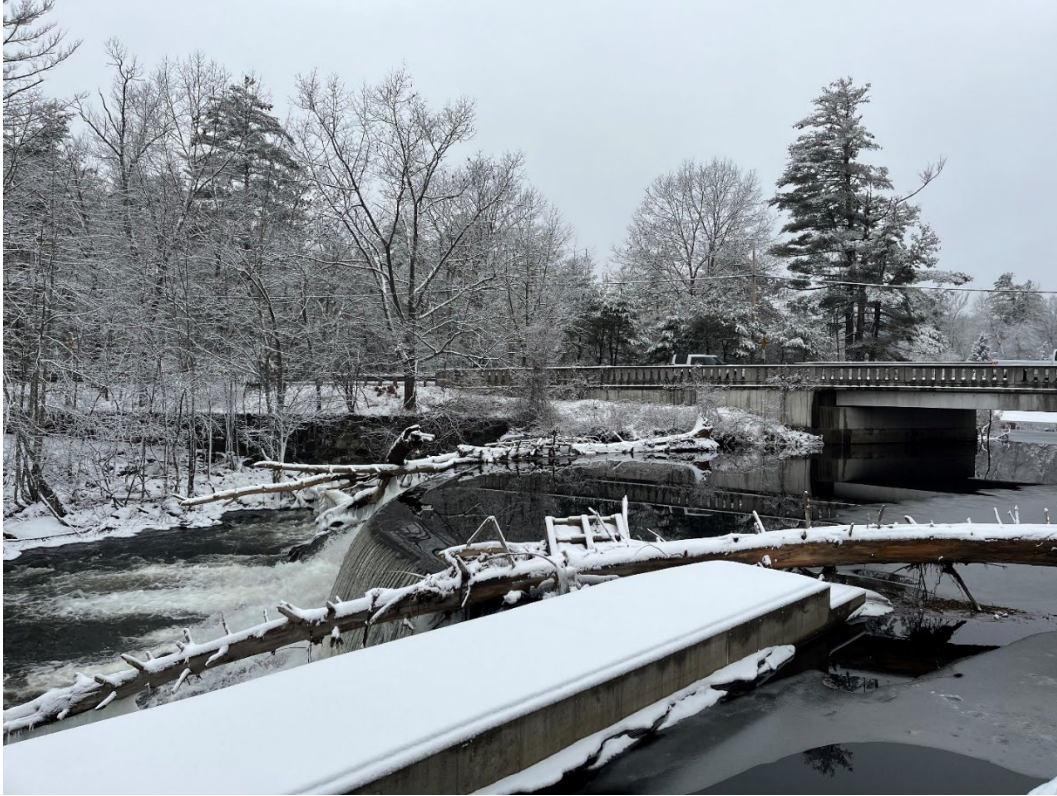
Figure 6. The Squannacook River Dam looking west, from the penstock (left bank) to Groton Road (Route 225) (right bank)

On the river left side of the dam, a 10-foot-high masonry training wall extends from the Dam parallel to the riverbank, forming a penstock. An overflow spillway at elevation 225.85 is located along this penstock, and a low level outlet structure consisting of a square wooded gate about 40 inches wide and tall is located at the bottom of the training wall. According to the DPW, the low level outlet is rarely used except in dry periods (typically in summer) when flow in the Squannacook River is insufficient out of the overflow spillway and the upstream impoundment becomes stagnant. During these times, the low level outlet is opened by one foot.

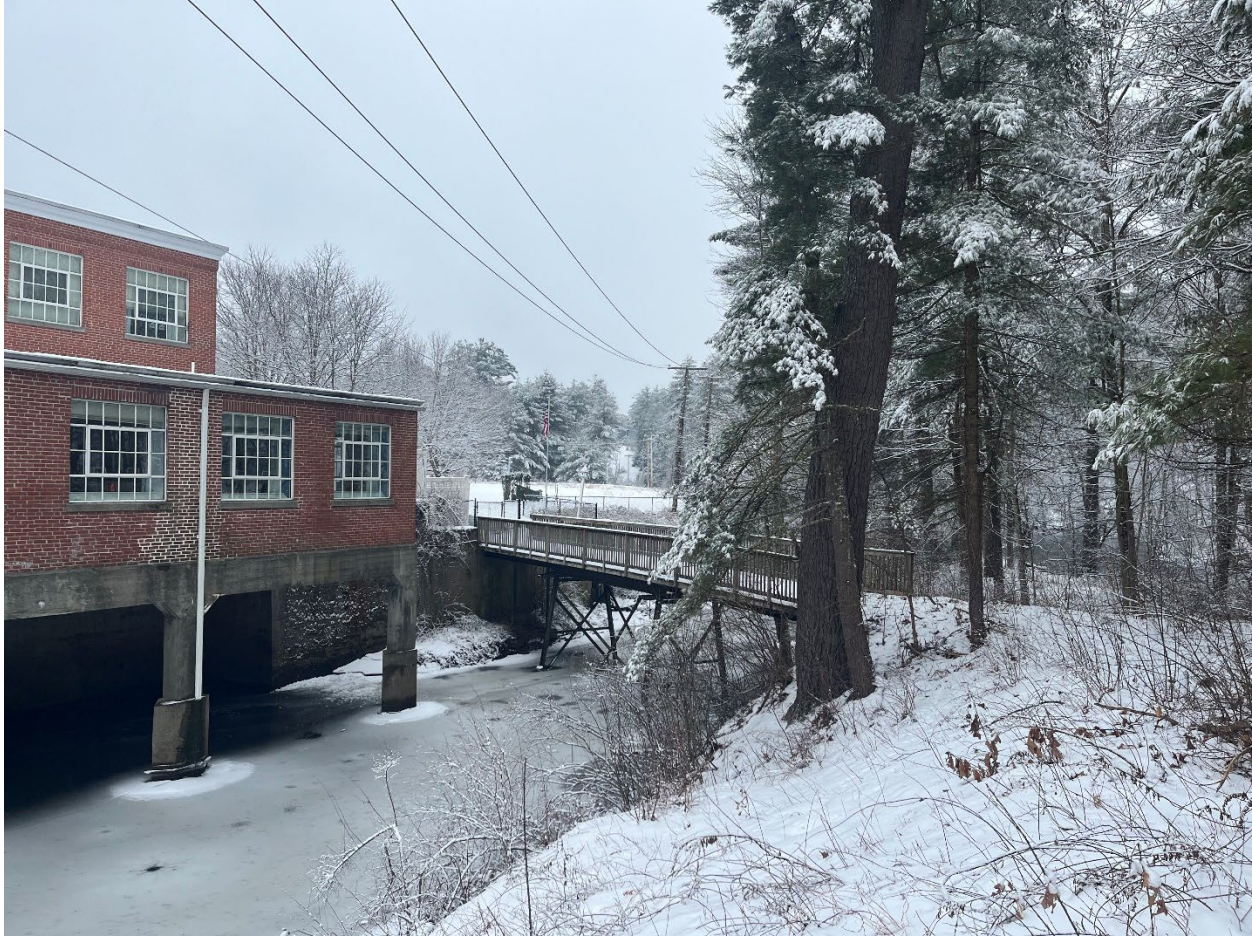
Figure 7. Looking east from the peninsula to the former mill building and parking lot

A 6-foot diameter pipe runs from the penstock approximately 100 to 150 feet along the former mill building – previously used to generate power at the mill. The pipe was plugged with concrete at some point between 1999 and 2006. A discharge channel from the former mill building runs between the legacy bank of the Squannacook River and the parking lot of the RiverCourt Residences, forming a peninsula in the river. A wooden pedestrian bridge on steel trusses connects the peninsula to the parking lot (**Figure 7**).

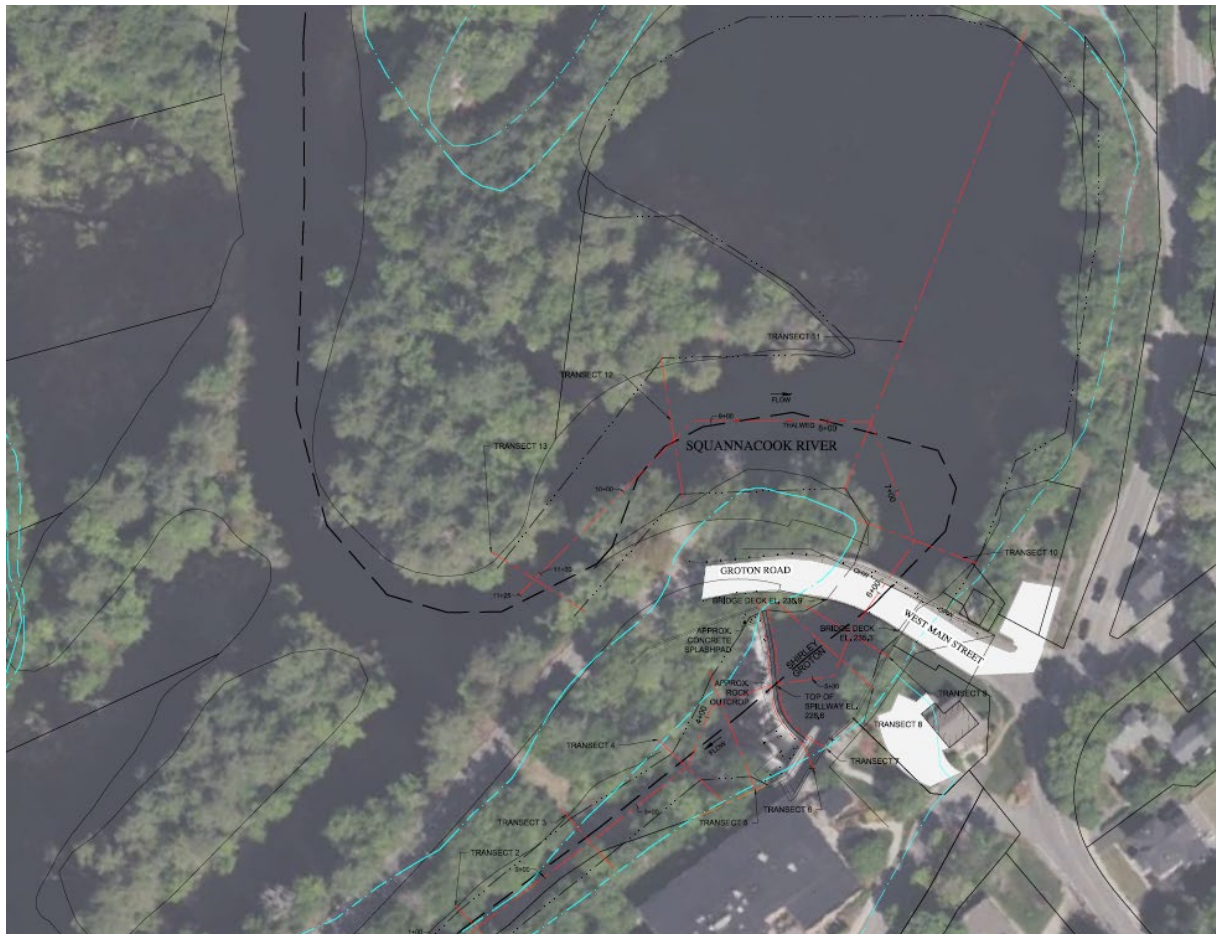
Figure 8. Squannacook River Dam Impoundment Schematic

HW survey data shows that at its deepest point, the impoundment bottom is 15.5 feet lower than the Dam spillway elevation and 9.6 feet lower than the estimated bedrock elevation underlying the Dam. The backwater section of the impoundment immediately upstream/directly north of the Dam (locally referred to as “Thompson Mill Pond”) was dredged in 2003, during which the impoundment was deepened by as much as 5 feet. The impoundment extents immediately upstream of the Dam are shown schematically below in **Figure 8**. The extents shown in **Figure 8** only include the project area, and do not include the full extent of the impoundment extending further upstream, as estimated in the Haley & Aldrich 2023 inspection report.

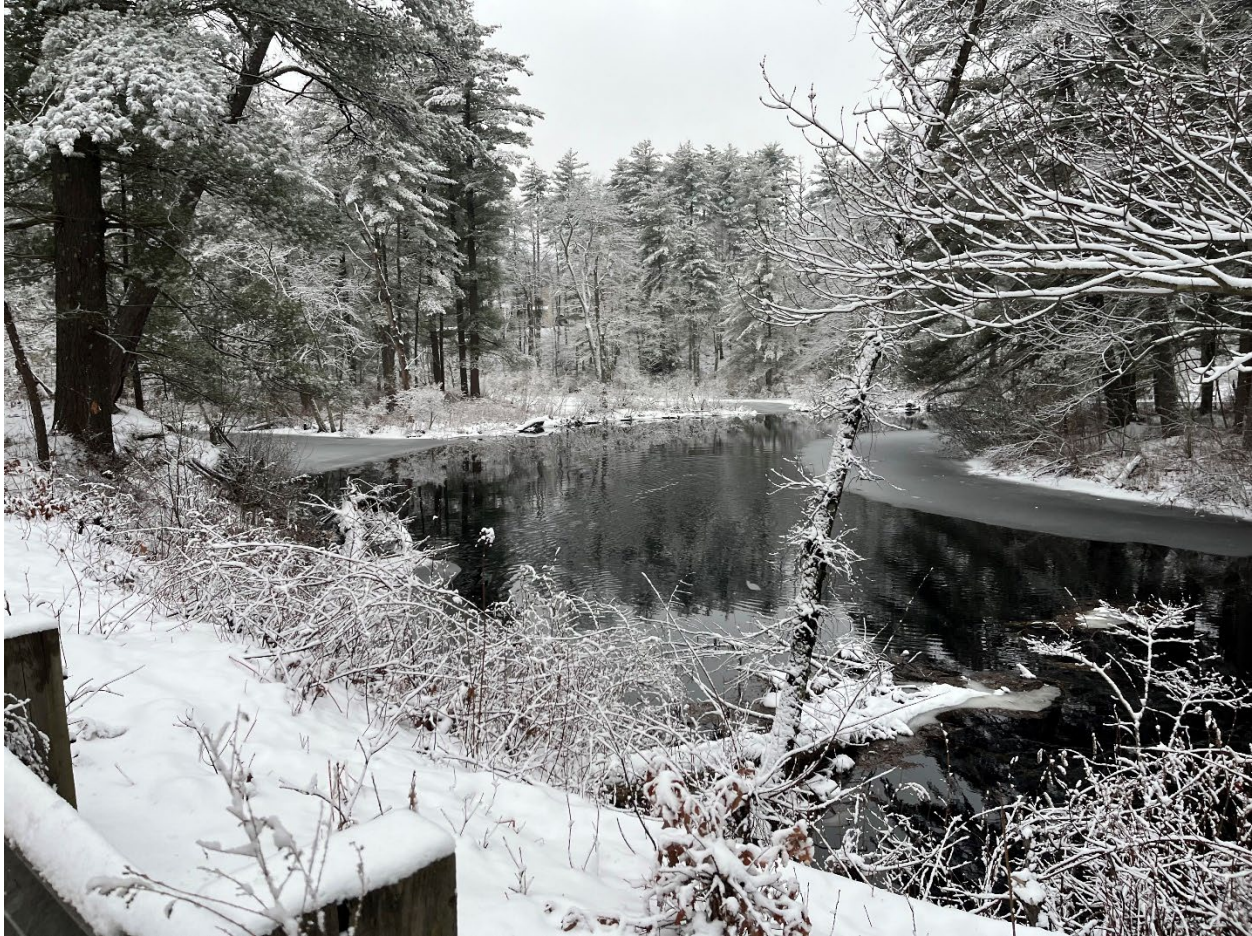
Figure 10. Reach of Squannacook River Upstream of West Groton Bridge

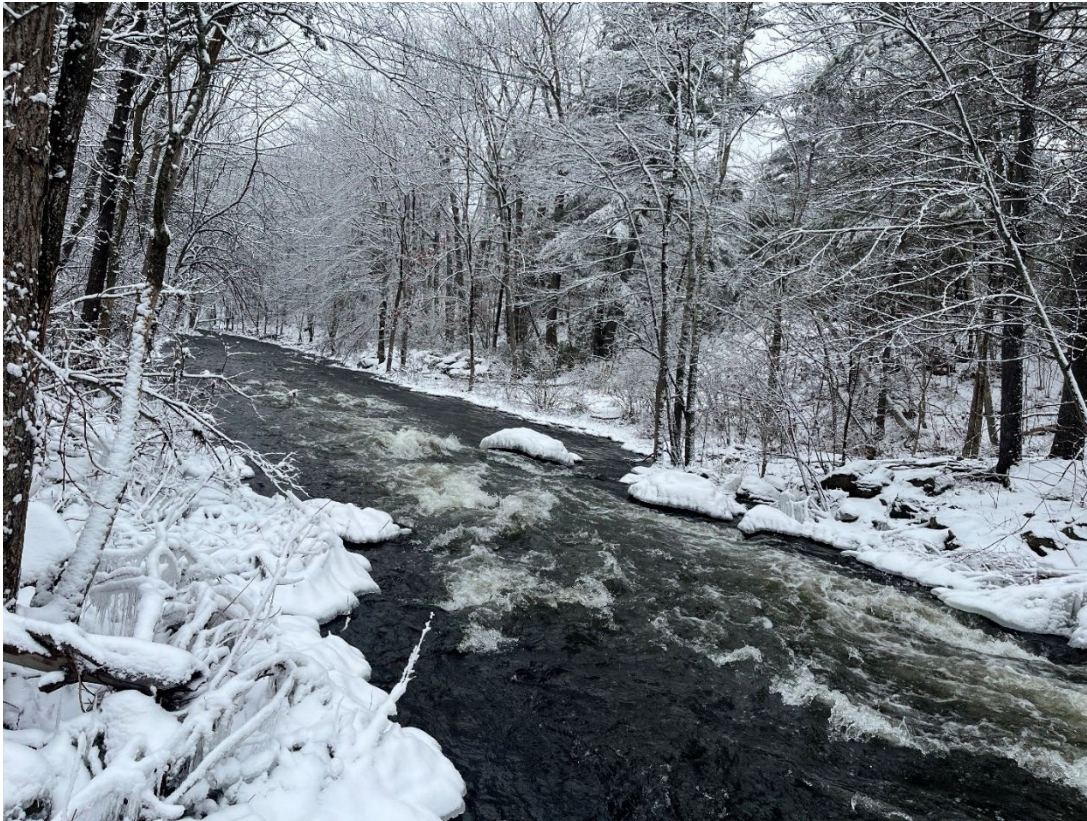
Figure 11. Reach of Squannacook River Downstream of Squannacook River Dam

This section of river slopes at a moderate 1.4%<sup>8</sup>. Despite the low gradient, water was observed flowing at a high velocity in this section. The river substrate consists of coarse material including gravel, cobbles, and boulders. The existing high velocity and coarse substrate are very likely a consequence of the high-energy outflow of the Dam, which drops over 12 feet from the crest of the Dam to the end of the plunge pool (approximately 50 feet downstream of the Dam). This downstream reach has an estimated bankfull width of 57 feet, nearly 40 feet narrower than the upstream reach, and is likely a reasonable estimate of the river's natural bankfull width were the Dam to be removed. Vegetation observed on the east and west banks downstream of the Dam includes various trees and shrubs from the alluvial hardwood community and the white pine-oak forest community, as well as both native and invasive vine species. The downstream reach

appears to be a good candidate to use as a reference reach for the project area of the Squannacook River.

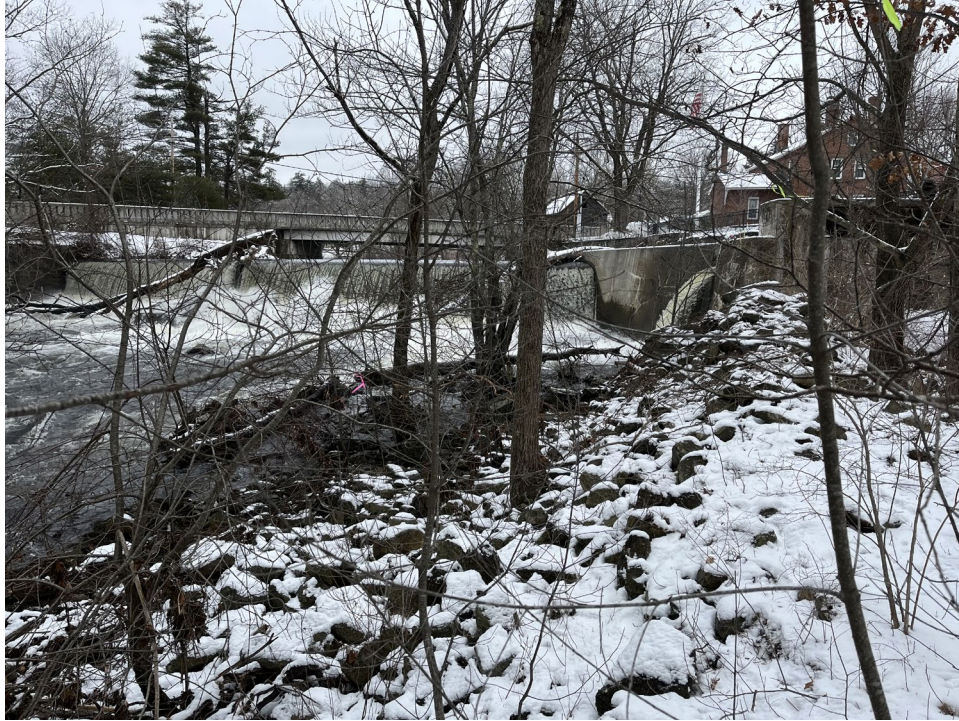
Figure 13. Looking upstream at the Bank south of the Dam, on the eastern side of the river.

Along the eastern side of the Squannacook River, south of the Dam structure, within the jurisdiction of the Town of Groton, the Bank consists primarily of a sparsely vegetated rock revetment, which rises steeply to the east from the edge of the river and then flattens out to a vegetated strip adjacent to the former mill building at the RiverCourt Residences property (**Figure 13**). Vegetation observed on the bank includes slippery elm (*Ulmus rubra*), red maple (*Acer rubrum*), glossy buckthorn (*Frangula alnus*), silky dogwood (*Cornus amomum*), alder (*Alnus sp.*), poison ivy (*Toxicodendron radicans*), and grape (*Vitis sp.*). Additional species observed directly adjacent to the Bank includes red oak (*Quercus rubra*), white pine (*Pinus strobus*), black cherry (*Prunus serotina*), cherry birch (*Betula lenta*), shrub honeysuckle (*Lonicera sp.*), glossy buckthorn, Japanese barberry (*Berberis thunbergia*), staghorn sumac (*Rhus typhina*), steplebush (*Spiraea tomentosa*), poison ivy, grape, and Asian bittersweet (*Celastrus orbiculatus*). Along this extent of the river, the locally defined (Town of Groton) upper boundary of Bank is distinct from the upper boundary of Bank as defined by the Massachusetts Wetlands Protection Act at 310 CMR 10.54(2)(a). HW delineated the upper boundary of the locally defined Bank at the first break in slope with consecutive bright green flagging stations labeled BANK 100 to BANK 102. HW delineated the upper boundary of the state-defined Bank at the mean annual flood level with consecutive pink flagging stations labeled MA BANK 100 to MA BANK 102.

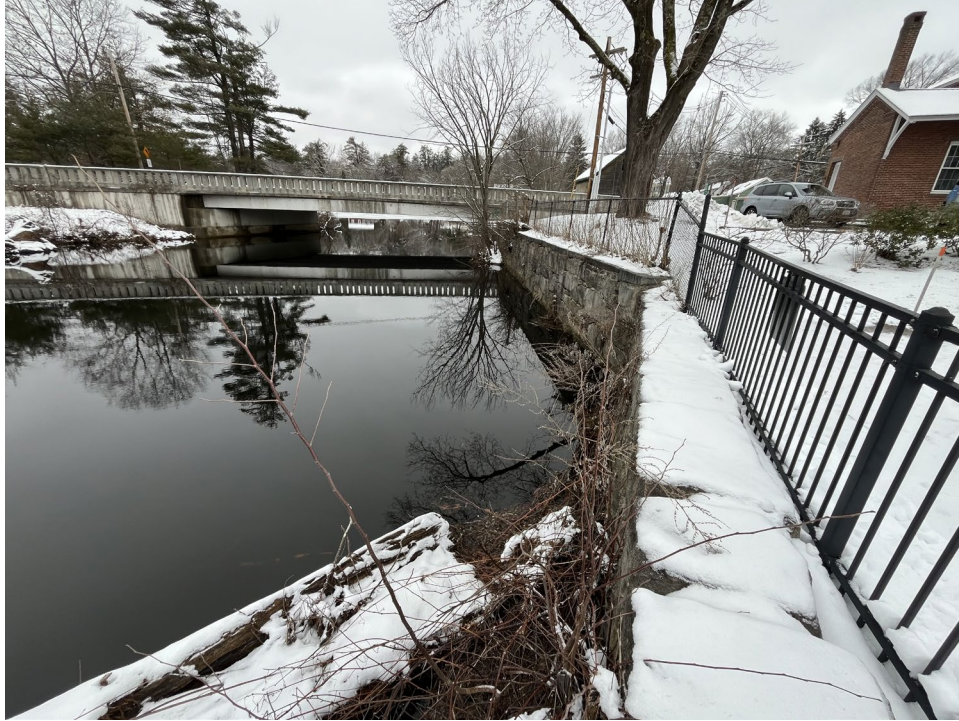
Figure 14. Looking upstream at the Bank along the eastern side of the river, between the Dam and bridge.

Along the eastern side of the Squannacook River, between the Dam structure and the West Groton Bridge, within the jurisdiction of the Town of Groton, the Bank is primarily defined by a vertical stone wall that confines the river along the west side of the RiverCourt Residences property (**Figure 14**). The adjacent upland area consists of lawn, landscaping, walkway, and parking lot features associated with the RiverCourt Residences. There is a small section of vegetated Bank at the base of the stone wall along this extent, which consists of slippery elm, red maple, common buckthorn (*Rhamnus cathartica*), highbush blueberry (*Vaccinium corymbosum*), Japanese barberry, silky dogwood, poison ivy, and grape. Along this extent of the river, the locally defined (Town of Groton) upper boundary of Bank coincides with the upper boundary of Bank as defined by the Massachusetts Wetlands Protection Act at 310 CMR 10.54(2)(a), due to the presence of the stone wall. HW delineated the upper boundary of the Bank with consecutive pink flagging stations labeled BANK 103 to BANK 106.

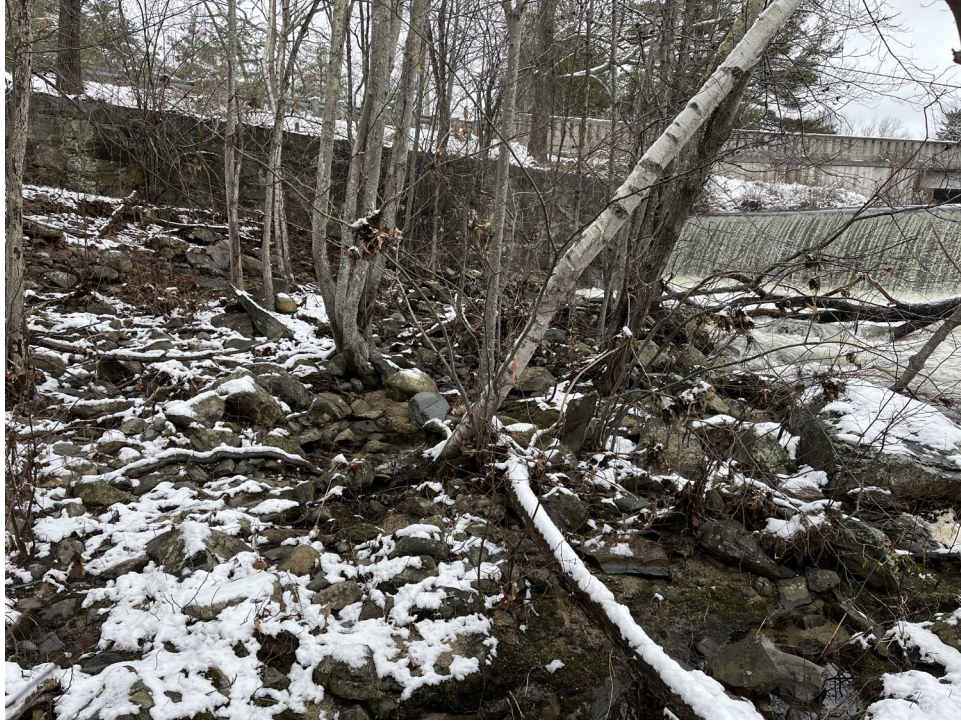
Figure 15. Looking upstream at the Bank along the western side of river, directly south of the Dam.

Along the western side of the Squannacook River, south of the Dam structure, within the jurisdiction of the Town of Shirley, the Bank is vegetated with a mix of trees and shrubs and represents the edge of an alluvial hardwood flat community present along the low-lying area adjacent to the river (**Figure 15** and **Figure 16**). The slope then rises steeply up to the right of way of West Groton Road and is vegetated with a white pine-oak forest community. From the downstream side of the Dam, a stone wall extends to the south, approximately parallel to West Groton Road. The eastern face of this wall is exposed along the northern section and confines the river at the mean annual flood level; therefore, the wall represents the upper boundary of the Bank along this section. Further to the south, the wall becomes embedded into the slope downgradient of West Groton Road, where the mean annual flood level occurs further to the east, downgradient from the wall. Vegetation observed on the bank includes slippery elm, red maple, river birch (*Betula nigra*), gray birch (*Betula populifolia*), and silky dogwood. Commonly observed species directly adjacent to the Bank include red oak, cherry birch, white pine, ash (*Fraxinus sp.*), slippery elm, and common buckthorn. The extent of the Bank in the section closest to the Dam was delineated along the mean annual flood elevation, where there is no distinct break in slope between the river and the mean annual flood elevation. Further to the south, the slope between the river and the mean annual flood elevation rises steeply from the river's edge before breaking sharply and transitioning into the alluvial hardwood flat community; therefore, the upper boundary of the Bank was delineated at the break in slope along this extent. HW delineated the upper boundary of the Bank with consecutive pink flagging stations labeled BANK 202 to BANK 207.

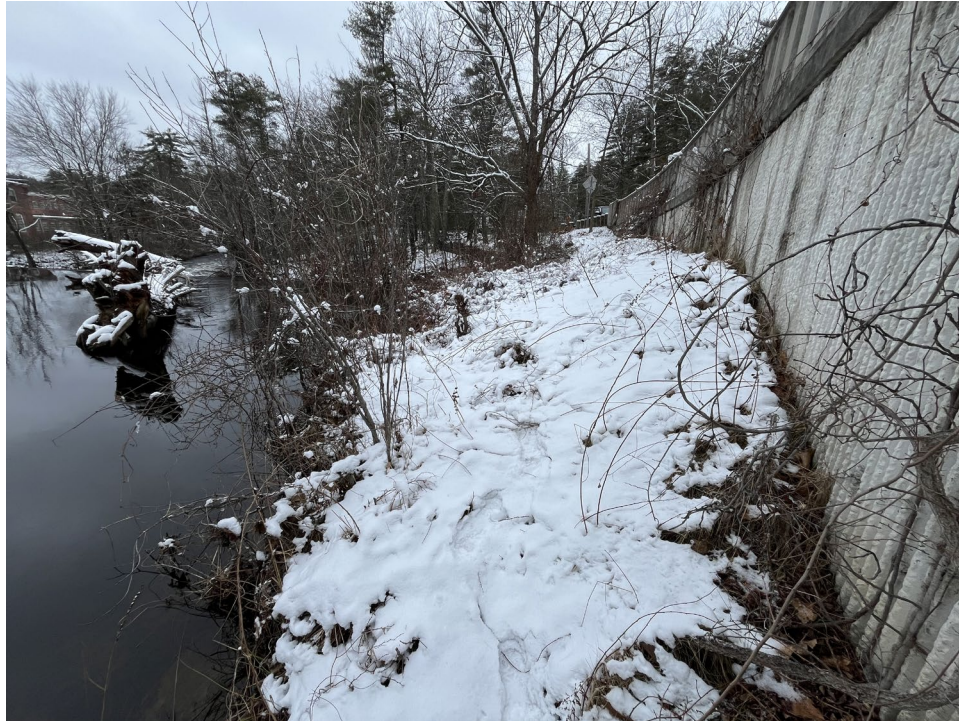
Figure 17. Looking downstream at the Bank between the bridge and Dam.

Along the western side of the Squannacook River, between the Dam structure and the West Groton Bridge, within the jurisdiction of the Town of Shirley, the Bank consists of an open mix of shrub and vine species and is defined by the mean annual flood level. The slope rises steeply between the Bank and the bridge and consists primarily of vines and herbaceous species (**Figure 17**). Commonly observed vegetation along the Bank includes slippery elm, glossy buckthorn, silky dogwood, and Asian bittersweet. Commonly observed species directly upgradient of the Bank include poison ivy, Asian bittersweet, and bush clover (*Lespedeza sp.*). HW delineated the upper boundary of the Bank with consecutive pink flagging stations labeled BANK 200 to BANK 202.

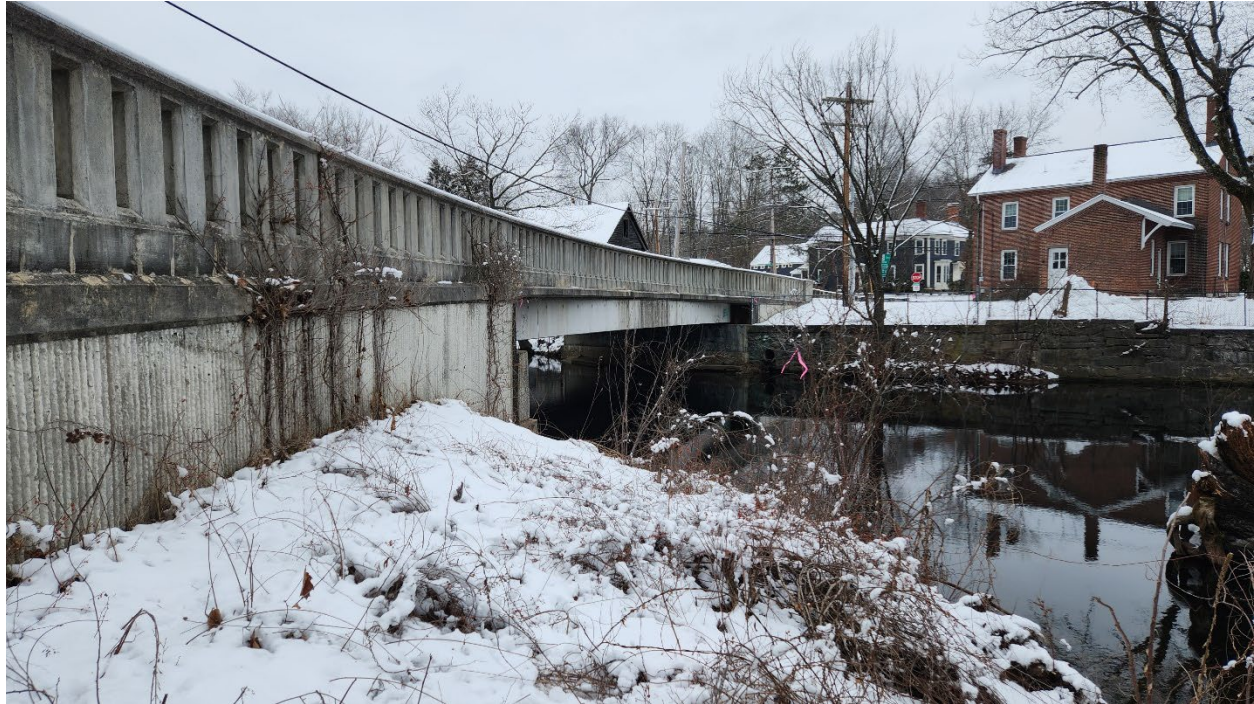
Figure 22. West Groton Bridge (Viewed from Downstream)

The West Groton Bridge (**Figure 22**) is a 20-foot-wide bridge that spans 65 feet of the Squannacook River along Groton Road. The bridge is comprised of concrete and stone masonry. The bridge deck is approximately 19 feet higher than the channel bottom of the Squannacook River at the thalweg, 6 feet higher than the ordinary high water elevation, and 8 feet higher than the Dam spillway. Proposed Bridge Replacement Plans by Luchs Associates, Inc. (Background Document #1) show that prestressed concrete box beams support the bridge under the deck. During the January 31, 2024 site visit, 6 feet of separation was present between the water level and the bridge deck.

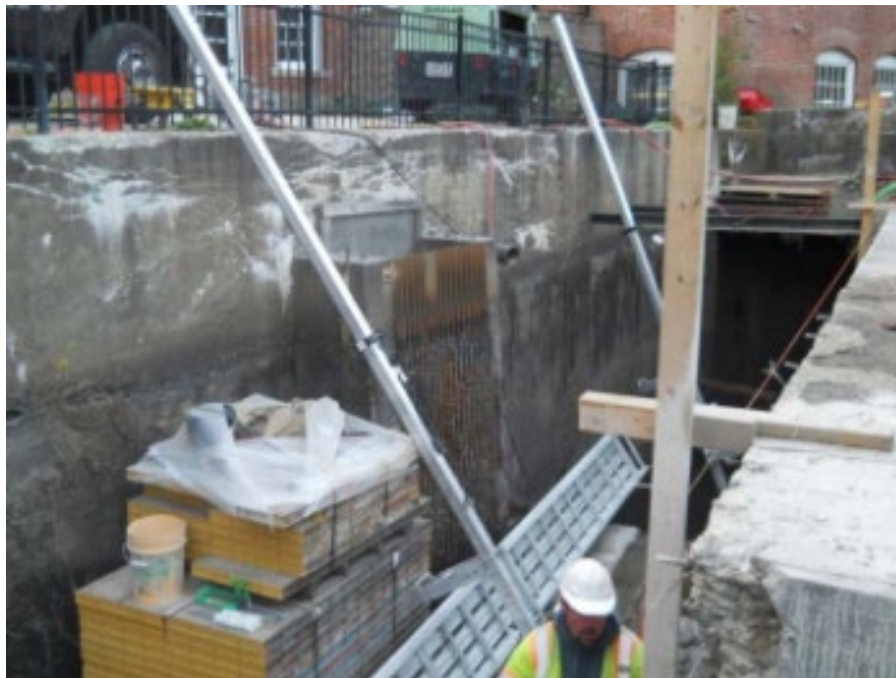
Figure 23. River-Left Retaining Wall During 2013 Dam Repairs

A retaining wall extending from the West Groton Bridge downstream to the penstock of the former mill building supports the earthen base of the RiverCourt Residences parking area. A portion of this retaining wall was exposed in 2013 when the Groton-side of the Dam was repaired in 2013. The wall is comprised of stone masonry from the West Groton Bridge until approximately 60 feet away from the former mill building, at which point it transitions to concrete (**Figure 23**).

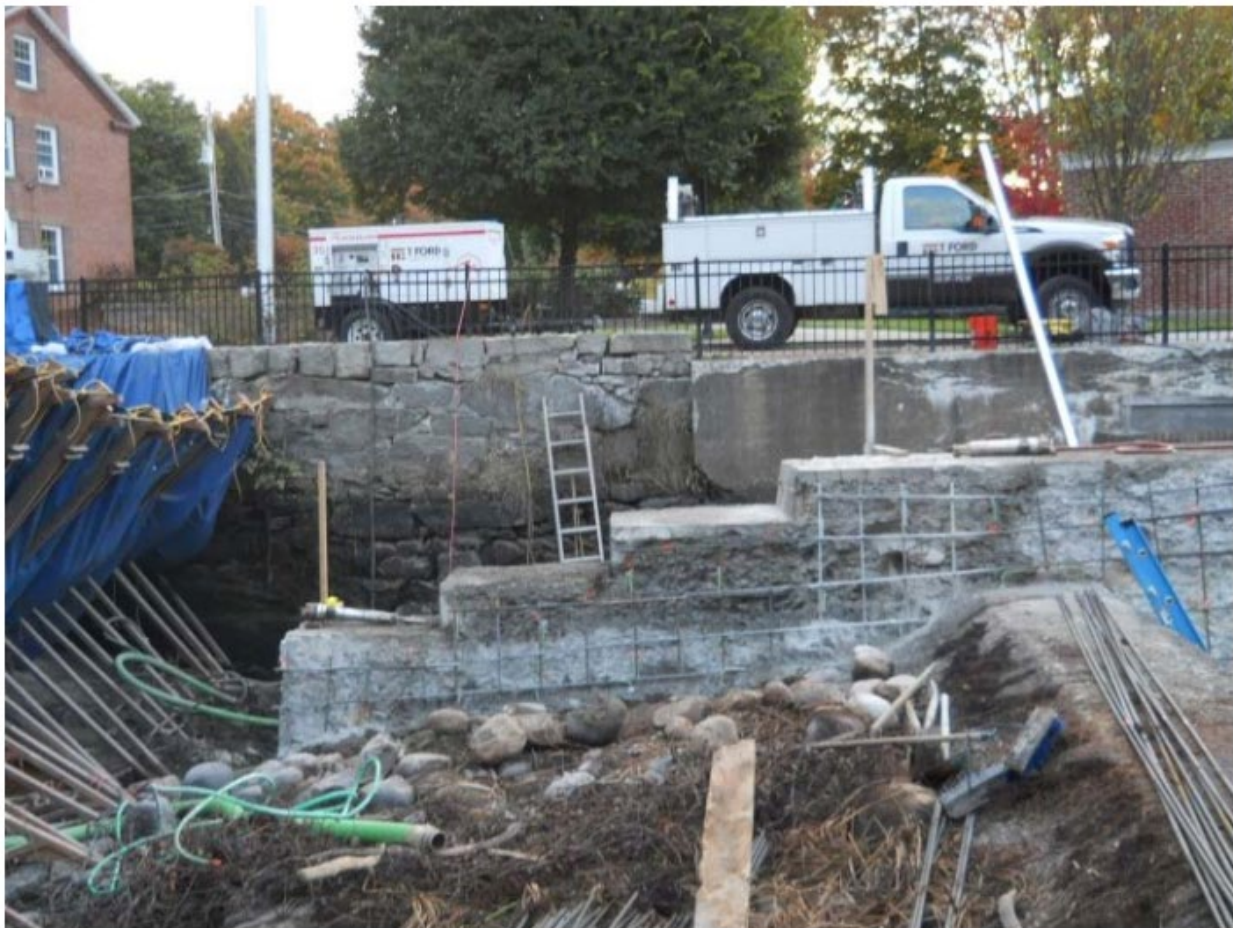
Figure 24. Access to Squannacook River Dam from RiverCourt Residences

As discussed further below, construction access to the Dam would likely be achieved through the northern driveway on the RiverCourt Residences property. This was the access route used during the 2013 repairs to the Groton side of the Dam (**Figure 24**). During the 2013 repairs, cofferdams were used to control water flow and create areas to work in the dry, and ladders were used to enter and exit the work area.

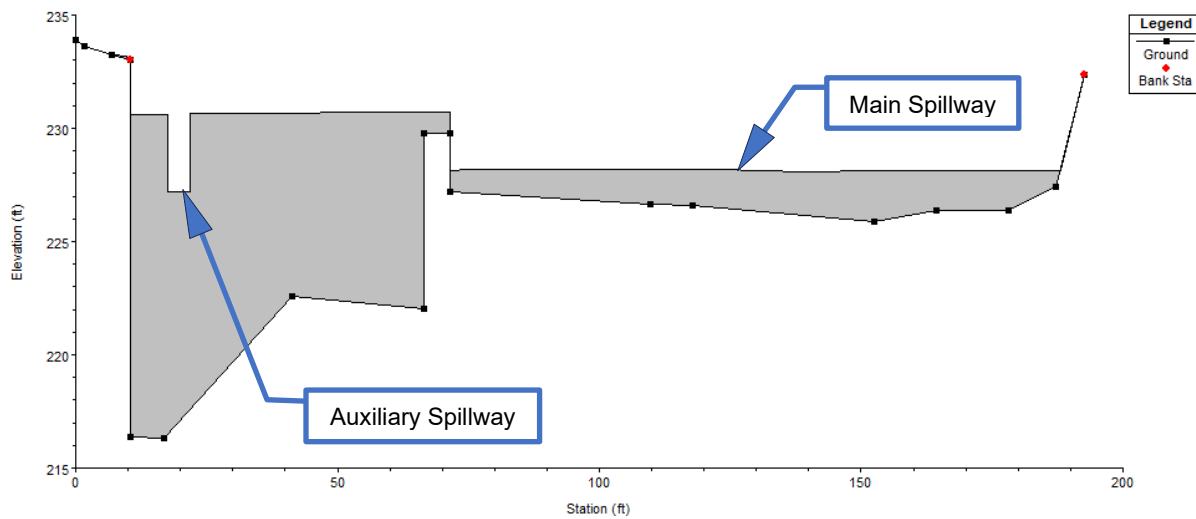
Figure 30. Squannacook River Dam HEC-RAS Model Schematic

Schematics of the Dam and the West Groton Bridge are shown below as **Figure 30** and **Figure 31**, respectively.

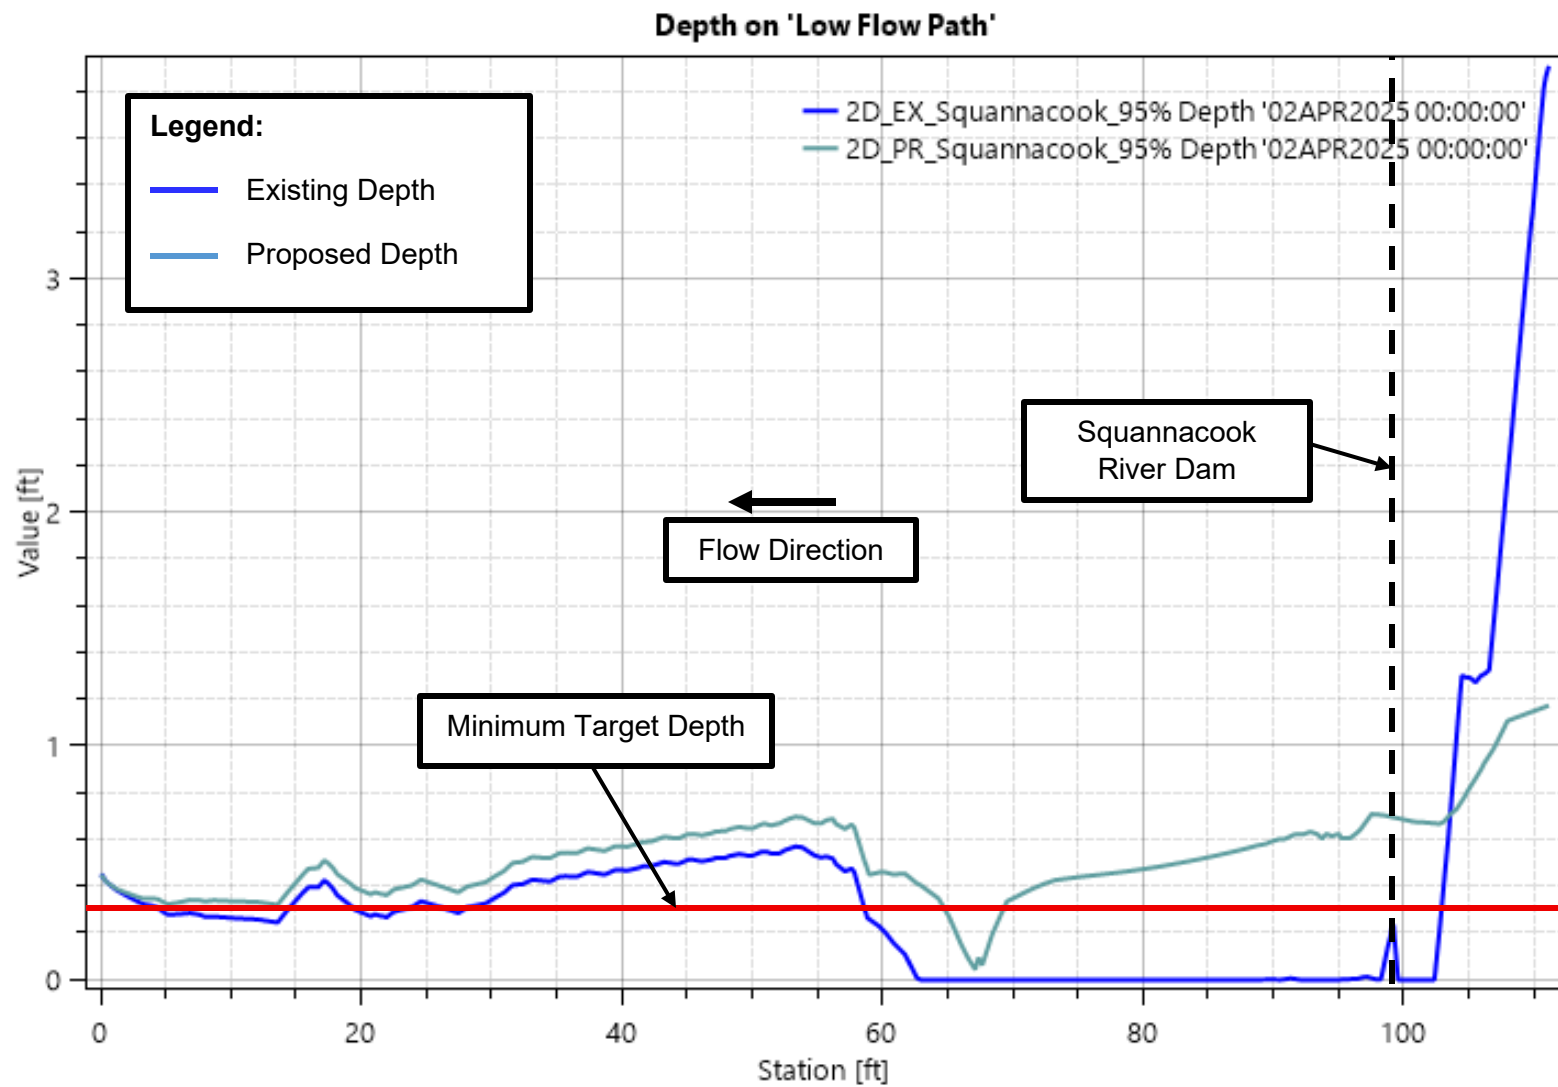
Figure 41. 95% Daily Exceedance Flow Depth

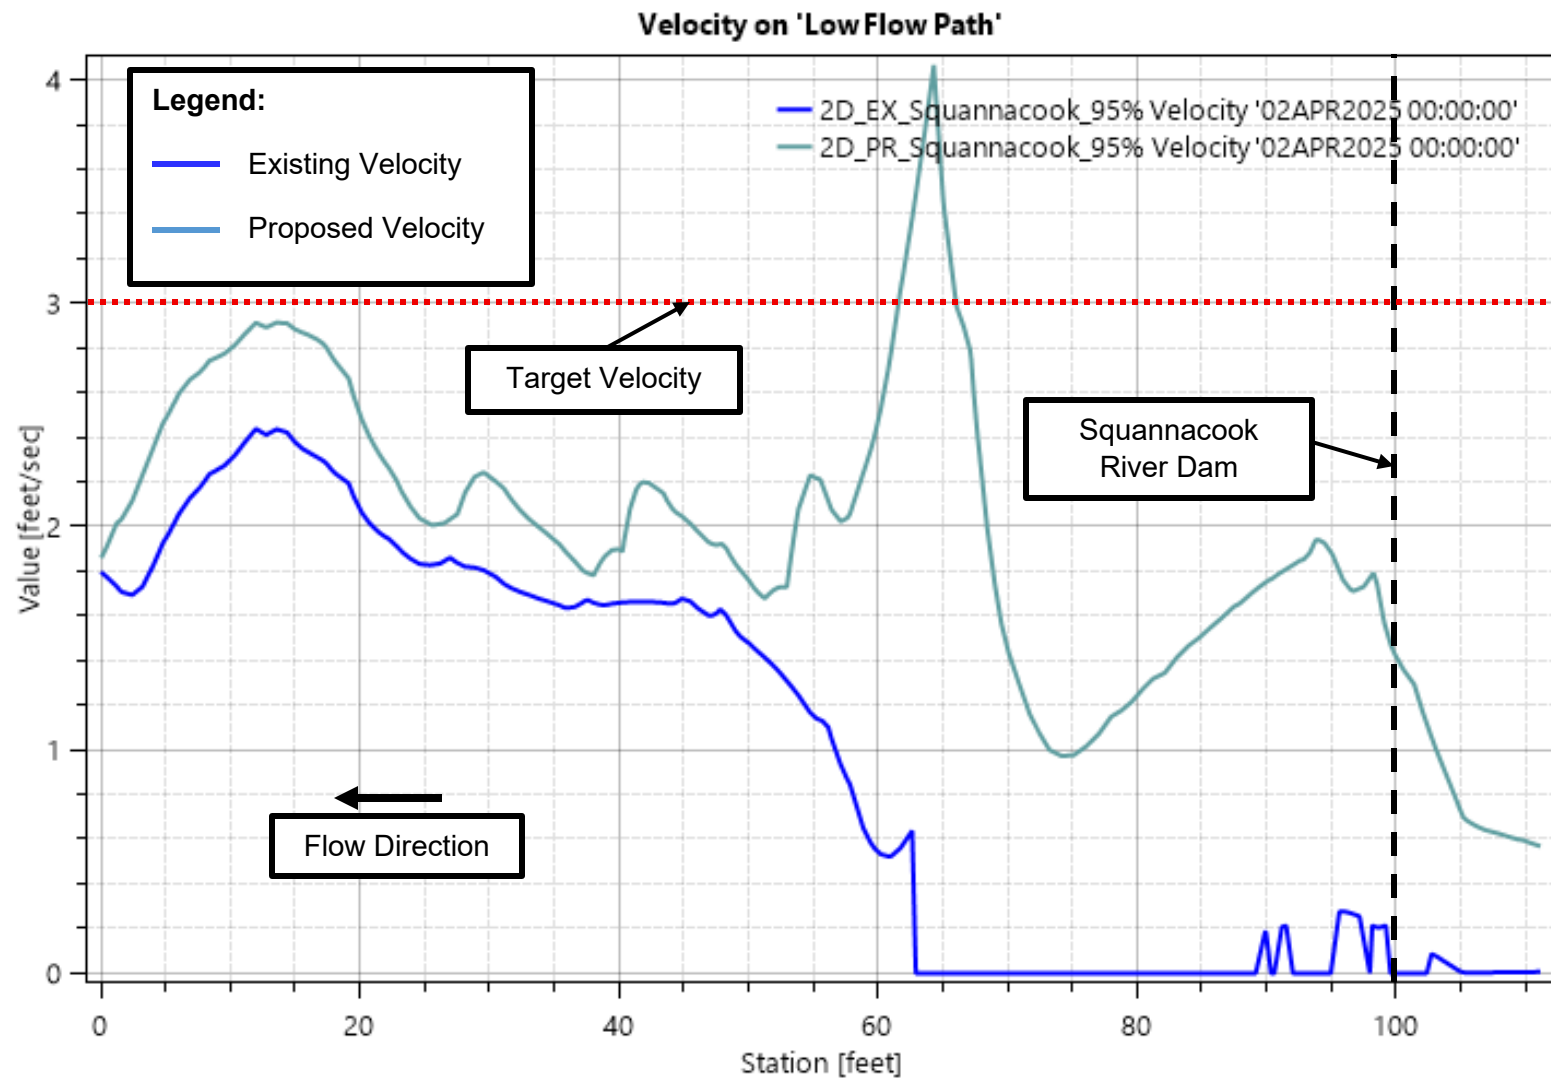
Figure 42. 95% Daily Exceedance Flow Velocity

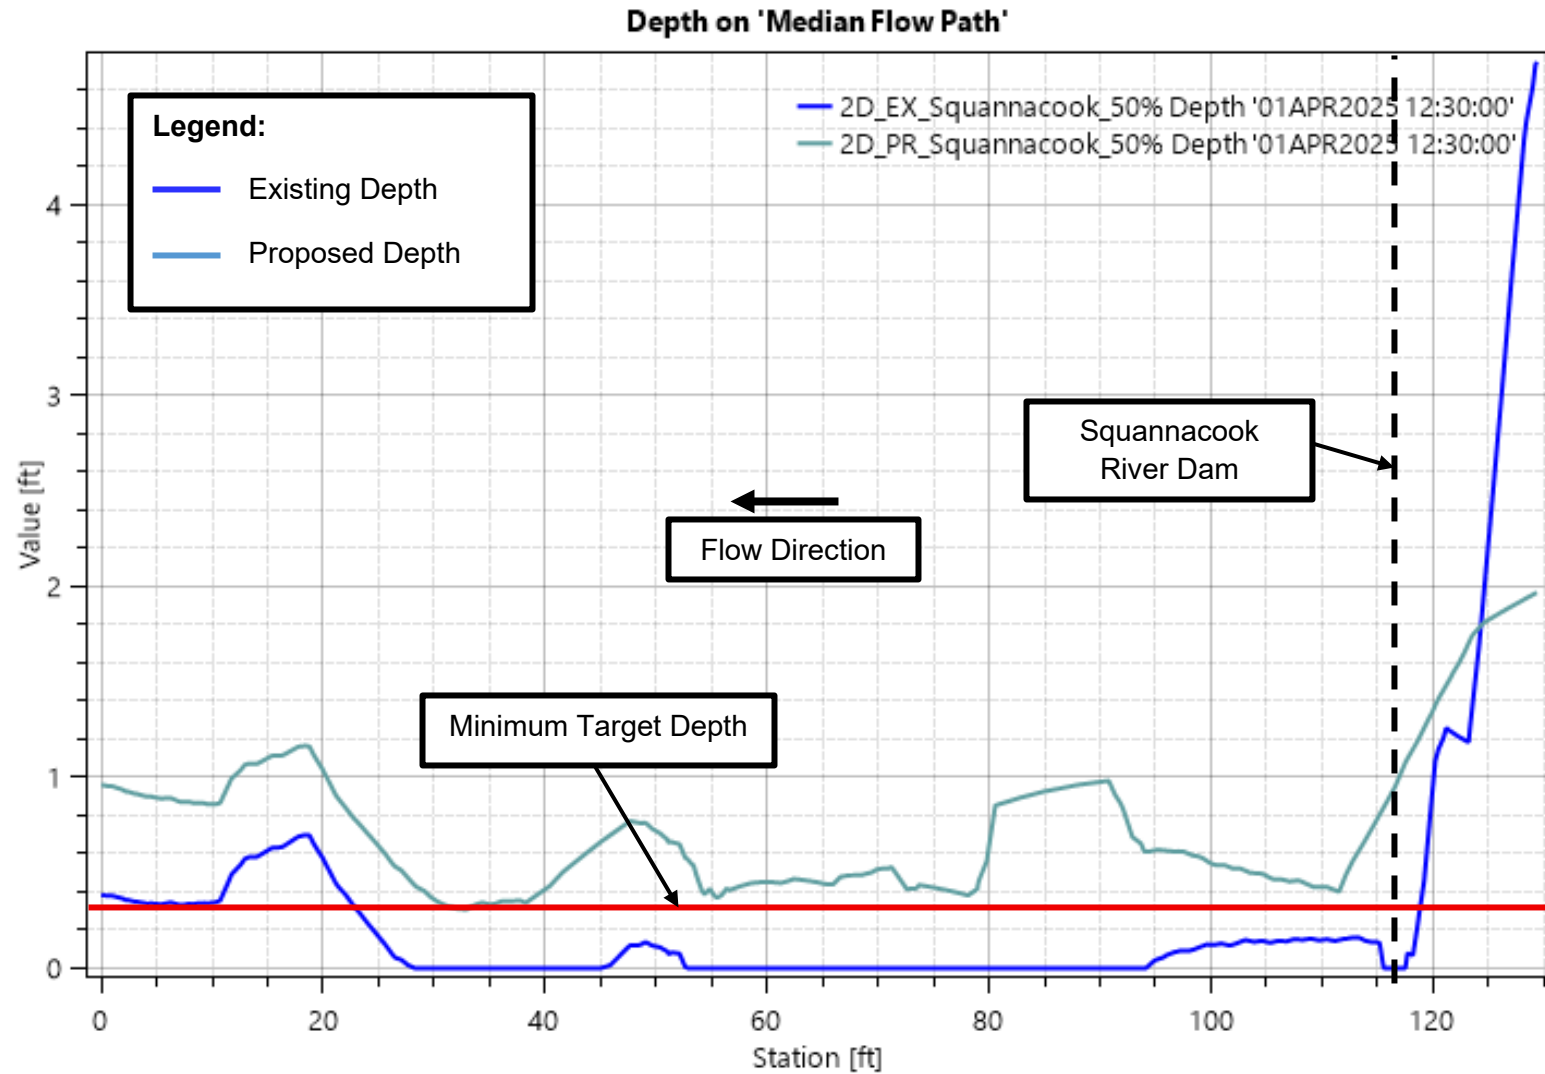
Figure 45. 50% Daily Exceedance Flow Depth

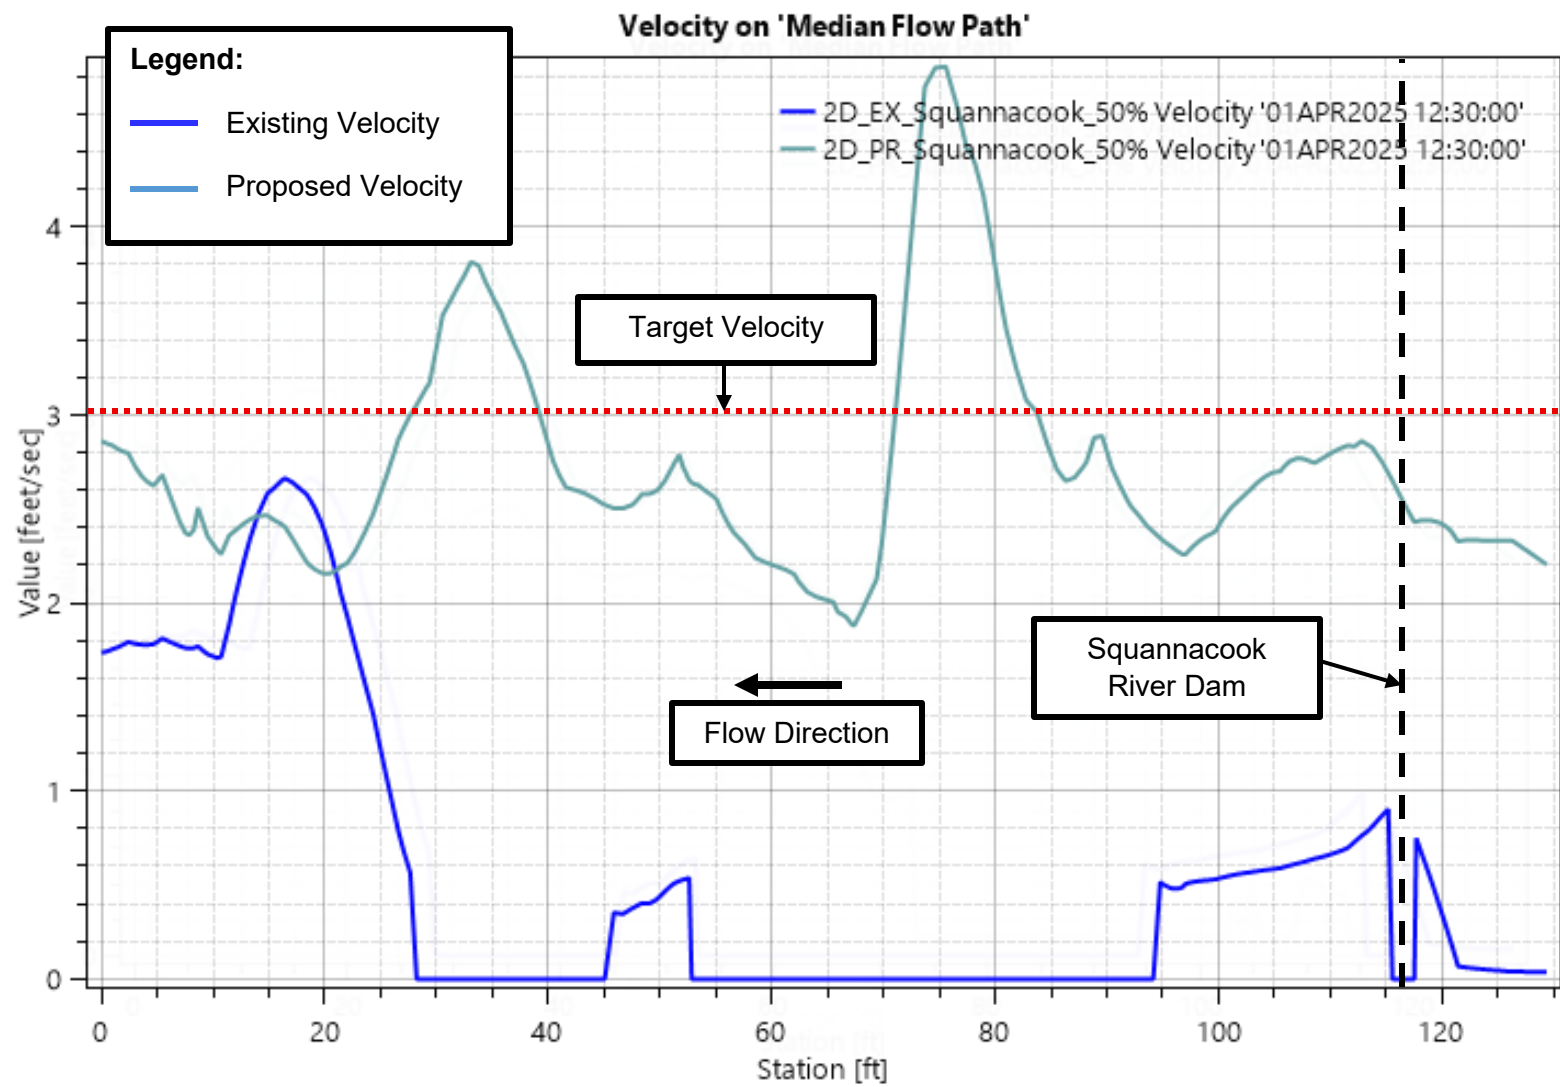
Figure 46. 50% Daily Exceedance Flow Velocity

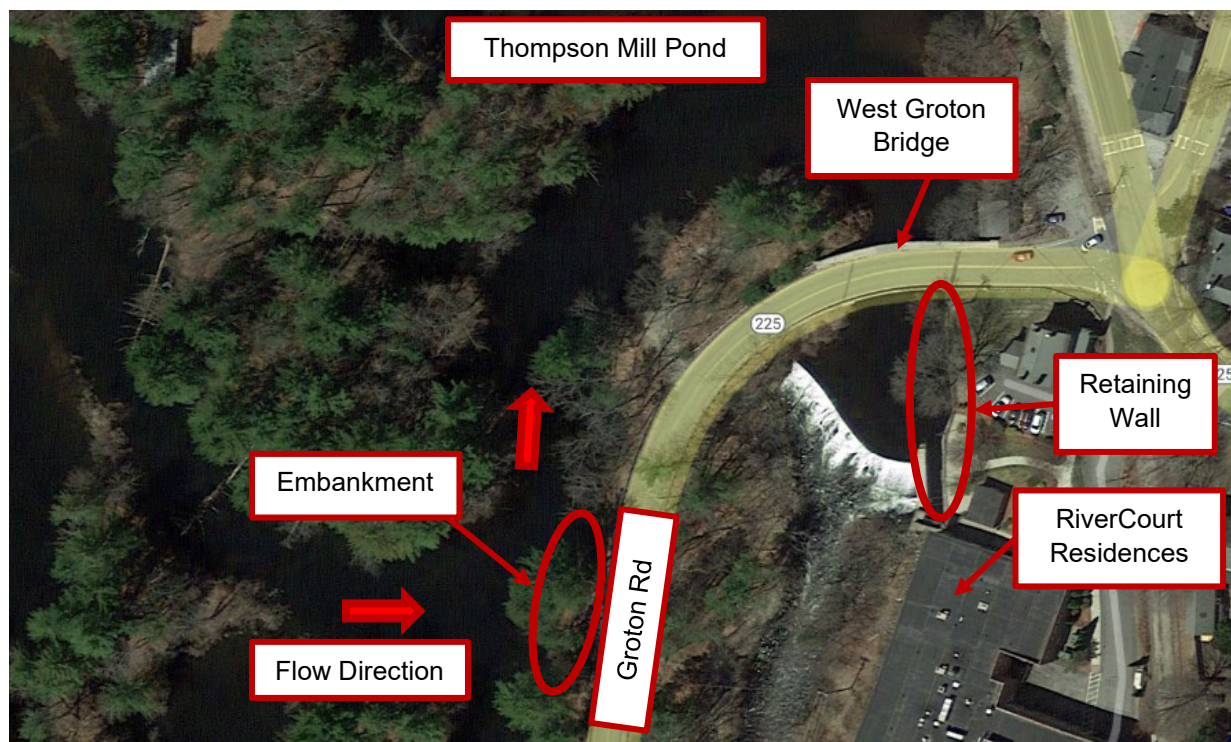
Figure 52. Retaining Wall and Embankment Scour Assessment Areas
