# SQUANNACOOK RIVER DAM REMOVAL BASIS OF DESIGN

November 2025

## Basis of Design Report

### Groton & Shirley, Massachusetts

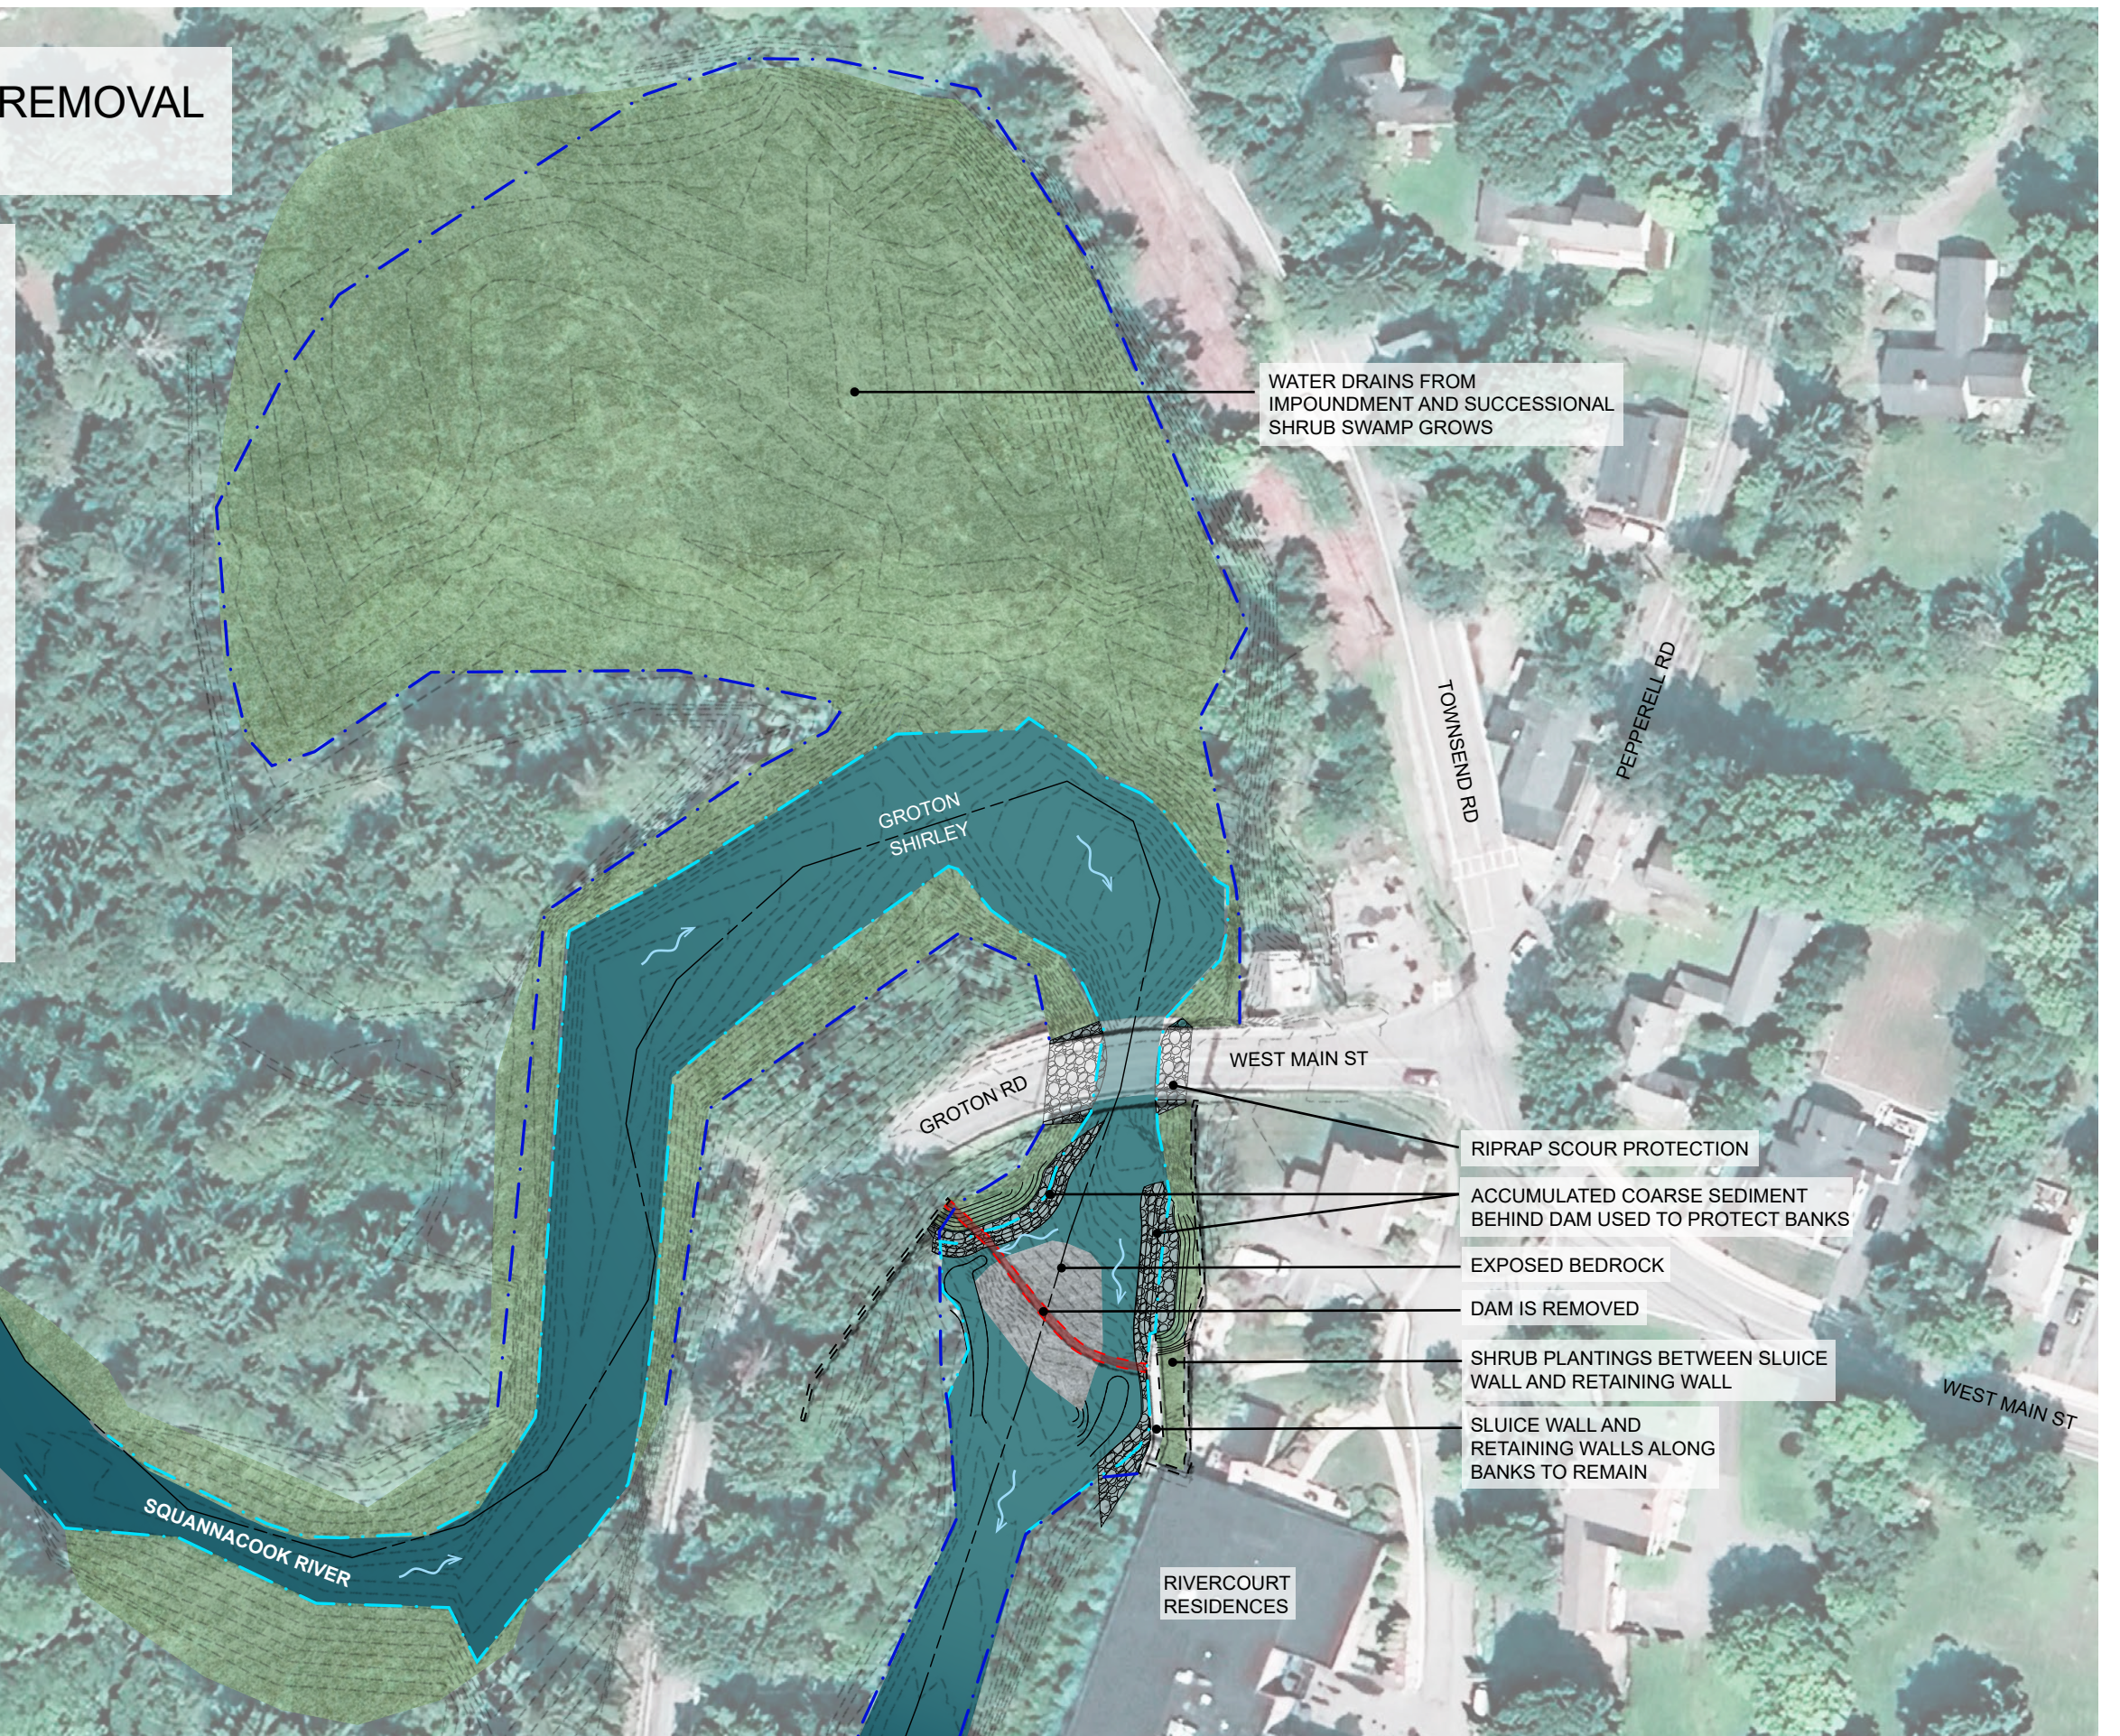
- TOWN BOUNDARY
- - - - - EXISTING 1 FT CONTOUR
- PREDICTED 1 FT CONTOUR
- . - . - EXISTING TOP OF BANK
- . - . - PREDICTED TOP OF BANK - 50% FLOW
- EXISTING DAM STRUCTURE TO BE REMOVED
- - - - - EXISTING RETAINING WALLS TO REMAIN
- RIVER FLOW DIRECTION - 50% FLOW
- RIPRAP BANK STABILIZATION
- EXISTING BEDROCK (APPROXIMATE)
- REVEGETATED AREA

NOTE: RIVER SHOWN AT 50% FLOW EXCEEDANCE -  
MEDIAN FLOW CONDITION
