# Baddacook Pond

Baseline Assessment Survey Report  
July 2011

**Aquatic Control Technology, Inc.  
Eleven John Road  
Sutton, MA 01590**

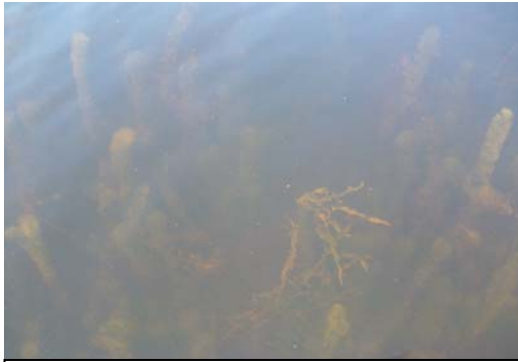
Fanwort and whitestem pondweed in Baddacook Lake

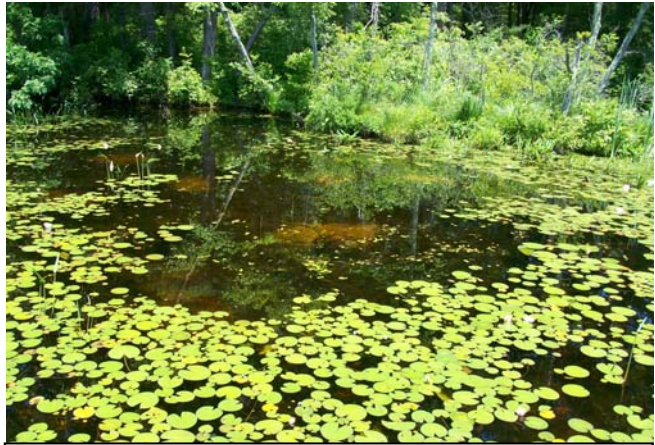
Dense waterlily growth in the shallow waters of Baddacook Lake

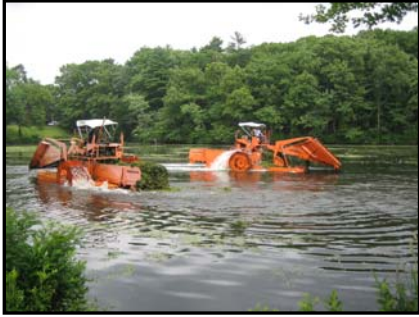
Mechanical techniques include mechanical cutting/harvesting and hydro-raking. Harvesting involves cutting the nuisance weed growth below the water's surface and collecting the cut plants for removal from the pond. In most cases, harvesting provides only short term control of the target plants and multiple cuttings over the course of a season may be required to maintain desirable conditions. Repetitive annual harvesting of some annual (seed producing) plants such as water chestnut or certain pondweed species, however, may can result in long-term control.

Aquatic Control operates several harvesting machines which cut the weeds 5-7 feet below the water's surface and collects the cut material for off-site disposal. We understand Baddacook Pond has access to a harvester of their own and has harvested in the past. In general, as compared to other vegetation control techniques like herbicide treatment, harvesting will be more expensive per unit area (unless you are able to borrow a machine and can run it yourself) and will provide shorter term control. As previously mentioned harvesting does have the advantage of removing the plant biomass from the system.

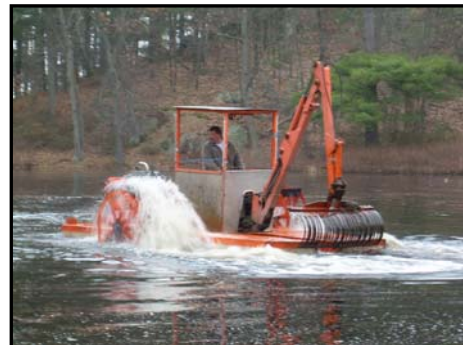
Another mechanical technique, Hydro-Raking, is performed with a "floating backhoe" type machine and involves the removal of plants, root systems and associated hydrosols. The Hydro-Rake is powered by hydraulic paddle-wheels and is capable of working in as little as 1.5-feet of water. Hydro-raking is typically not recommended for control of submersed plants especially those species that can reproduce through vegetative fragmentation such as fanwort or milfoil, but rather for emergent plants, like cattails, and floating leaf plants, like waterlilies. Control of submersed plants is seasonal at best, while control of plants with significant root-systems can be 2-3 years or more. Hydro-Raking would not be the method of choice for widespread control of submersed plants, but could be effective on areas of emergent vegetation and waterlilies and would be a valuable tool to clean individual shorefronts of leaf litter and other debris.

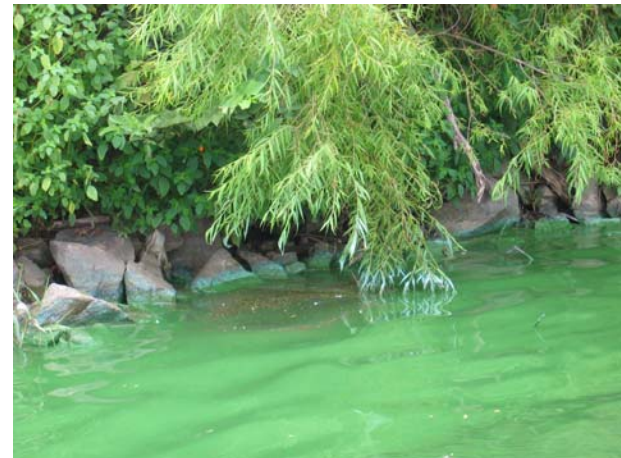
Monomonac, Rindge

- **How to recognize it:**
  - Pea-green scum on surface
  - Blue-green colored algae (clumps, uniform through water, clouds in the water or scum on surface)

- **What to do:**
  - Call ACT at 508-865-1000
  - Take a picture and collect a sample:
    - Clean glass or plastic bottle
    - Label with specific location (perhaps make a mark on a map to send along as well), date of collection, collector's name and brief (5-10 word) description
    - Keep on ice
    - Wash hands
    - Drop off at ACT for identification
  - Stay out of the water and keep pets out of the water
  - If you think you may have been exposed, take a shower immediately.
  - If you feel ill, visit the doctor and explain that you may have been exposed to Blue-green algae toxins.
