LOST LAKE AND KNOPS POND AQUATIC VEGETATION MANAGEMENT PROGRAM 2013 ANNUAL REPORT

October 2013

**Groton Lakes Association
And the Town of Groton
c/o Mr. Art Prest
8 Weymisset Road
Groton, MA 01450**

**Aquatic Control Technology
11 John Road
Sutton, MA 01590**

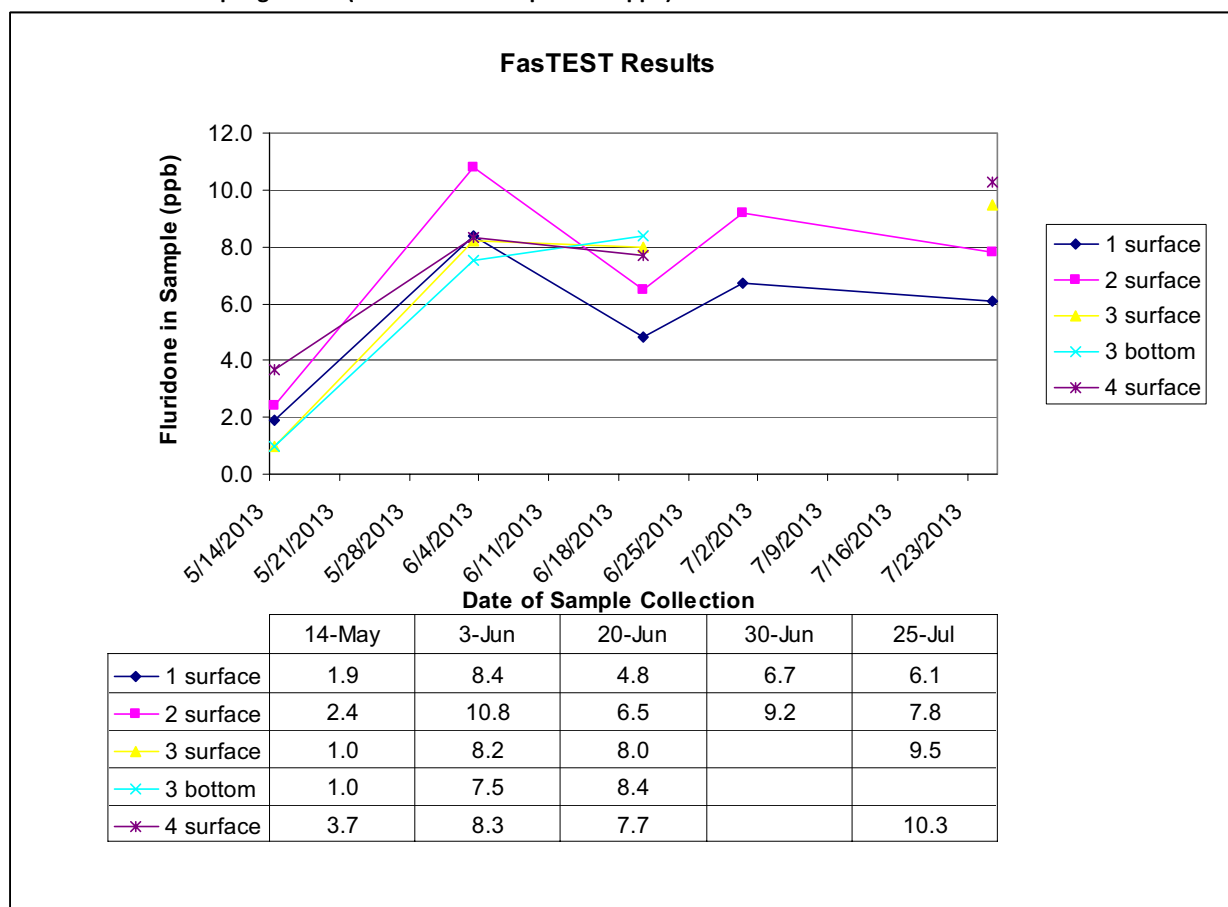
Table 1: FastTEST sampling results (concentrations reported in ppb)

On May 14th approximately two weeks after the initial application, water samples were collected from four in-lake locations located within the treatment area and one sample was collected below the thermocline using a Van Dorn collection bottle (Figure A_1 in Appendix A). There was no outflow from the lake, so downstream fluridone sampling was not performed. The in-lake concentrations were uniform and still below the targeted lake-wide concentration, so plans were made to proceed with the second application immediately.

FasTEST samples were collected from the four in-lake surface stations on June 3rd and June 20th. The average in-lake concentration increased to 8.9 ppb on June 3rd and to 6.75 ppb on June 20th. On June 30th two additional surface samples were collected with an average concentration of 8 ppb. The increase in concentrations between June 20th and June 30th may have indicated that fluridone was still releasing off of the clay pellets several weeks after the herbicide was applied. During the June 30th sample collection it was noted that curlyleaf pondweed and Eurasian milfoil plants were completely controlled in the majority of locations; fanwort was highly chlorotic and

A final round of FasTEST samples were collected on July 25th. Only surface samples were collected during the final sampling round. The average Sonar concentration during the July 25th sampling round was 8.4 ppb. Given the length of time that the herbicide was held at this level in the water column and the efficacy observed on the plants, it was determined that no further treatment would be necessary in 2013.

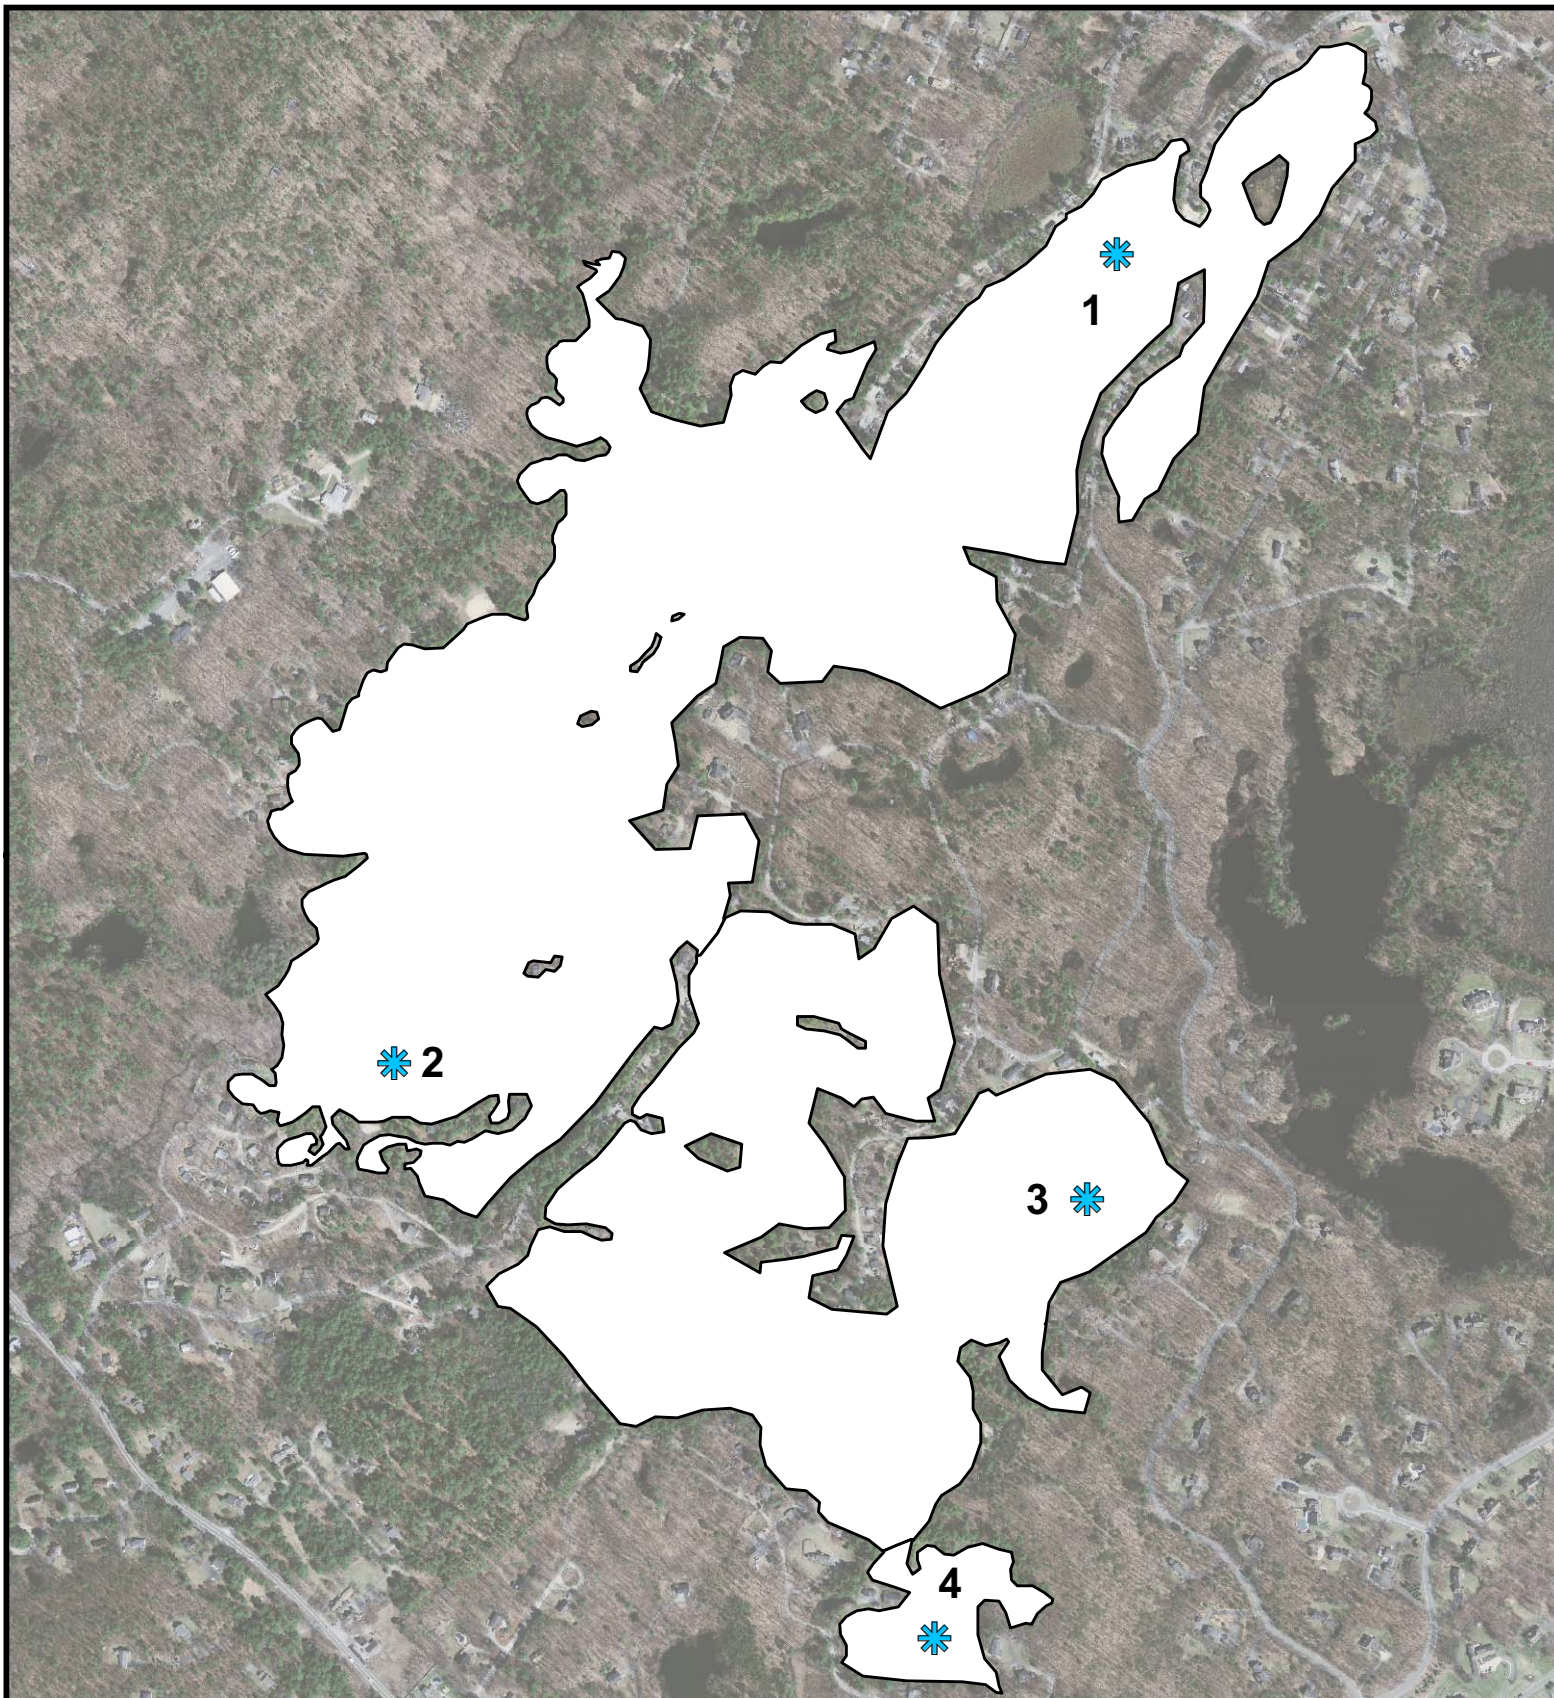
Groton MA
FastTEST Sample Site Locations

Lost Lake and Knops Pond

- Application 1 Report (4/24/13)
- Application 2 Report (5/22/13)
- Application 3 Report (7/9/13)
- FasTEST Sample Location Map (Figure 1)
- FasTEST Laboratory Reports (5/14, 6/3, 6/20, 6/30, 7/25)
- Photo-documentation of treatment program

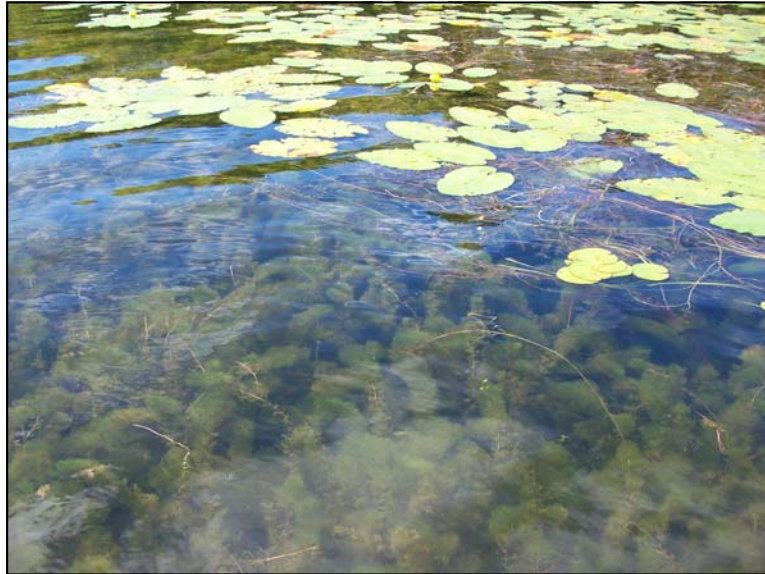
Dense Fanwort and Eurasian milfoil cover September 2011

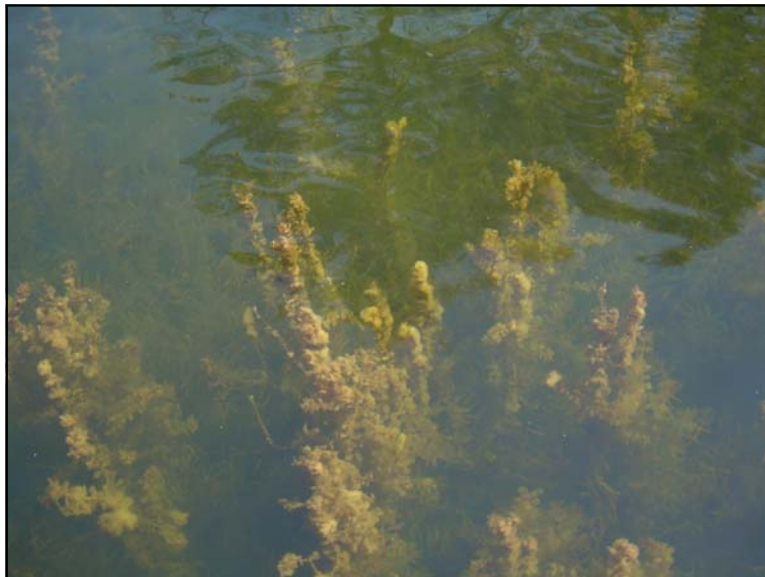
A mix of 2012 growth and an understory of 2013 growth of Eurasian milfoil. April 2013 (Pre-treatment)

On 8 April 2013, the entire shoreline littoral area of the lake was surveyed by Aquatic Control Technology to determine the stage of milfoil growth and to make adjustments to the 2013 treatment scope. Fanwort plants appeared to be showing less than one foot of new active growth. Eurasian milfoil and curlyleaf pondweed had reached heights of 2-3 feet in the water column. Variable milfoil growth was high in the water column and at the surface in many locations. Due to the brown color and rigidity of the plants the variable milfoil growth appeared to be overwintered growth from 2012. Water temperatures were greater than 10 °C (50 °F) throughout the majority of the water column and the water level was favorably low. A mutual decision was reached to schedule and perform the initial Sonar herbicide application on 24 April 2013.

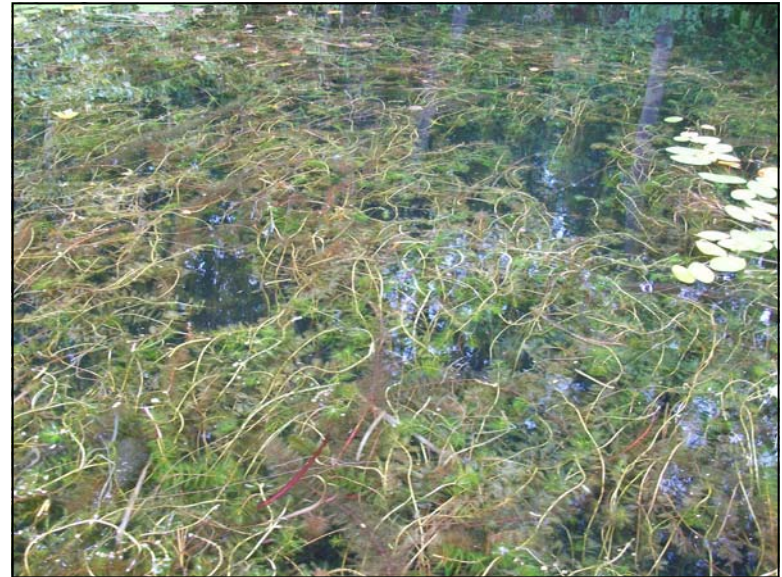
Dense Eurasian milfoil matted to the surface September 2011

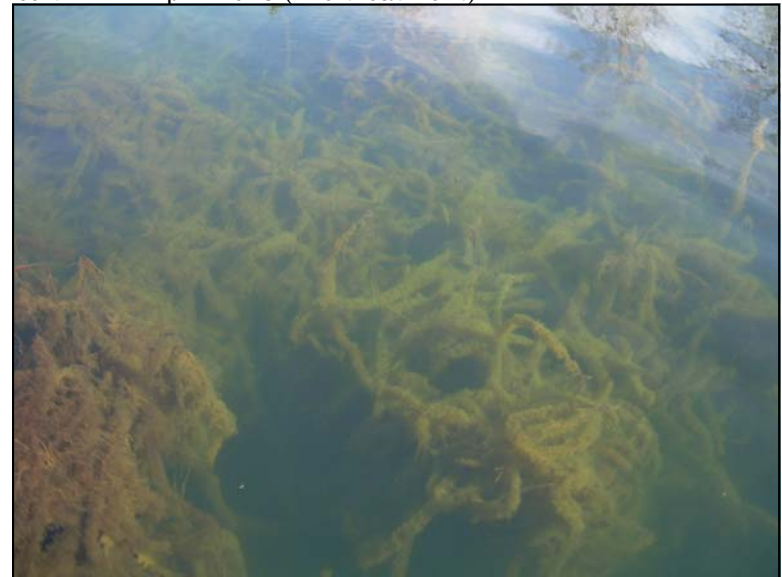
2012 growth of variable milfoil remaining in the water column in April 2013 (Pre-treatment)

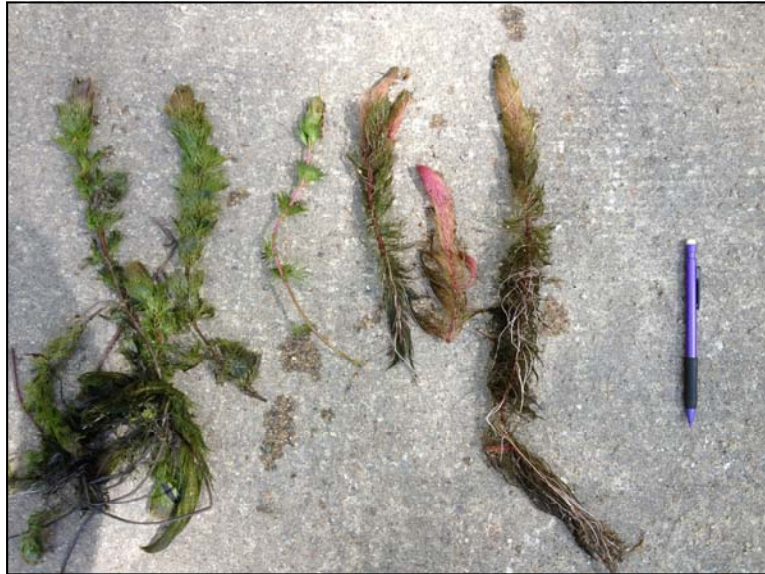
Progression of chlorosis in fanwort and variable milfoil on
May 7, 2013

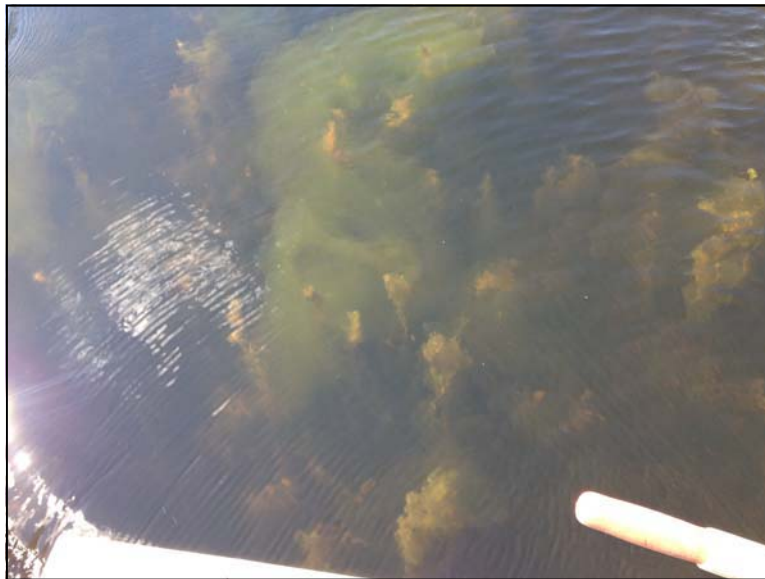
Dying Eurasian milfoil covered in periphytic algae

The second herbicide application was scheduled and performed on May 22nd. Again an Airboat equipped with a bow-mounted cyclone seeder/spreader was used for the Sonar One herbicide application. Sonar Genesis was applied using an on-board 100 gallon calibrated spray tank and herbicide was applied directly to the plants through weighted hoses. Treatment proceeded systematically around the lake applying the targeted 15 ppb of Sonar One to the fanwort and variable milfoil infested areas and 3 ppb of Sonar One to the areas infested with only Eurasian watermilfoil. Additionally, 5 ppb of liquid Sonar Genesis was applied lake-wide. Weather conditions were again favorable with partly cloudy skies, a 75° F air temperature and a light variable wind. The surface water temperature had increased to 20.5° C and the dissolved oxygen concentration was still approximately 11.10 mg/L. A total of 560 pounds of Sonar One and 48 gallons of Sonar Genesis were applied. The treatment took about 3.5 hours to complete. The areas in the southern portion of Lost Lake that were not accessible during the initial treatment were accessible during the booster application. A hand blower and small pump were used to boost the herbicide concentrations in these areas. Eurasian milfoil and fanwort plants were already showing visible signs of chlorosis, bleaching symptomatic of exposure to fluridone, and curlyleaf pondweed plants had lost rigidity and were covered in periphytic algae.

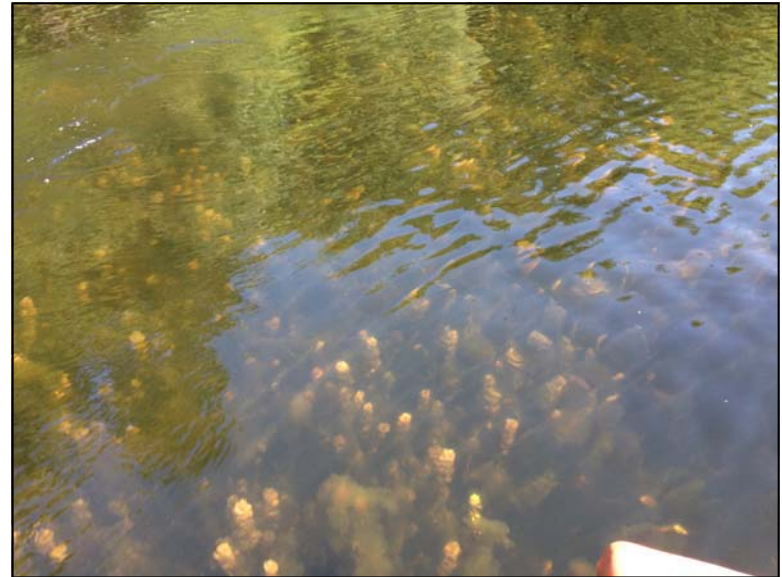
Chlorosis of Fanwort visible from the surface June 20 2013

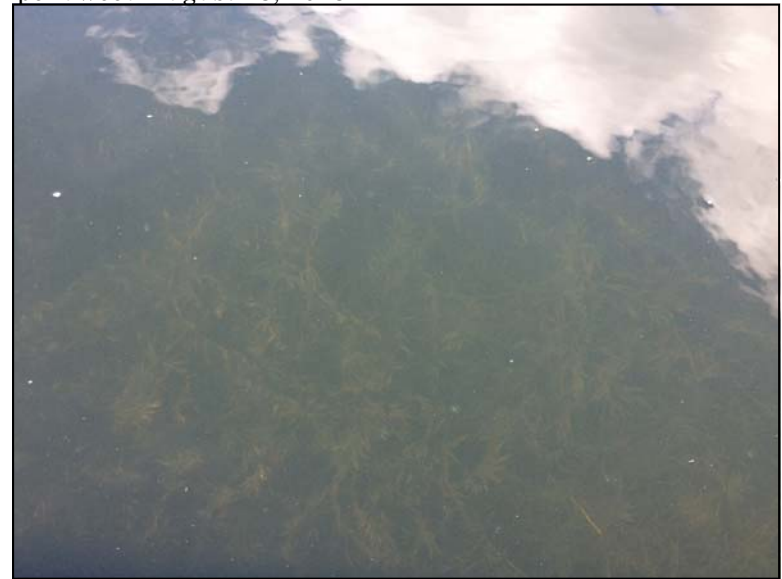
Healthy bottom cover of low growing native Robbins
pondweed August 23, 2013

Impacts to several native aquatic plants were expected due to their sensitivity to fluridone. These species are usually impacted during the year-of-treatment, but typically begin active recovery the year-after-treatment. Among the species the native species observed after the treatment program Robbin's Pondweed was the most dominant. Robbin's Pondweed is a desirable native plant species because it creates a dense bottom cover of native plants, which helps to shade out non-native competitors. Additionally due to its low growing nature Robbin's Pondweed rarely negatively impacts recreational use.

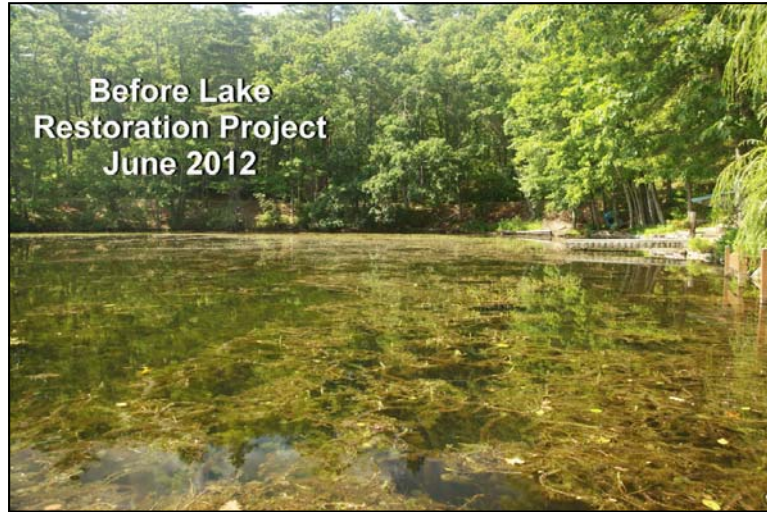
Before Lake Restoration Project. Photo taken by the Groton Lakes Association

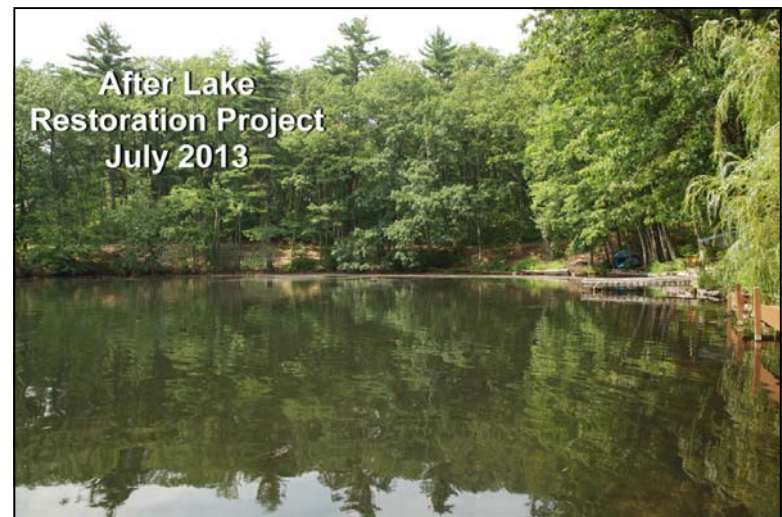
After Lake Restoration Project. Photo taken by the Groton Lakes Association

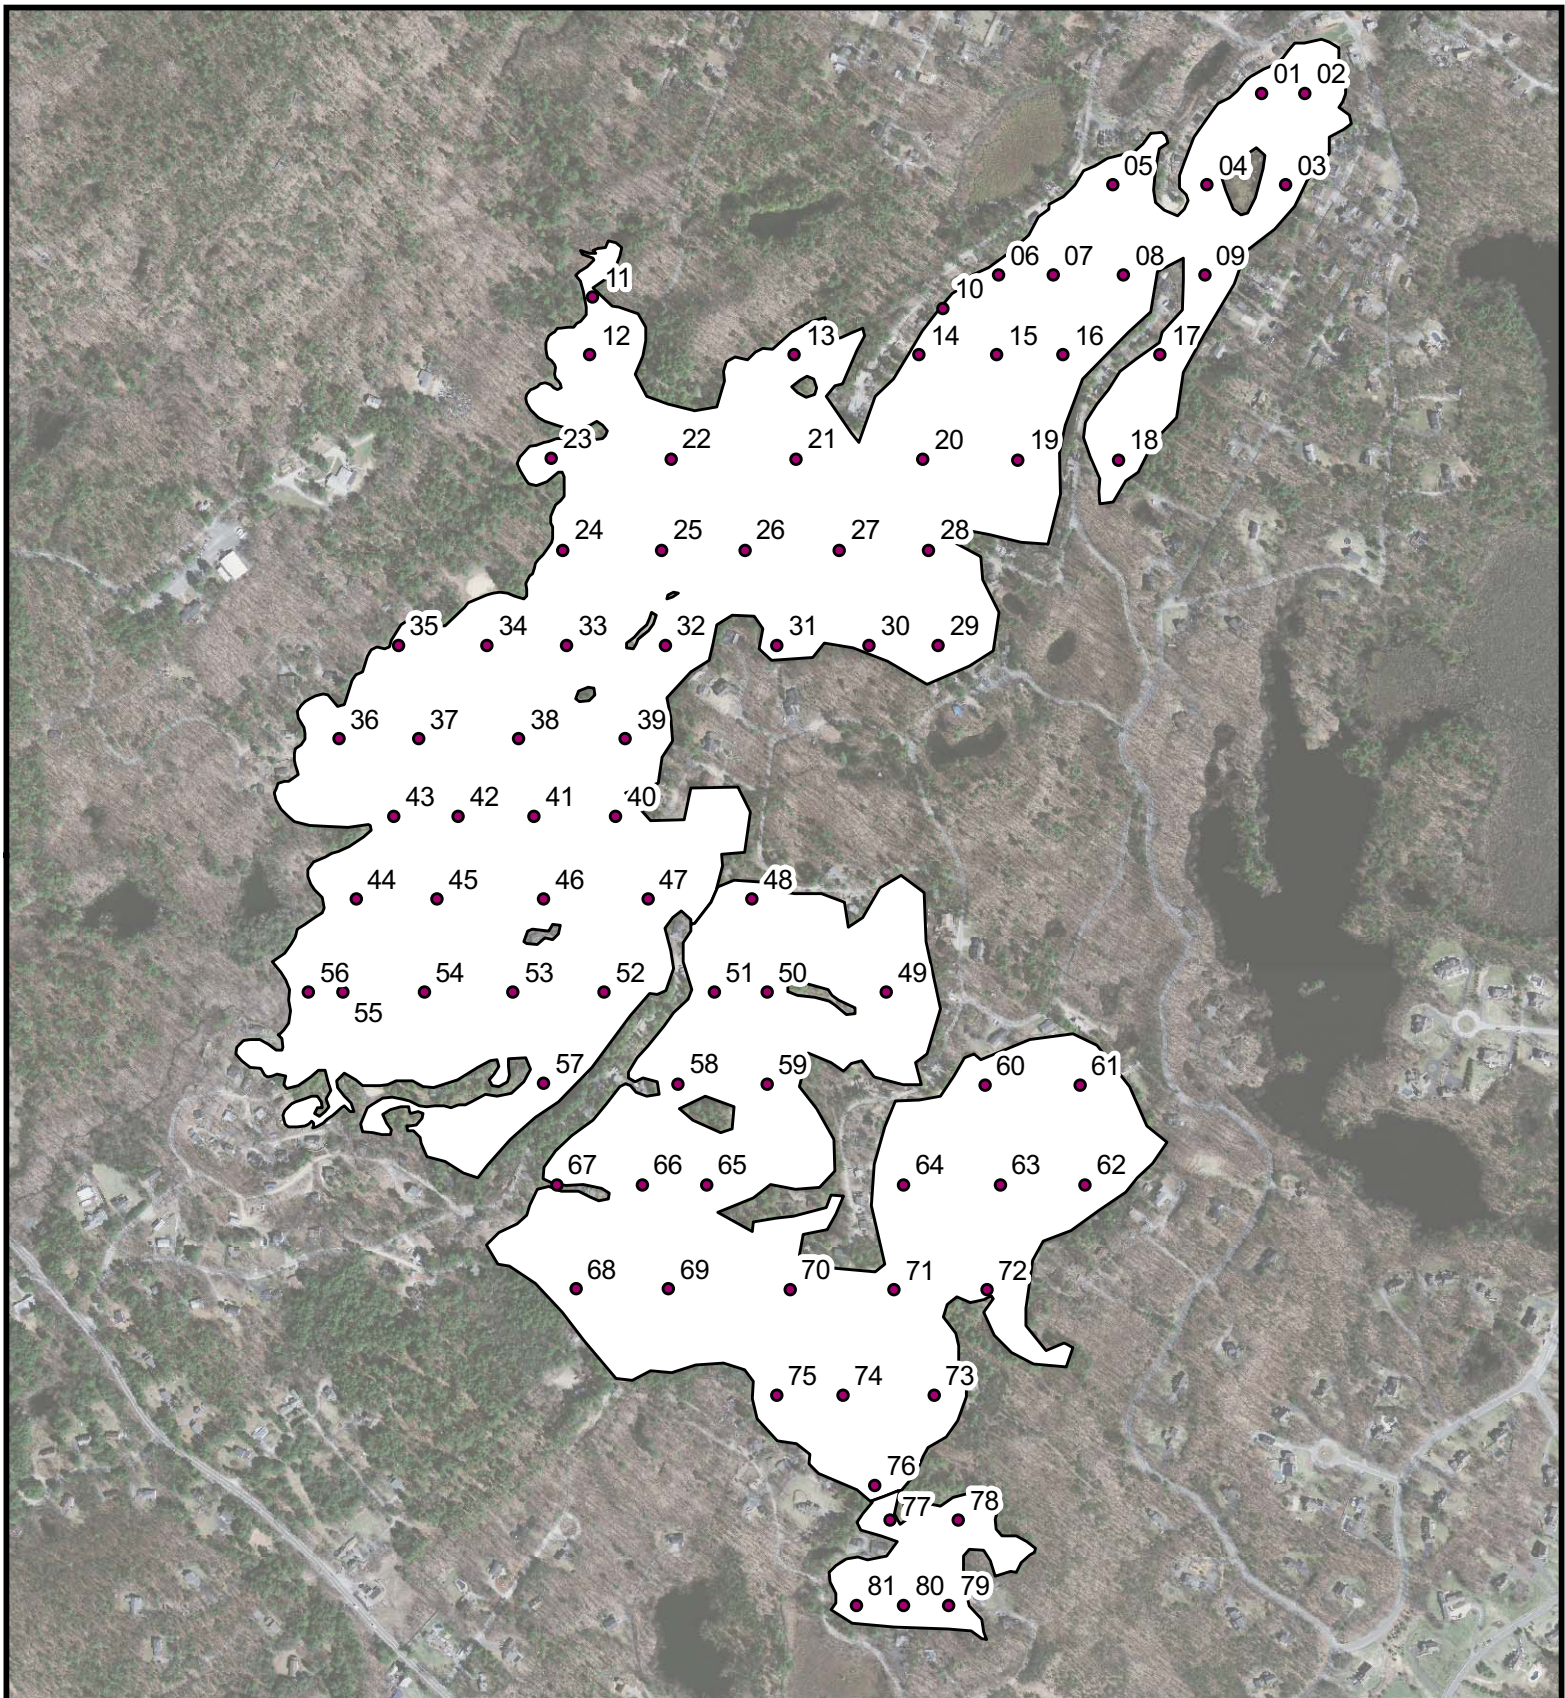
Groton MA
Transect Point Locations

Lost Lake and Knops Pond

Using ArcView software, 81 points along 20 transects were created and superimposed over the lake's littoral zone. Points were distributed across both Lost Lake and Knops Pond so as to create an accurate representation of the vegetation in the waterbody (figure 1).
