# Year-End Report for the 2017 Management of: **Baddacook Pond**

*Groton, MA*

**Submitted: December 15, 2017**

SOLitude Lake Management  
590 Lake Street  
Shrewsbury, MA 01545  
Phone: (508) 480-5253  
FAX: (888) 358-0088  
info@solitudelake.com  
www.solitudelakemanagement.com

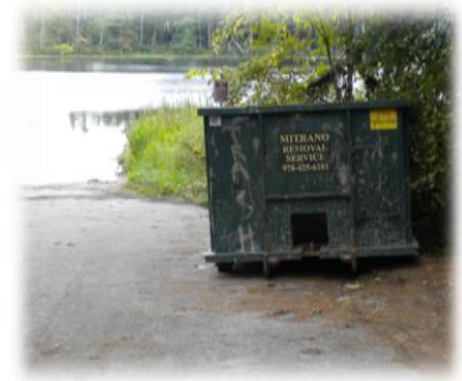
**Image 1:** Photo of the dumpster at the off-loading area

Seventeen (17) days of mechanical harvesting ensued, concluding on August 29. During operations, all collected material was off-loaded into a skid steer loader at the designated off-loading area. The plant material was then placed into a container to properly de-water (**Image 1**). Once full the containers were transported to the local landfill/composting site. During operations the harvester operator started south and then proceeded around the pond in a counter clockwise fashion, focusing on invasive species removal and recouping open water space. Please refer to **Figure 2** for a map of the harvested areas during this management period.

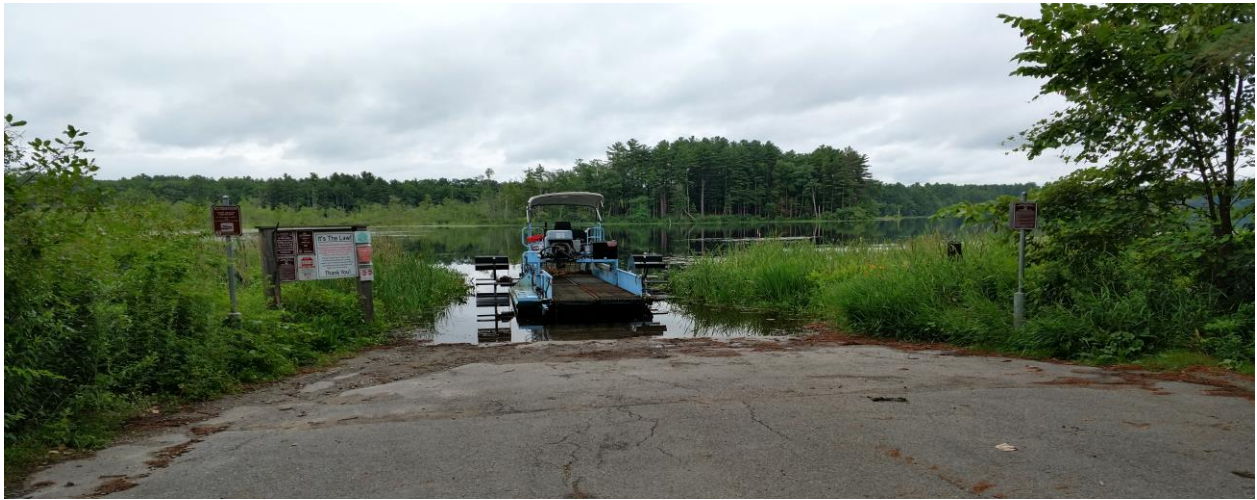
**Image 1:** Photo of the Baddacook Pond boat launch before the hydro-raking operation

matter. Please refer to **Image 1** and **2** for photos of before and after hydro-raking around the boat launch.

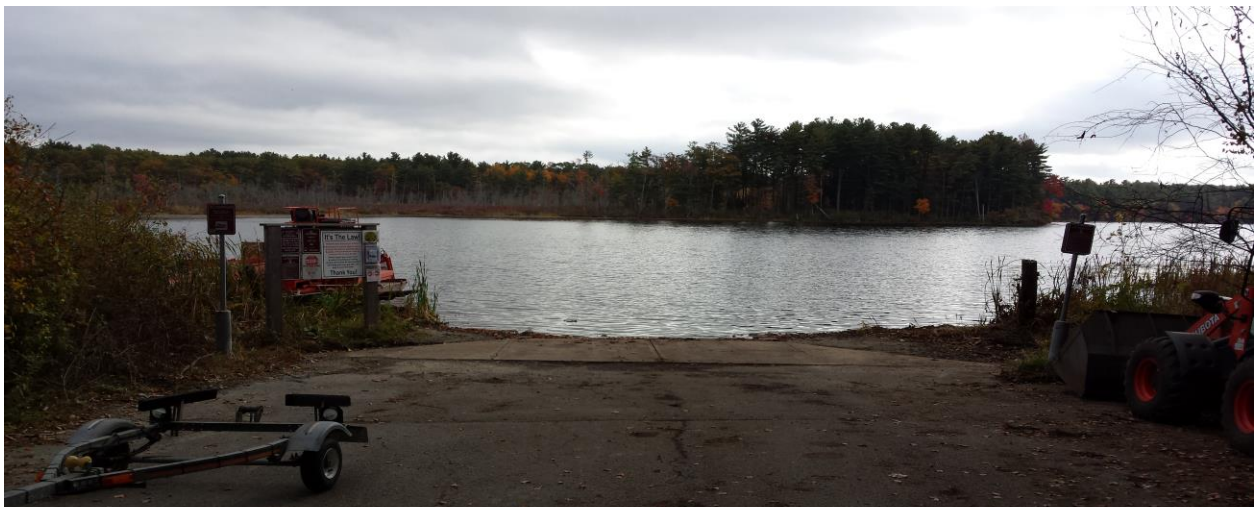
**Image 2:** Photo of the Baddacook Pond boat launch after the hydro-raking operation

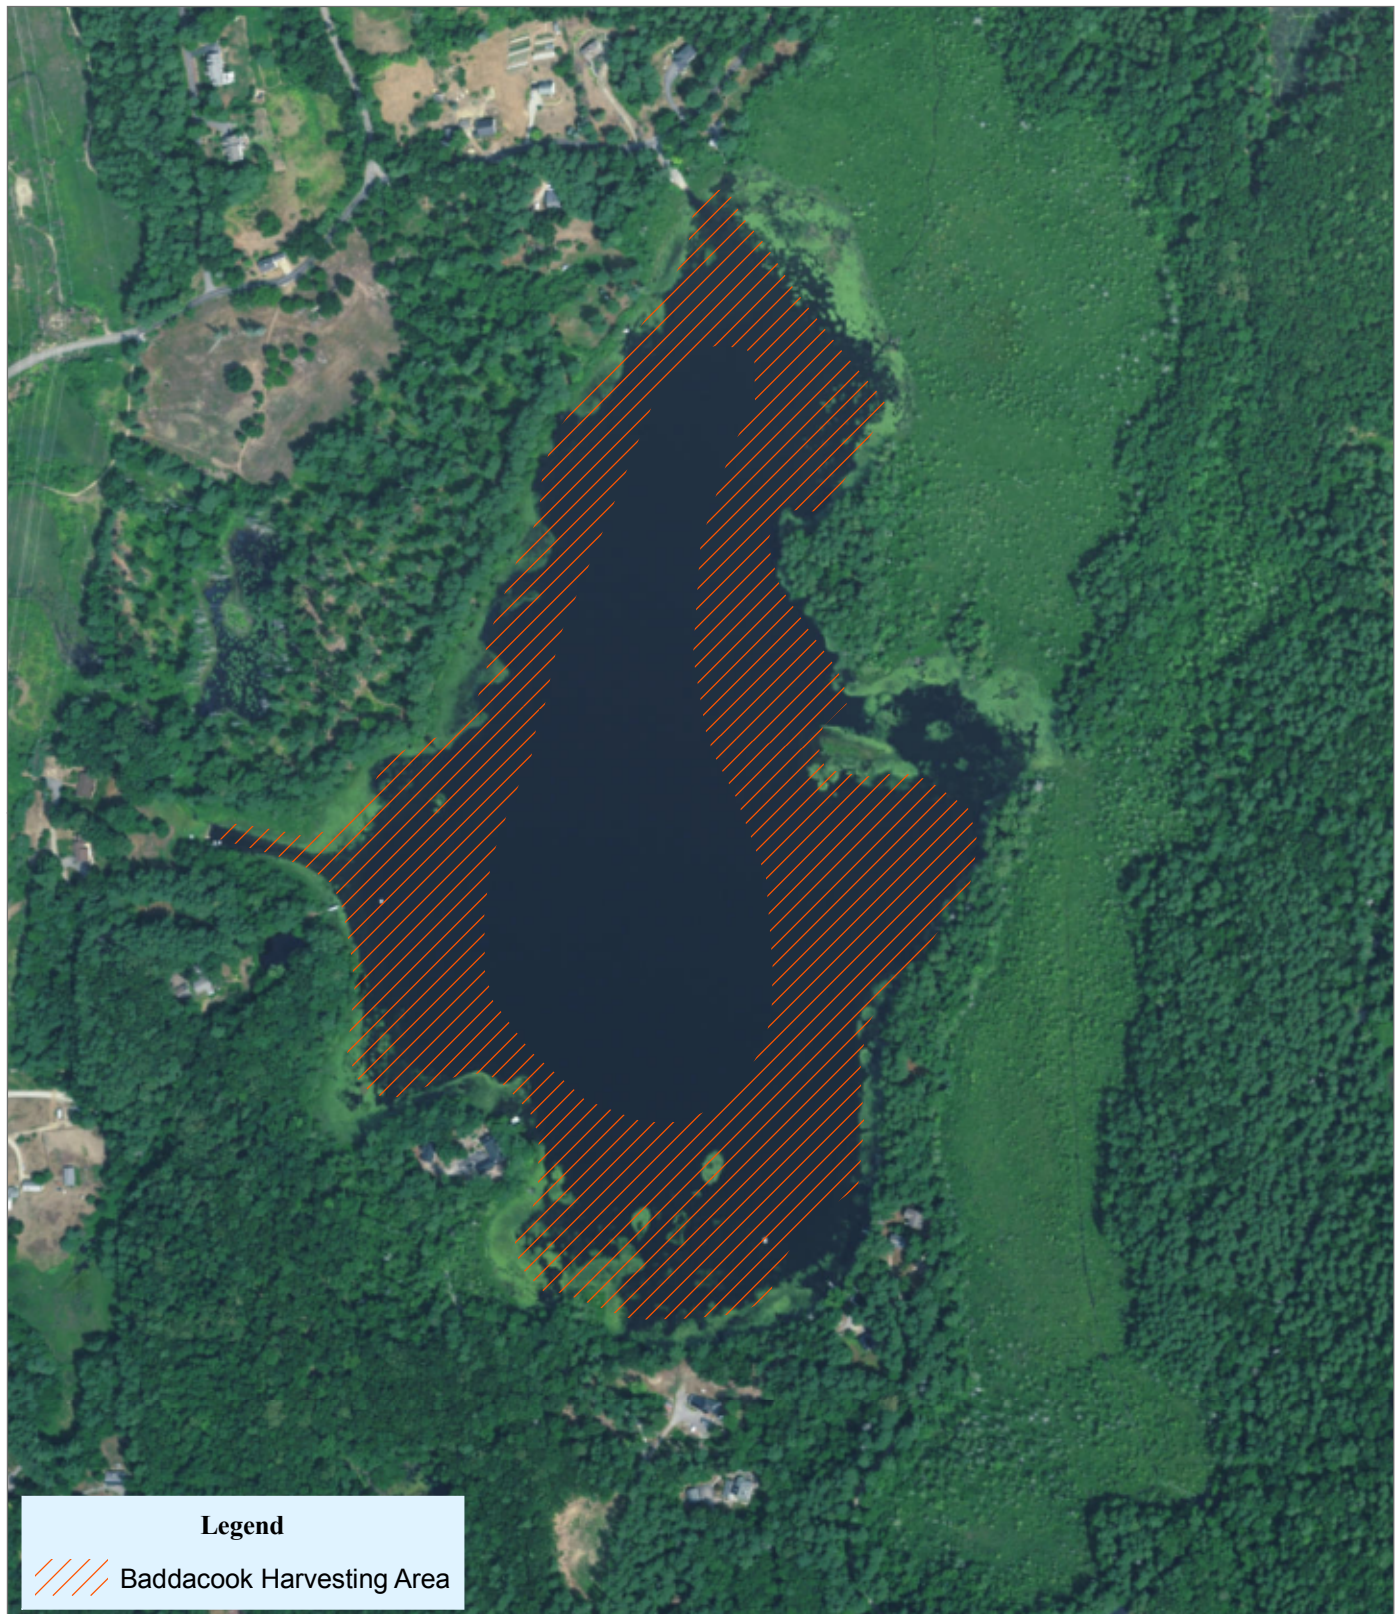
Figure 2: 2017 Harvested Areas

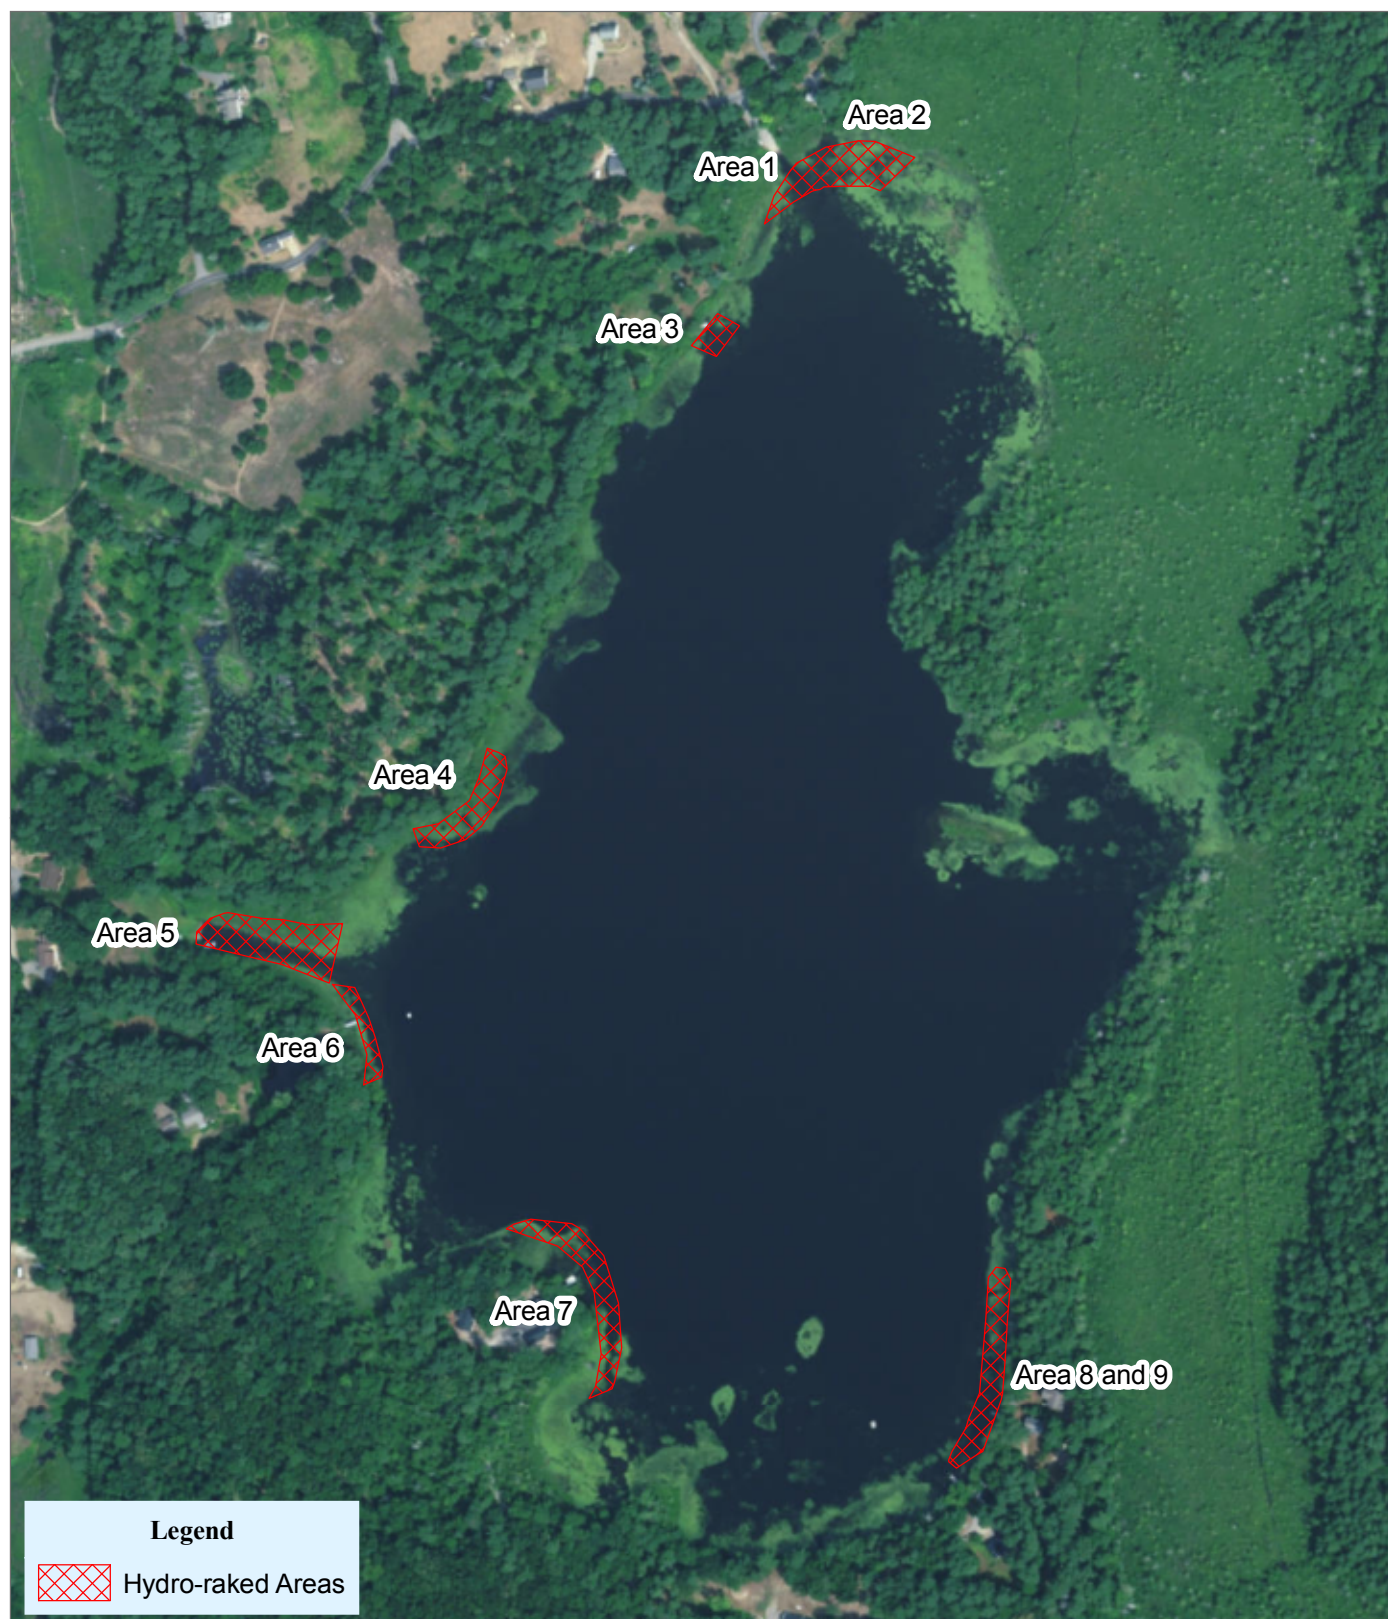
Figure 3: 2017 Hydro-raked Areas

Hydro-raking services were performed on select areas of Baddacook Pond, including both common areas as well as private shoreline areas. Please refer to **Figure 3** for a map of the designated hydro-raking areas, as well as **Appendix A** for a chart of the areas Hydro-raked each day. The collected organic material comprised of a combination of accumulated organic matter, floating islands, emergent vegetation, floating-leaf vegetation, and submersed vegetation.
