Annual Report
2017 Aquatic Vegetation Management Program
Lost Lake & Knops Pond
Groton, Massachusetts

Prepared by: Solitude Lake Management
590 Lake Street
Shrewsbury, MA 01545

Submitted in: December 2017

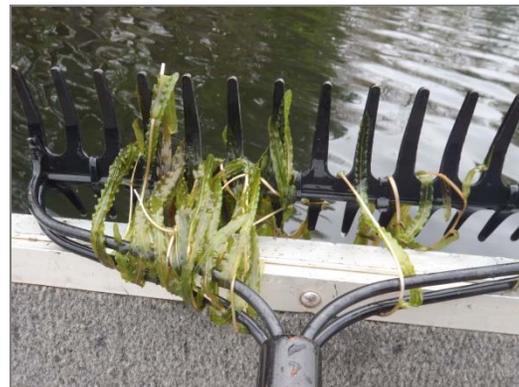
Image 1: A collection of Curly-leaf Pondweed on a throw-rake

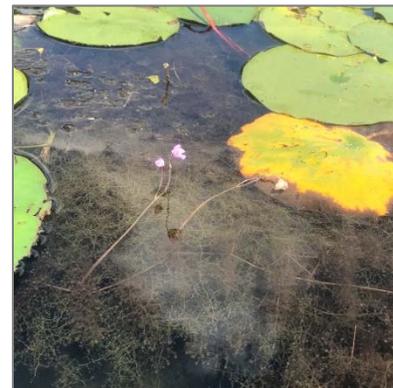
Image 2: Purple bladderwort flower (purple) next to flowering common bladderwort (yellow).
