Year-End Report for the 2019 Management of: Baddacook Pond

Groton, MA

Submitted: December 12, 2019
SOLitude Lake Management
590 Lake Street
Shrewsbury, MA 01545
Phone: (508) 823-6213
FAX: (888) 358-0088
lsullivan@solitudelake.com
www.solitudelakemanagement.com

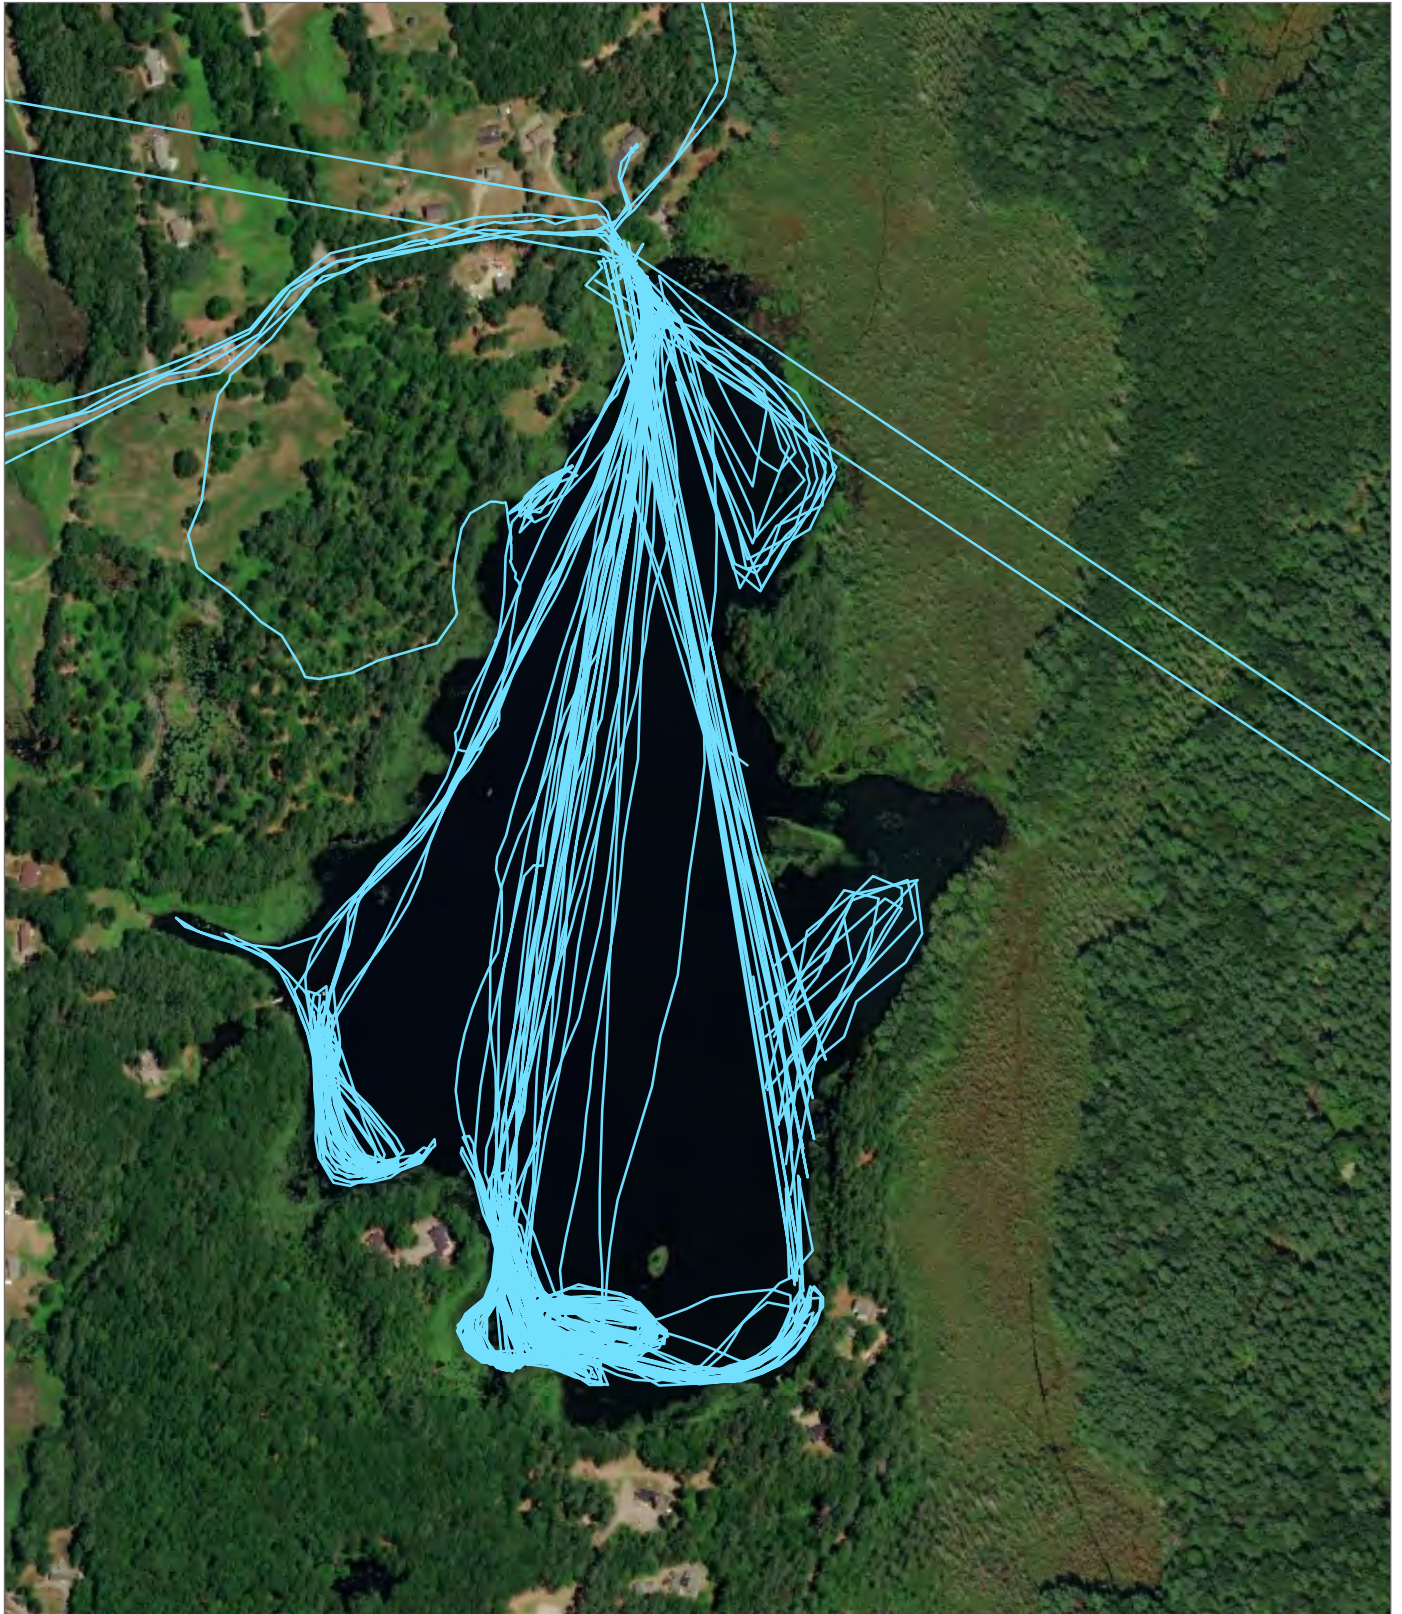
Figure 2: Harvester GPS Tracks

During operations the harvester operator started south and then proceeded around the pond in a counterclockwise fashion, focusing on invasive species removal and recouping open water space. Please refer to Figure 2 for a map of the harvested areas during this management period. The first harvesting event removed a total of 59 loads of material from the waterbody, each load was approximately 4 cubic yards in volume, totaling 236 cubic yards.

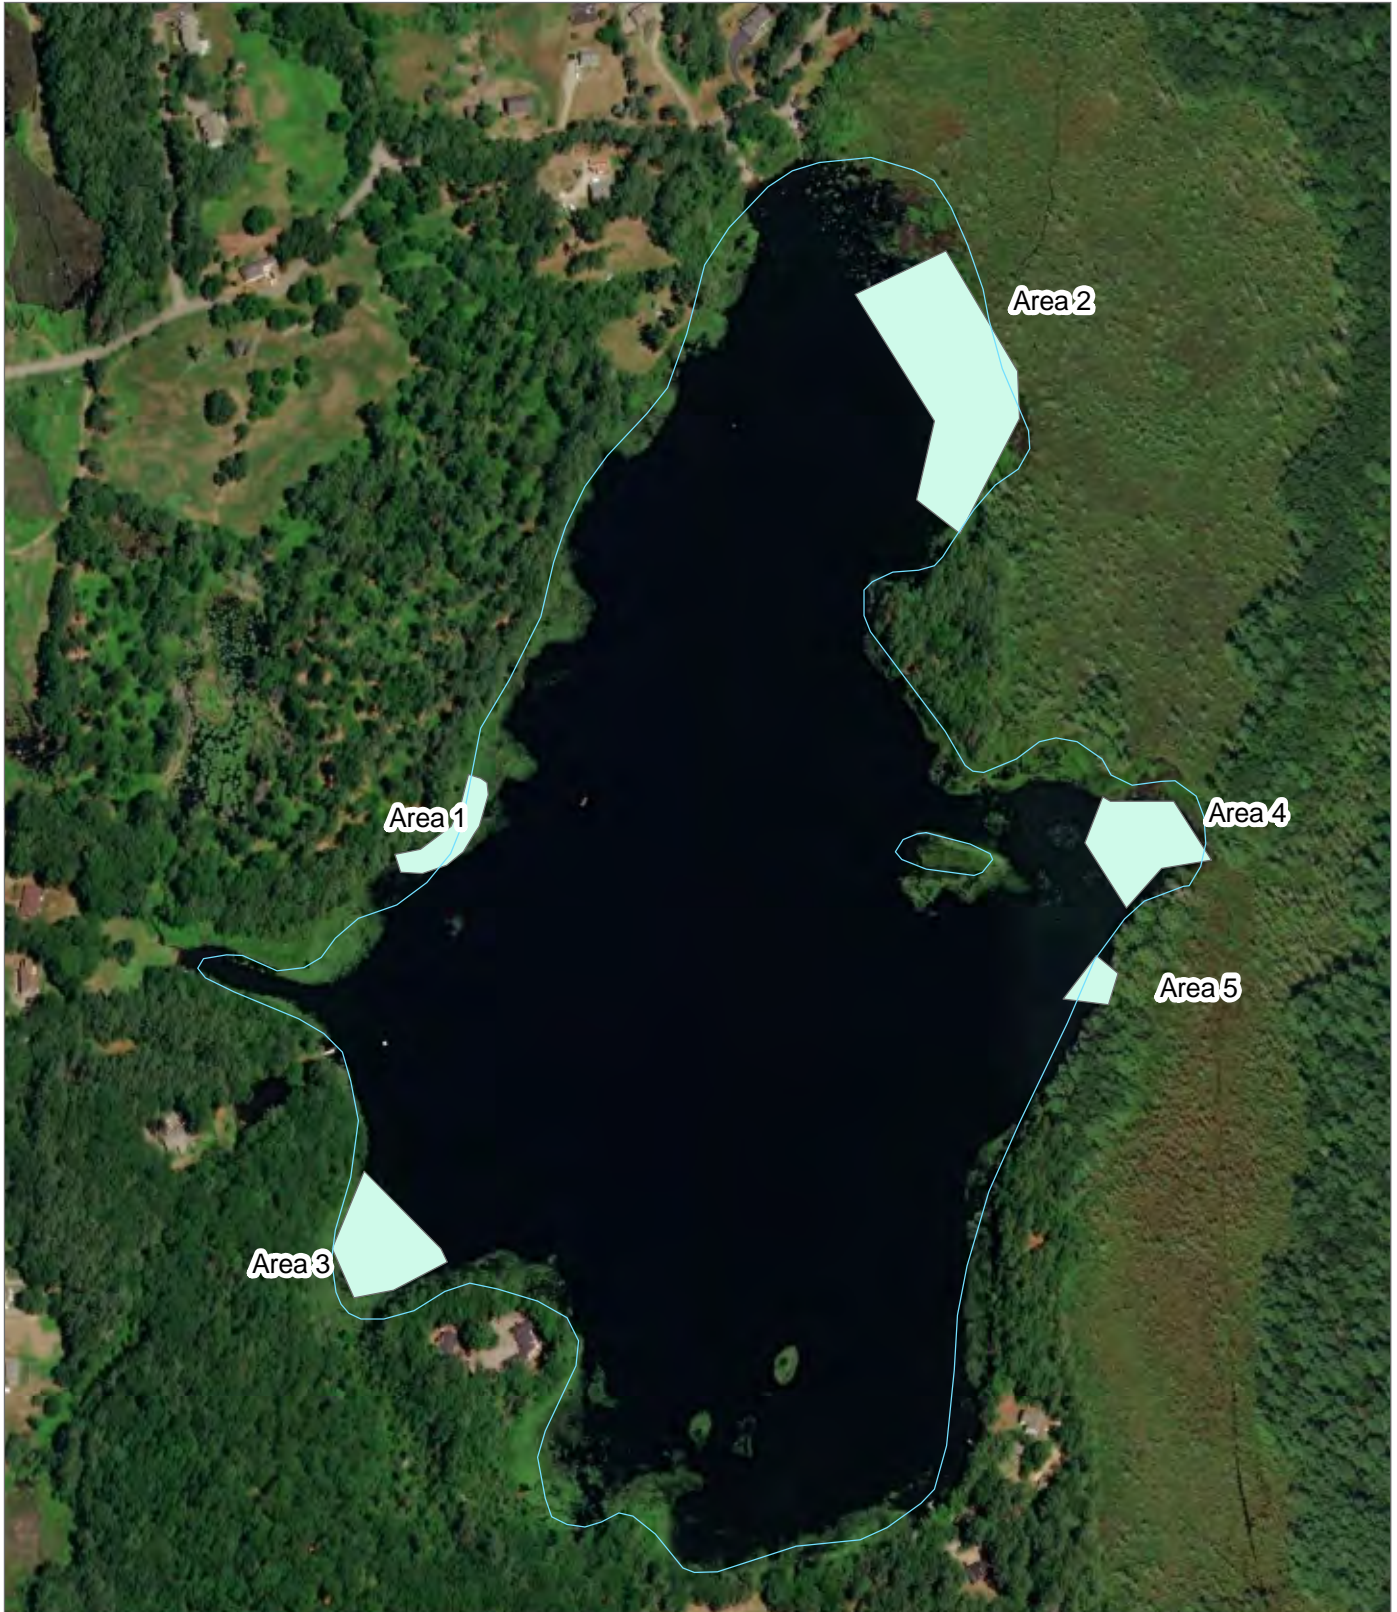
Figure 5: 2019 Hydro-raked Areas

Hydro-raking services were performed on select areas of Baddacook Pond, including both common areas as well as private shoreline areas. Please refer to Figure 3 for a map of the designated hydro-raking areas, as well as Appendix A for a chart of the areas hydro-raked each day. The collected organic material comprised of a combination of accumulated organic matter, floating islands, emergent vegetation, floating-leaf vegetation, and submersed vegetation.
