**Rehabilitation of Fitch's Bridge
Groton**

Application

Transportation Enhancements Program

PRELIMINARY DESIGN REPORT

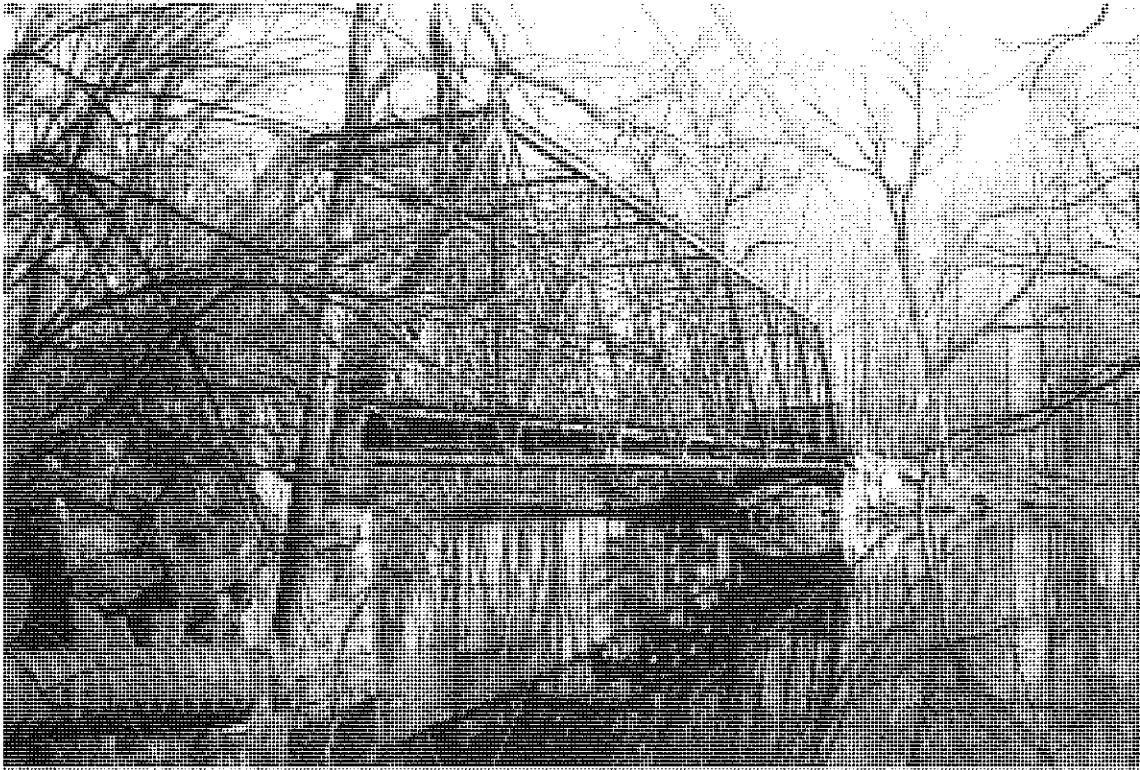
Photo 1 - South Elevation

The bridge is a single-span, simply-supported, riveted steel, double-intersection Warren through-truss (Photos 1 and 2 in Appendix A). No original drawings of the structure could be located. Therefore, base plans of the structure were developed using field measurements obtained during the inspection.

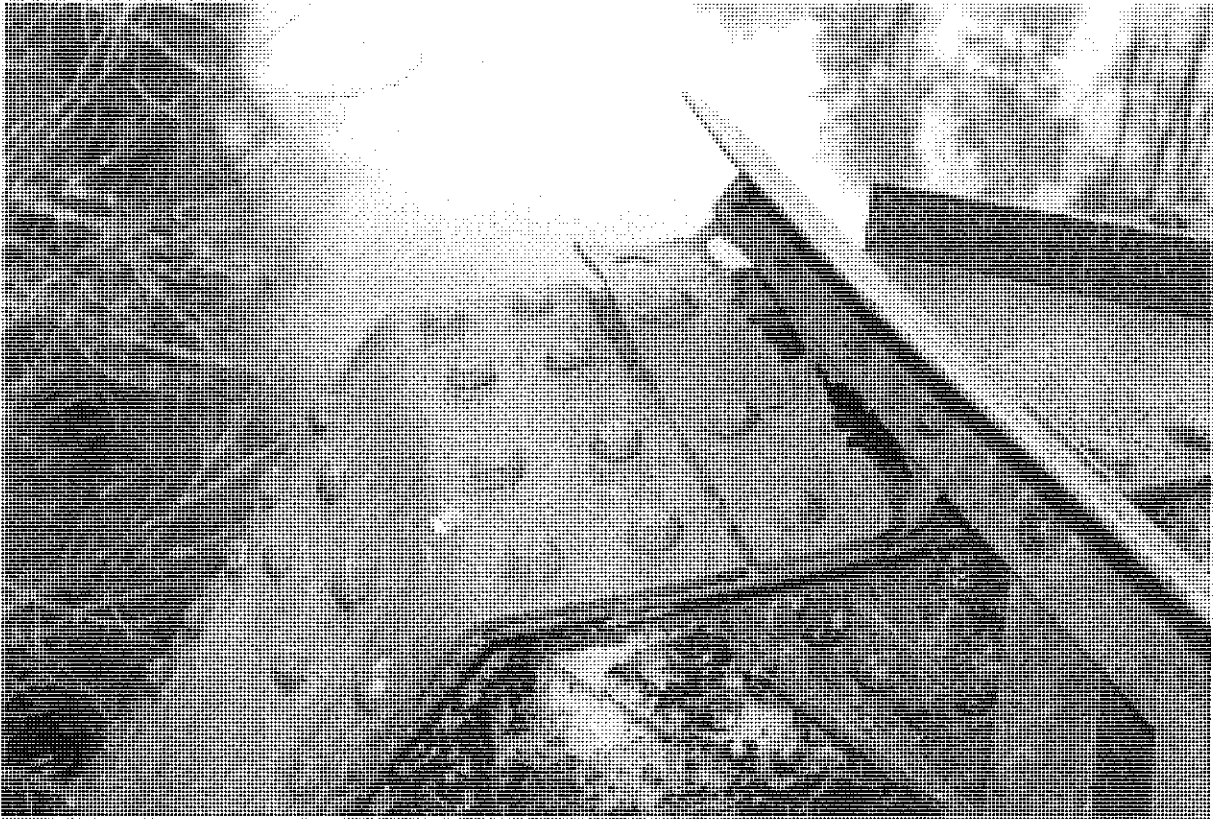
The top flanges of the top chords are heavily corroded with holes in several locations. At nodes N2, N8 and S2, there is heavy corrosion and pack rust between the portal frame top angle connection plates and the top flange plate of the top chord with large holes in the top flange plate. (Photo 5) Pack rust is corrosion build-up between two metal surfaces which continues to expand as the corrosion continues. In addition, there are several locations with heavy pack rust and corrosion between the top chord bracing angles and the top chord flange plate which has resulted in heavy corrosion and holes in the top chord flange plates. (Photo 6). In one case, the expansive force of the pack rust actually popped a rivet.

Photo 5 – Corroded Brace Connection and Hole in Top Flange Plate at Portal Connection
at N2 Top Chord

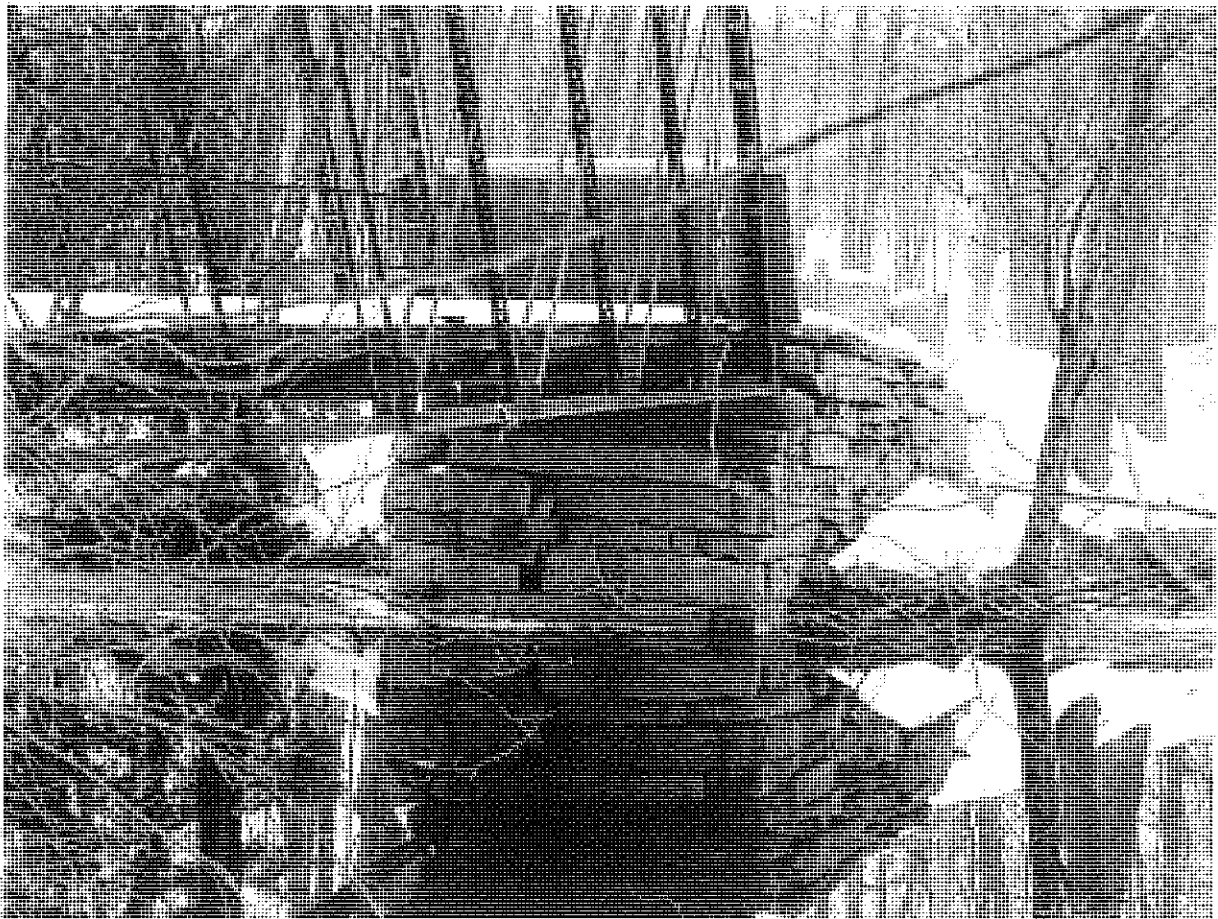
Photo 18 – East Abutment

It does appear that both abutments have settled and rotated slightly towards the south side. This can be observed in Photos 17 and 18 against the level water line. It is difficult to determine when such settlement may have occurred. The settlement and rotation of the abutments appears to be relatively uniform across the entire width of the abutments. Comparing photos taken in 2000 with photos taken during our inspection, we do not note any significant changes in the stone masonry which indicates that the settlements may have occurred a long time ago.

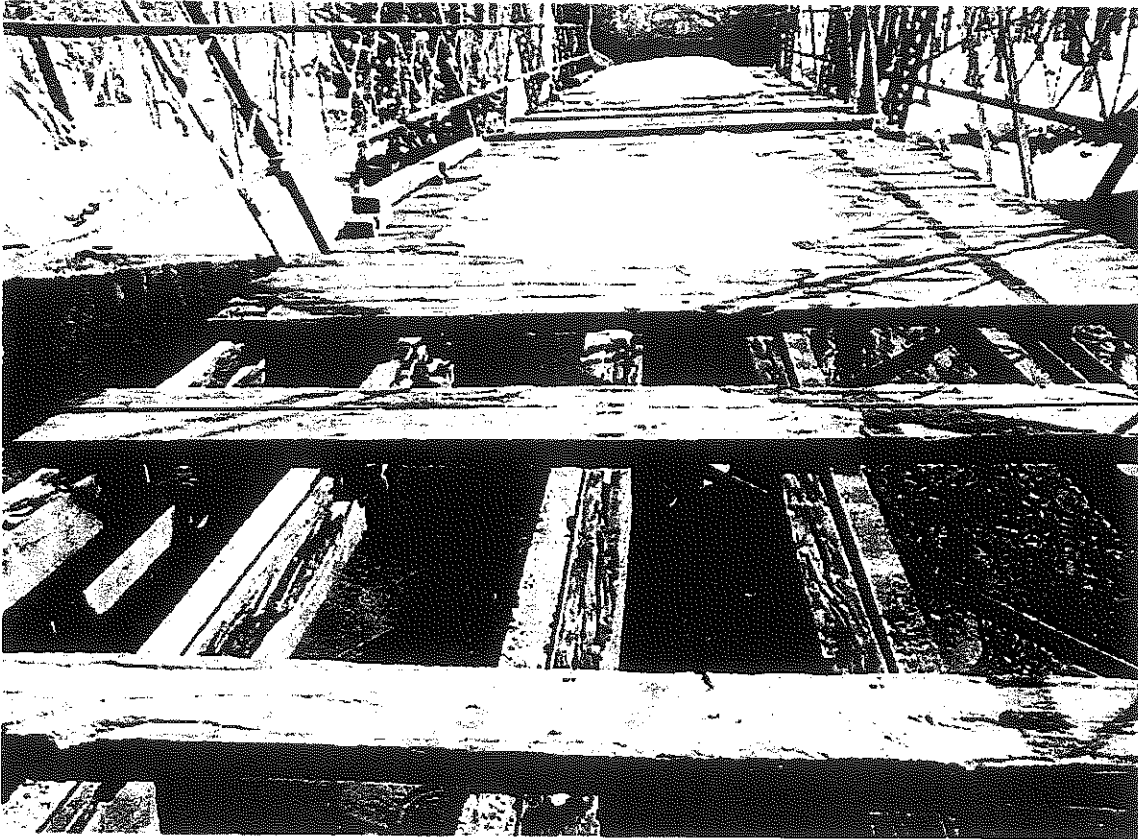
Photo 4

The floor system consists of wood planking placed perpendicular to the steel stringers. Most of the wood planking and the wood curbing are missing. The wood planking that is still present is in poor condition. Wood beams are bolted to the steel stringers to allow for the nailing of the wood planking. The steel stringers are perpendicular to the steel floorbeams. The steel stringers are connected to the top flange of the steel floorbeams. The steel floorbeams transfer the floor system loads into the truss through the bottom chord at the panel points. The wood beams attached to the steel stringers are in poor to fair condition. The steel floorbeams are in good shape with very little sign of section loss. See photo 4 for a view of the flooring system.
