Electronic Town Meeting Voting Investigation

Grafton Information Technology Committee

May 13, 2019

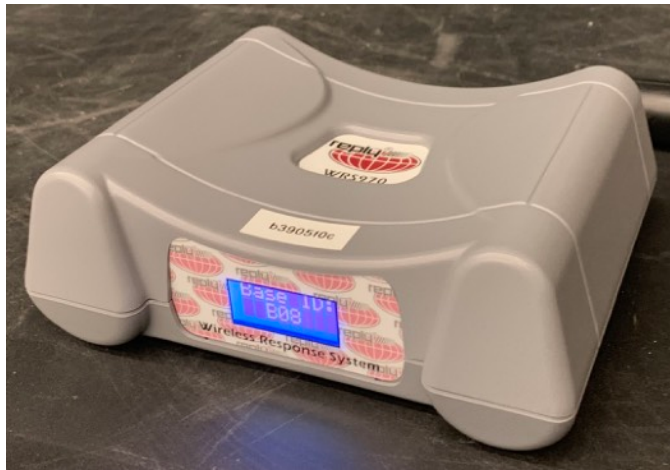
Figure 1: WRS970 Base Station

WRS970	Large base station (see Figure 1); box (roughly 5” x 6”) form factor; USB cable connection; accommodates a room up to 650’ x 650’; 300 mA maximum USB current draw
WRS971	Small base station (see Figure 2); USB stick form factor; accommodates a room up to 300’ x 300’; 50 mA maximum USB current draw

The manufacturer's description of the capacity and current draw of the two base stations implies that the WRS970 is significantly more powerful than the WRS971. The physical size difference between the two tends to support this notion.

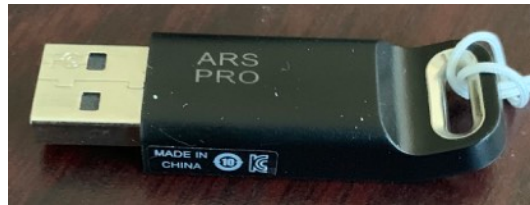
Figure 3: Sentinel HASP Software Key

Software key Sentinel HASP (Hardware Against Software Piracy) (see Figure 3); small USB stick form factor; authorizes software application for a specific set of keypads and base stations

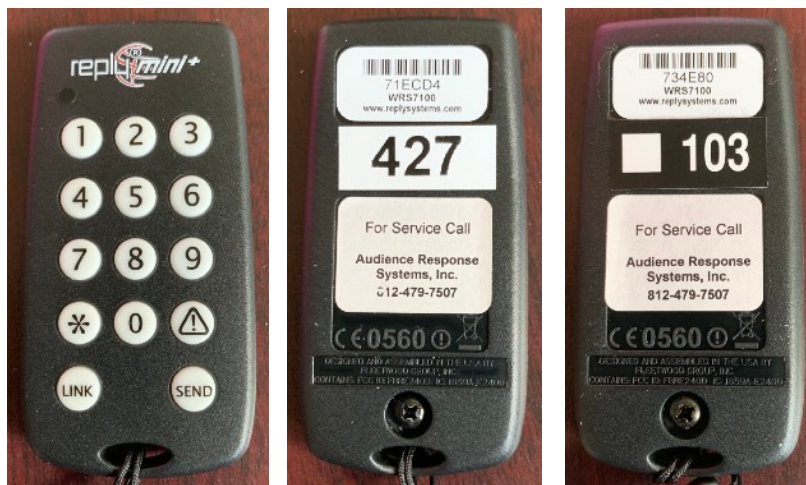
Figure 4: WRS7100 Keypad
(L to R) Front, Original (Channel 1) Back, New (Channel 8) Back

WRS7100 Keypad (see Figure 4) with buttons for the digits 0-9, four additional buttons for special functions, and green and red lights; form factor similar to an automobile key fob

The keypads in each set of up to 500 WRS7100 keypads are numbered 1 through 500, corresponding to the address mentioned above. The keypad number is printed on the keypad's label. This means that, in a case like Grafton's where more than one set of keypads is used, two or more keypads may have the same number. To distinguish among keypads, the appearance of the label is distinctly different for each set of keypads. Figure 4 shows the different labels in Grafton's two sets of keypads.

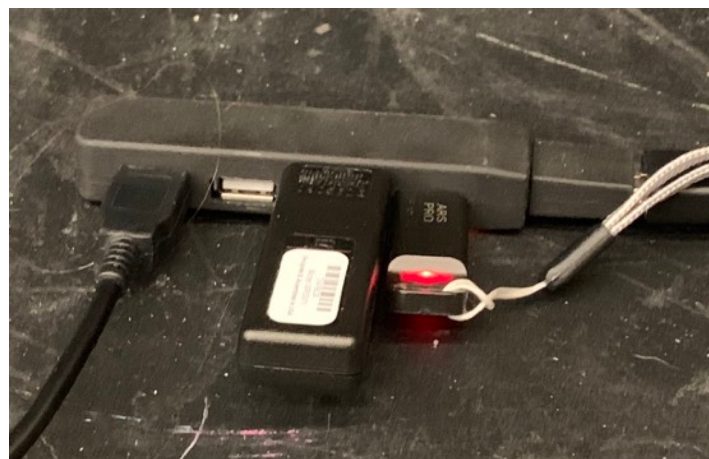
Figure 5: USB Hub With (L to R)
Cable to WRS970, WRS971 and HASP

Figure 5 shows the unpowered USB hub that Grafton has been using to connect the software key and the two base stations to a laptop computer. The placement of the three devices in the ports on the hub is not critical; they could be placed in any order.

Structural elements blocking radio signals	Structural elements, such as walls or pillars, can attenuate the radio signal, sometimes sufficiently to cause poor performance. There are no such problematic structural elements in the auditorium.
USB hub	The vendor suggests using a powered USB hub, to ensure that the base stations have a power supply sufficient to transmit at the maximum power of which they are capable. We have been using an unpowered hub, successfully at the February 2018 meeting and successfully during the testing described herein (failures during testing were clearly attributable to base station separation, not to lack of USB power). Nevertheless, it is probably wise to use a powered hub in the future.

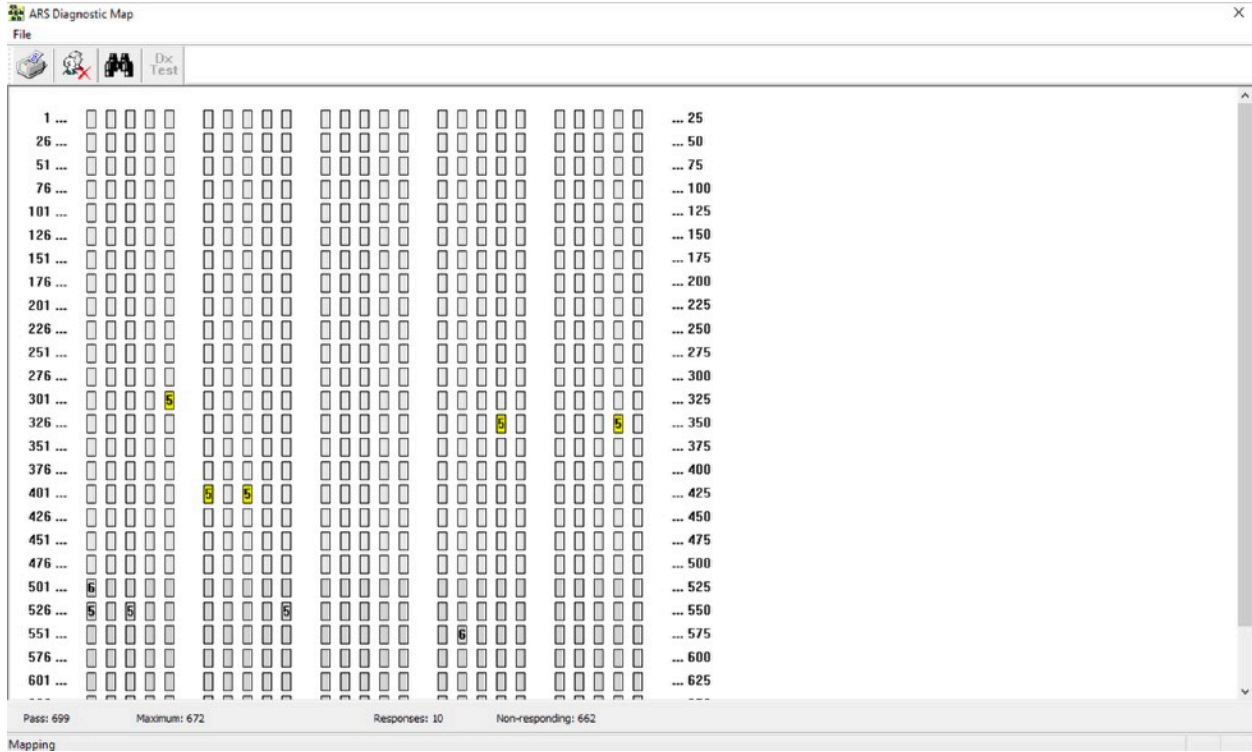
Figure 5: Keypad Map

Table 3 summarizes the results of this inventory. Every one of the keypads was operated one or more times in close proximity to the base stations while observing the keypad responses in the diagnostic map of the ARS Pro application. That map consists of an array that shows the status of every configured keypad, and for each keypad it shows the key, if any, that was pressed and highlights that keypad in yellow if the keypad reported a low battery status when the key was pressed (see Figure 5).

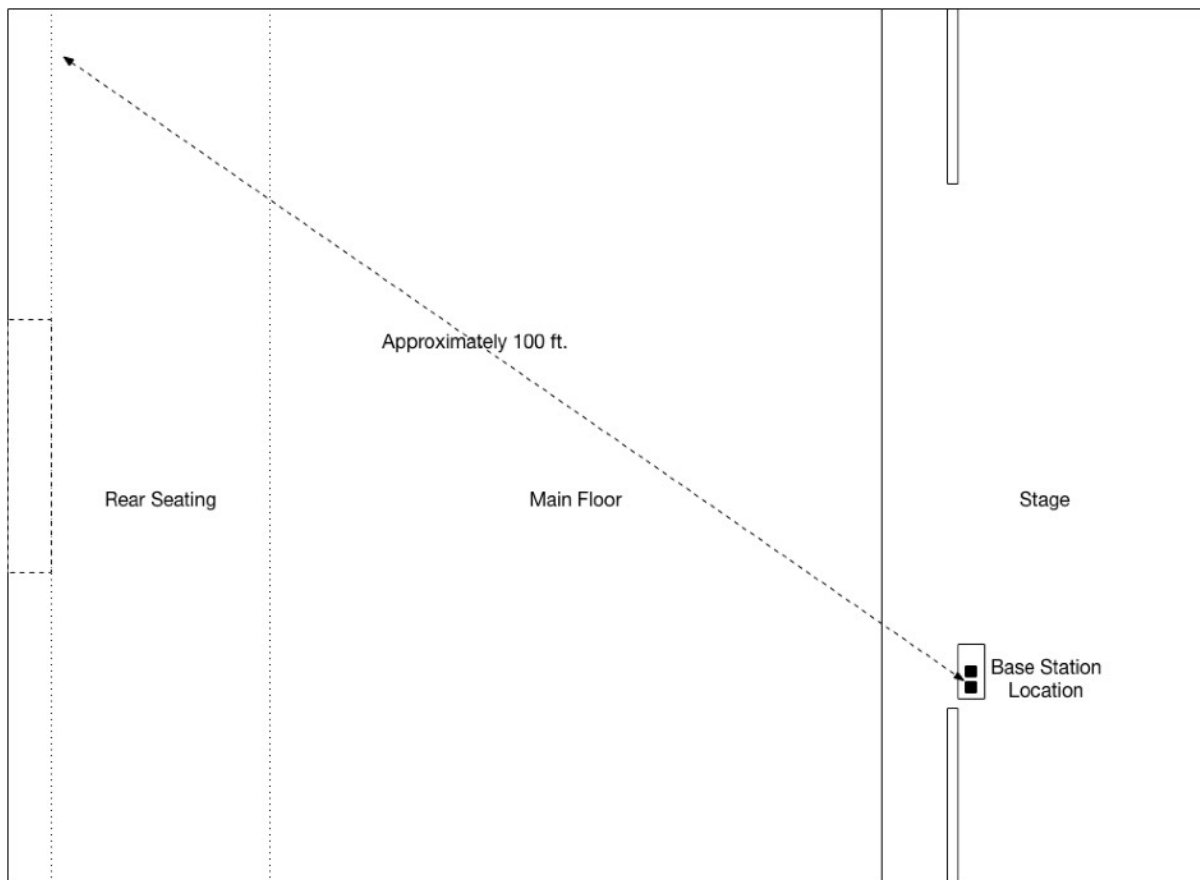
Figure 6: Grafton High School Auditorium for Town Meeting

Town Meetings are held in the Grafton High School auditorium, with the keypad system base stations located on the stage and the keypads distributed in the seating around the auditorium. This obviously means that some keypads are located close to the base stations and others are quite far away. The auditorium seating area (from the front edge of the stage to the rear of the room) is more or less a square, approximately 80 feet on each side, with the stage on one side. The stage opening facing the audience is approximately 48 feet wide. With the keypad system base stations located on a table at one end of that stage opening, the distance to the seat farthest away (on a diagonal, and accounting for the height at the rear) is approximately 100 feet. See Figure 6.
