Subject: Proposed Residential
500 Main Street, Groton, MA

Bayside Engineering is in receipt of MDM Transportation Consultants, Inc. (MDM) May 3, 2023 review of the Traffic Impact and Access Study (TIAS) prepared for the proposed redevelopment of 500 Main Street in Groton, MA. The purpose of this letter is to respond to the comments raised on the Bayside TIAS (dated December 9, 2022). Bayside has prepared the responses below.

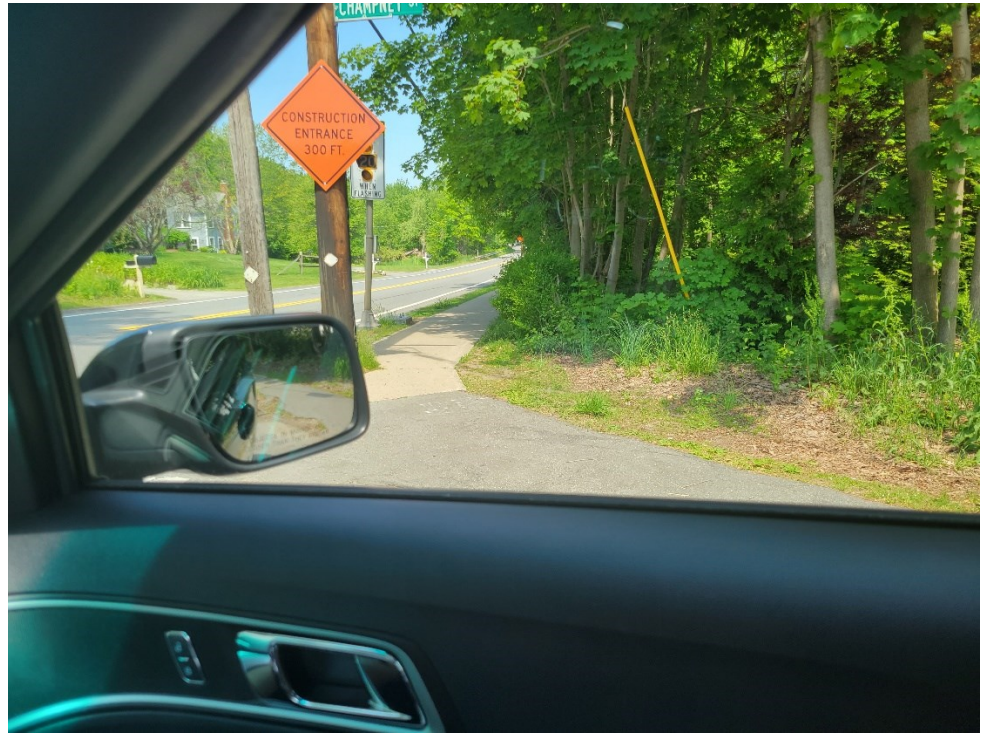
Field review indicates that sight lines looking west from the Champney Street stop position are limited by vegetation. A photo of the existing situation is shown on the following page.

As can be seen, visibility to oncoming (eastbound) vehicles is reduced due to the tree canopies. The applicant has contacted MassDOT to alert them to the described conditions as Main Street is under MassDOT jurisdiction.
