On Site Existing Conditions Assessment

Building Envelope Sciences

Photo 1 – Overall view of the Groton Public Library from the Main Street entrance. The yellow line indicates the approximate limits of the original 1893 structure and the 1999 addition.

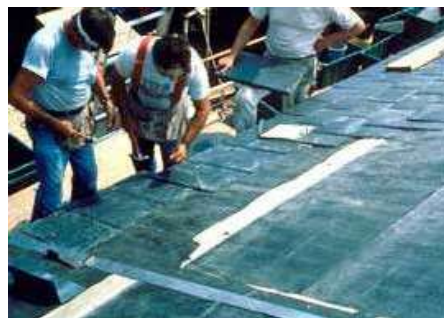
Roofing felt is being installed over the decking; a rubberized membrane is used selectively at the eaves and under some flashing. Photo: NPS files.

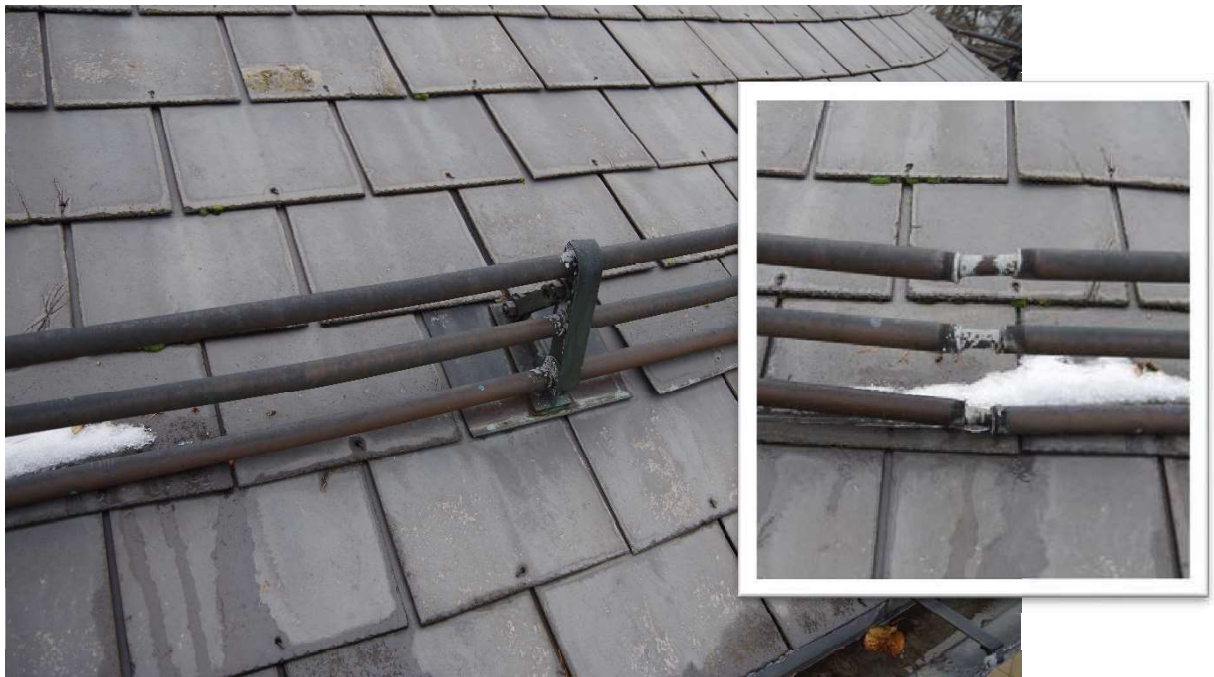
Photo 42 – Partial view of three rail pipe style snow guard at synthetic slate roof system. Snow guards are typically installed on slate roof areas to prevent snow and ice from sliding off the roof edge, especially in areas of pedestrian and vehicular traffic below. Loose pipe rail connections were observed at several locations. Deteriorated snow rails may be a potential fall hazard.

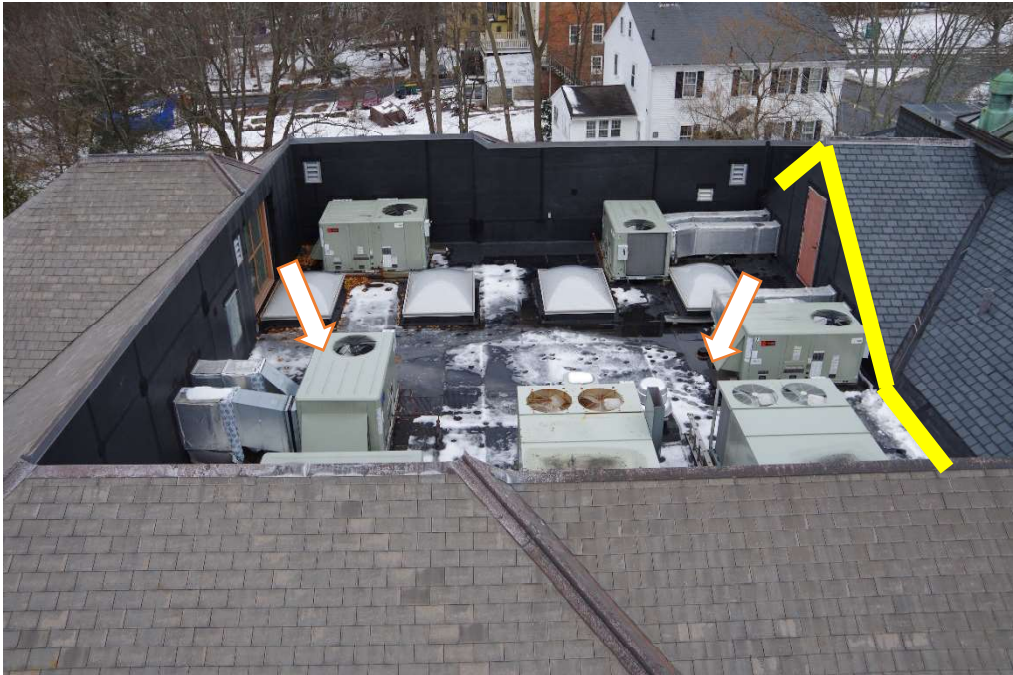
Photo 43 – Overall view of low-slope, single-ply elastomeric roof system, which includes a 60 mil, fully-adhered membrane. The yellow line indicates the approximate location of roof and wall expansion joint (abutment of original 1893 building and 1999 addition). Arrows indicate the approximate location of roof drains. Most of the library's HVAC equipment is installed here, therefore, it has the most roof penetrations of all the roof systems. Four large skylights are also located at this roof.

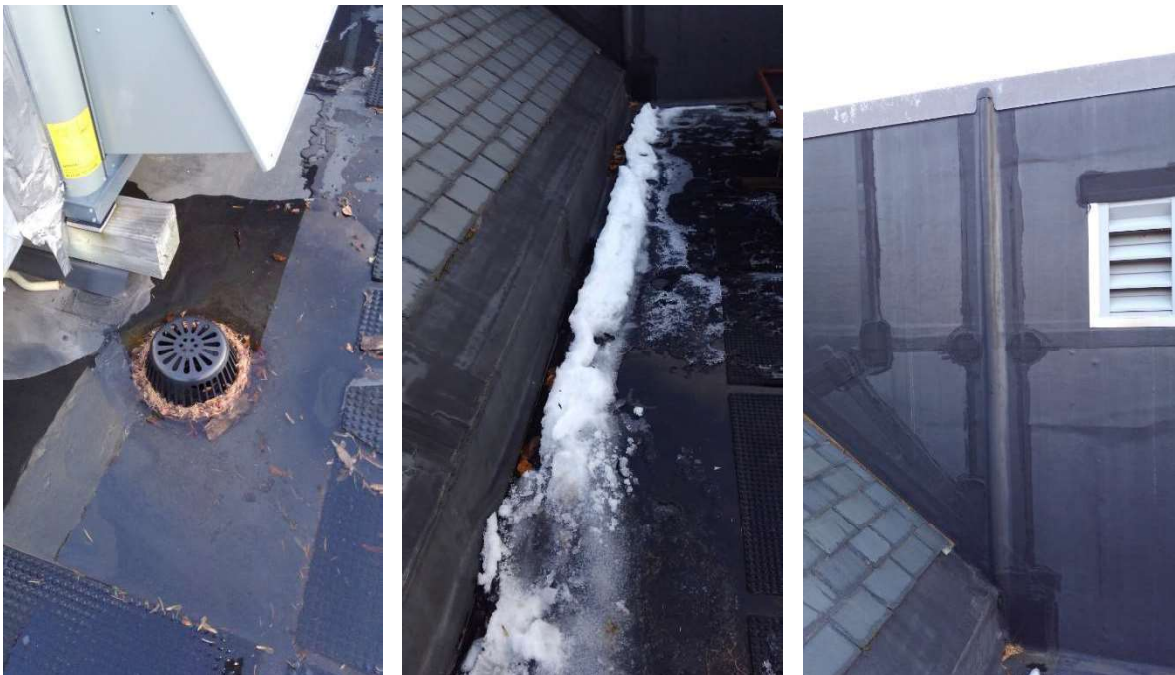
Photo 44 – Partial view of low-slope, single-ply elastomeric roof system. Ponding water and debris were observed around the strainer at both roof drain locations. The horizontal expansion joint, located at the knee wall, transitions vertically up the wall cladding.

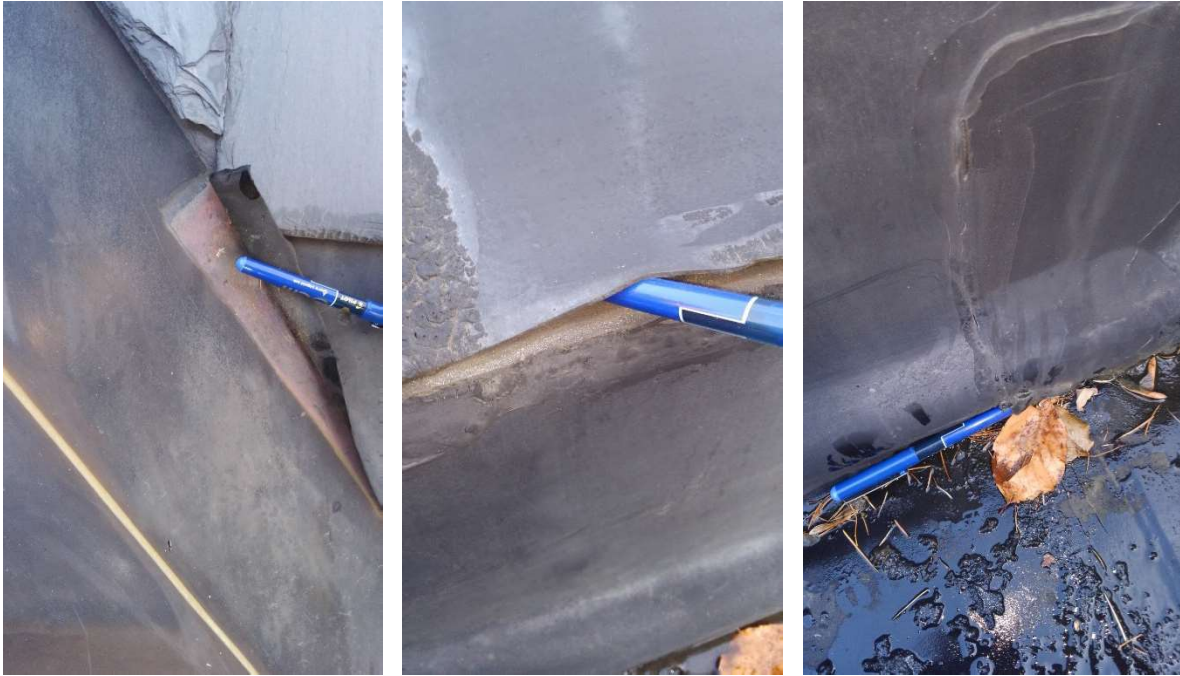
Photo 45 – Partial view of representative open seams found in the elastomeric roof membrane. A puncture in the membrane was found at the roof to wall expansion joint.

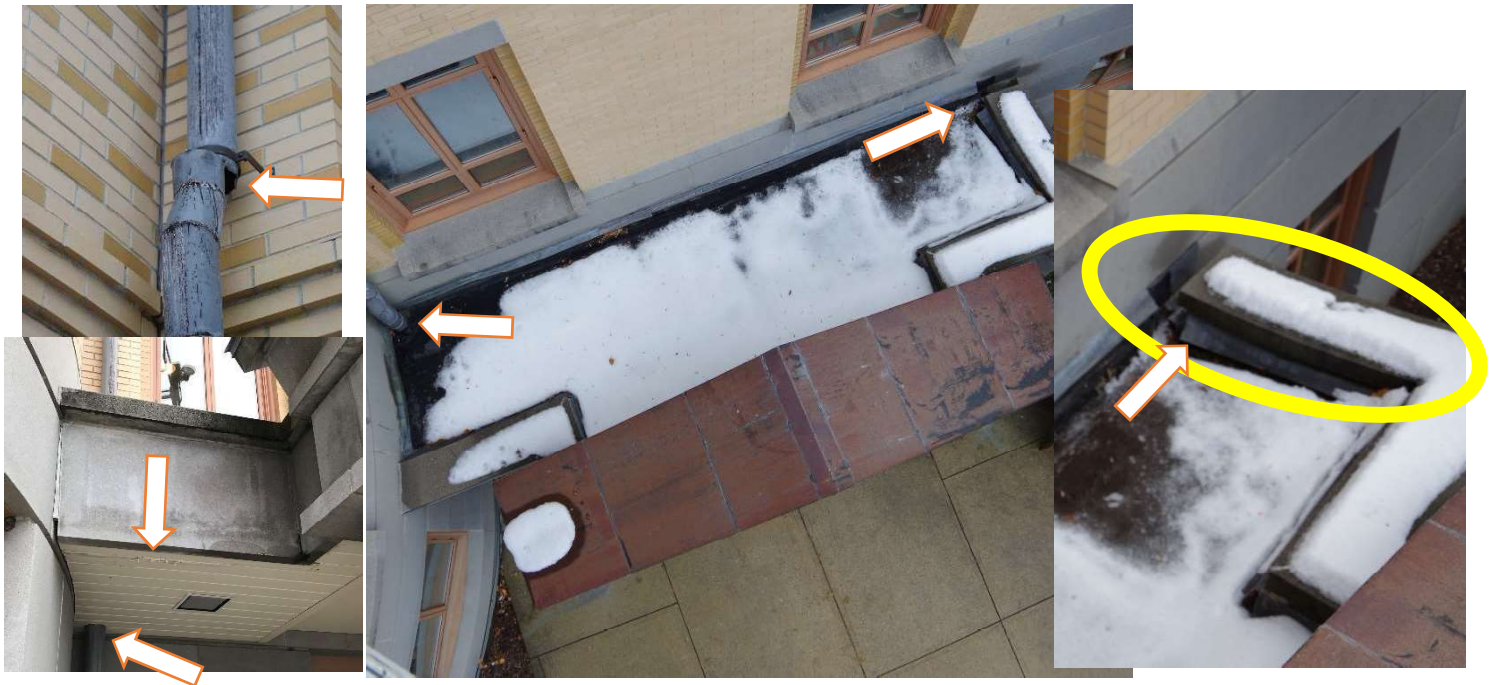
Photo 46 – Overall view of single-ply elastomeric (EPDM) roof system located at the west elevation entrance (center photo). The roof membrane transitions up the wall and terminates under a lead coated copper flashing. The circle indicates where the roof membrane was observed to be open (right photo). The arrows indicate a roof scupper, where the roof area is sloped to drain. The downspout above this roof area has a broken joint (top left photo). Moisture related deterioration was also observed at the left side of the entrance near the downspout penetration through the entrance canopy (bottom left photo). The gabled portion of the entrance portico has a copper cap flashing with soldered joints.
