# COL. WM. PRESCOTT ELEMENTARY SCHOOL

145 Main Street Groton, MA 01450 978.448.0380

## Property Background

## Existing Conditions

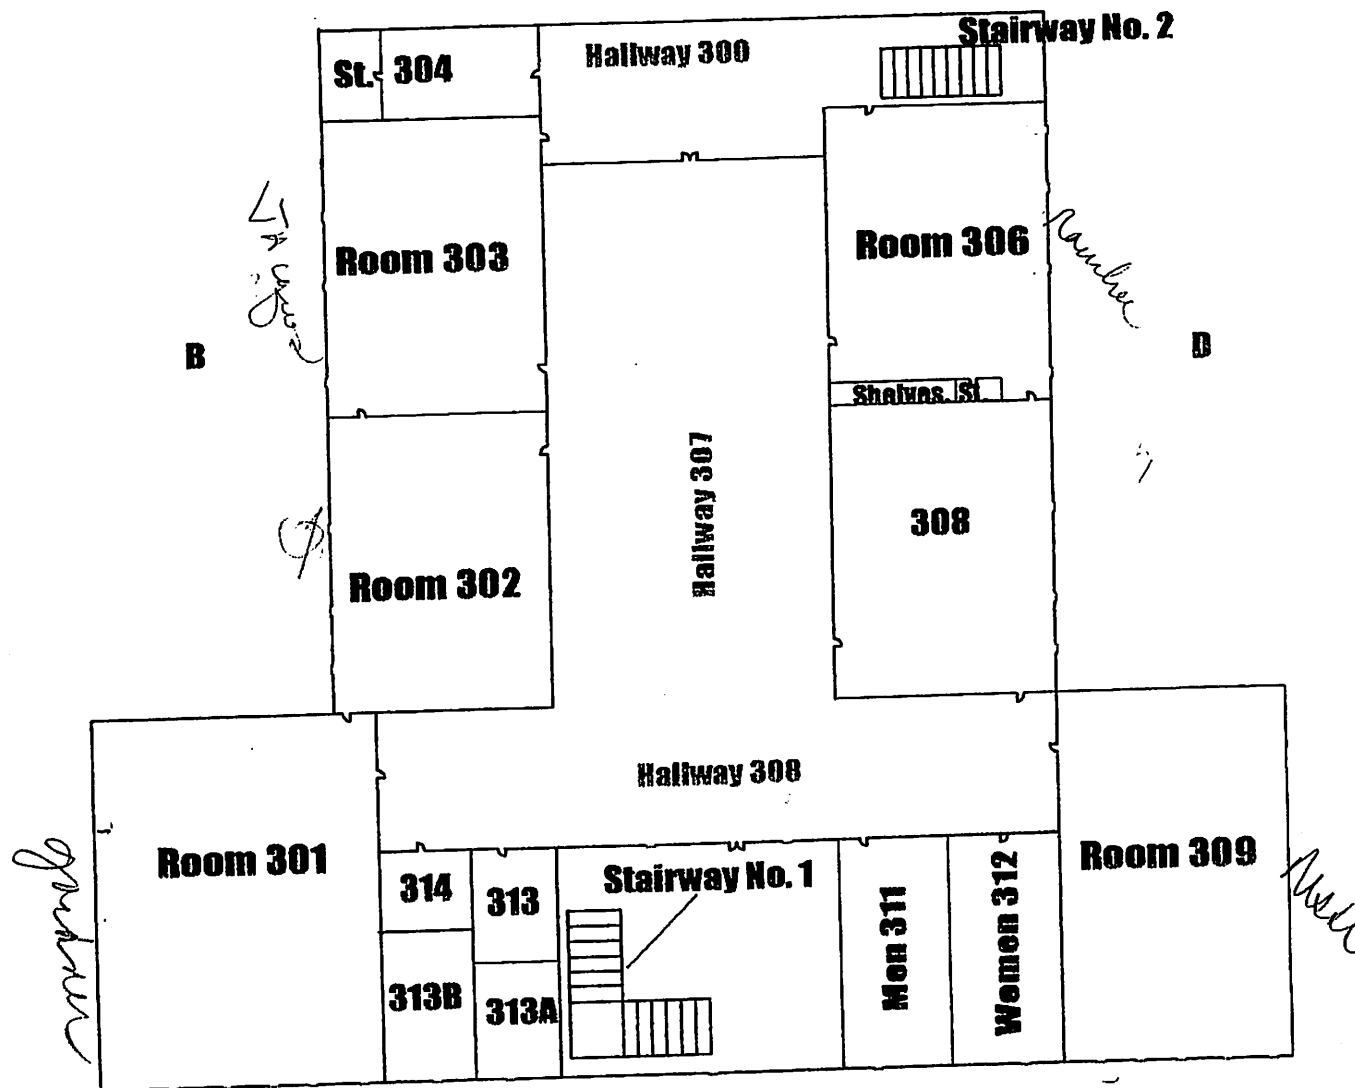
## Upper Level

# Groton Prescott Elementary School
