11. CPA PROJECT APPLICATION FORM

HISTORIC PRESERVATION OF 1893 GROTON PUBLIC LIBRARY (NEW ROOF & DRAINAGE SYSTEMS)
CPA Project Application # 2020-06 (Slate Roof Replacement)

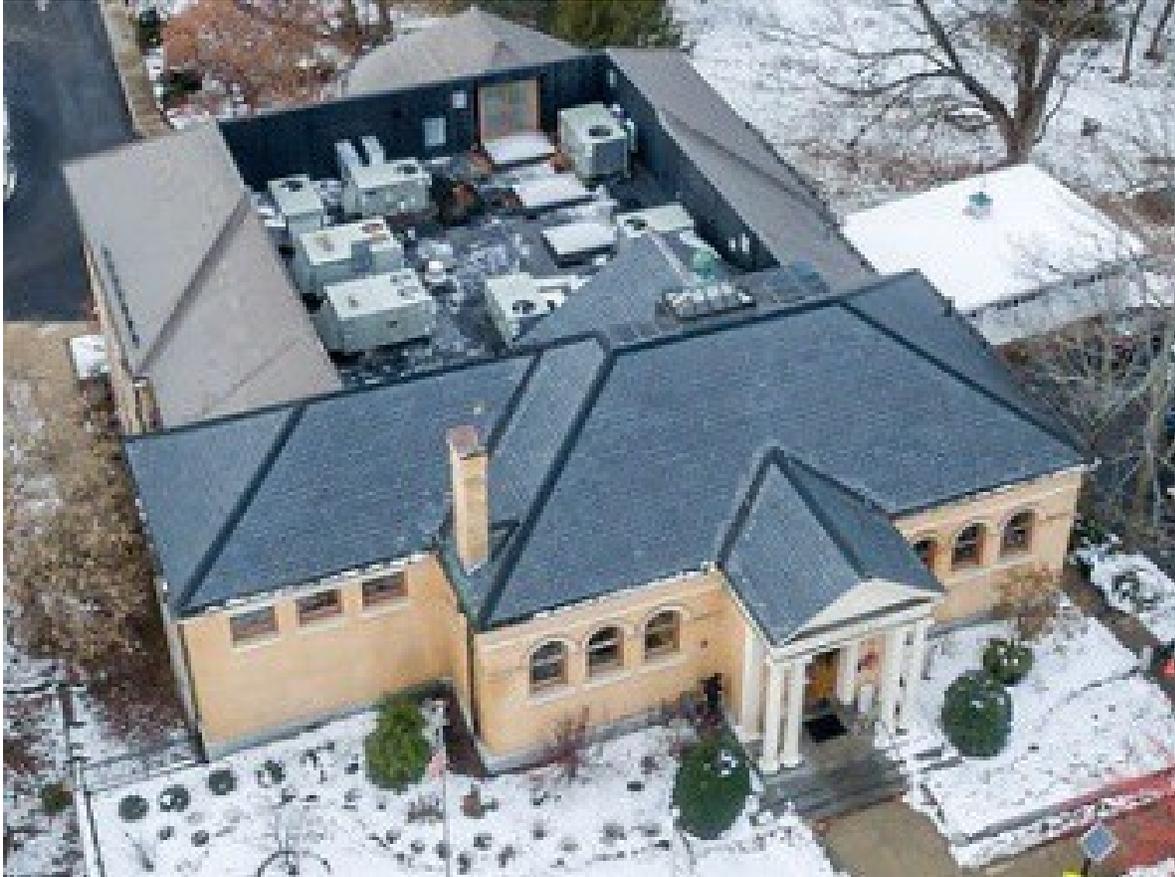
View of the 1893 library slate roof, with elastomeric membrane (EPDM) roof and HVAC area behind, and 1999 sloped roof to the rear.

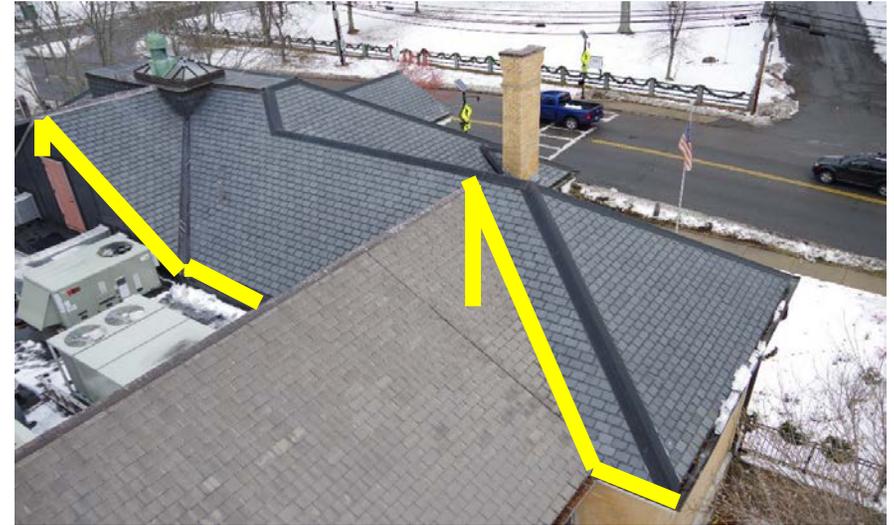
Above: Approximate demarkation of 1893 Slate Roof from 1999 addition.
Below: 1893 Flat Seam Copper Roof with Skylight
