Legion Hall Groton, MA
ADA Transition Plan

To: Michelle Collette, ADA Coordinator
Town Hall, 173 Main Street
Groton, MA 01450

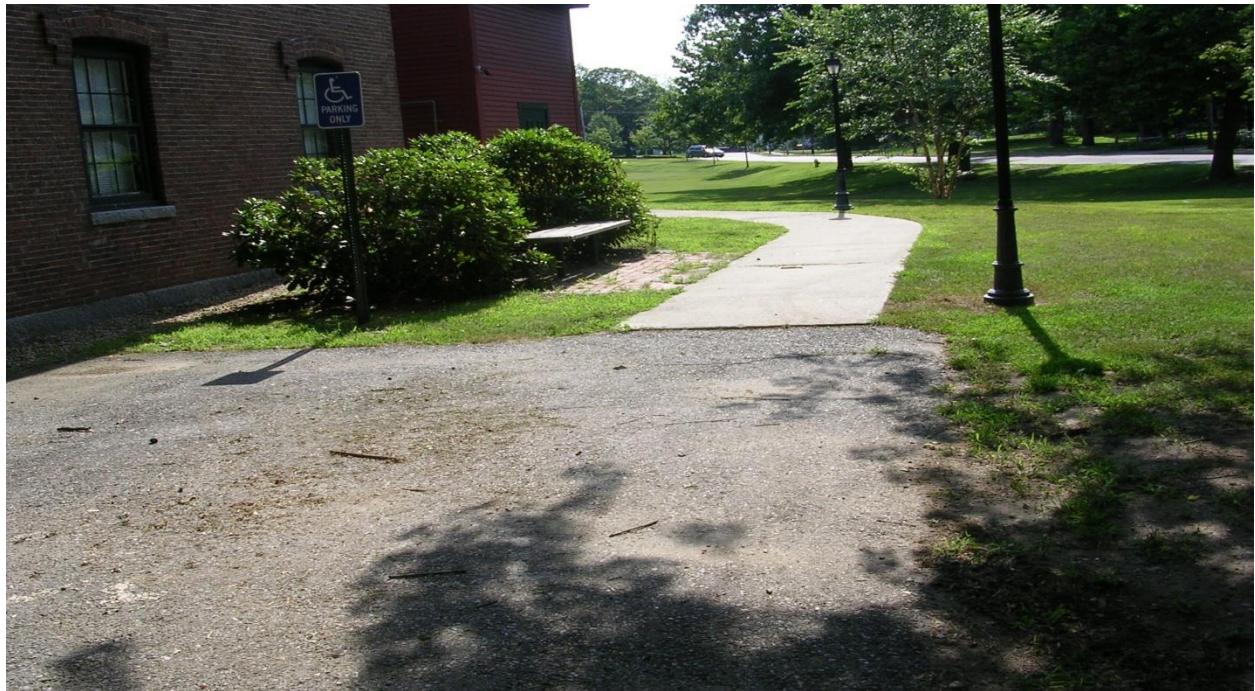
In our opinion the following issues were found:
