TOWN OF GROTON, MASSACHUSETTS

SENIOR CENTER FEASIBILITY STUDY

FINAL STUDY REPORT

October 3, 2016

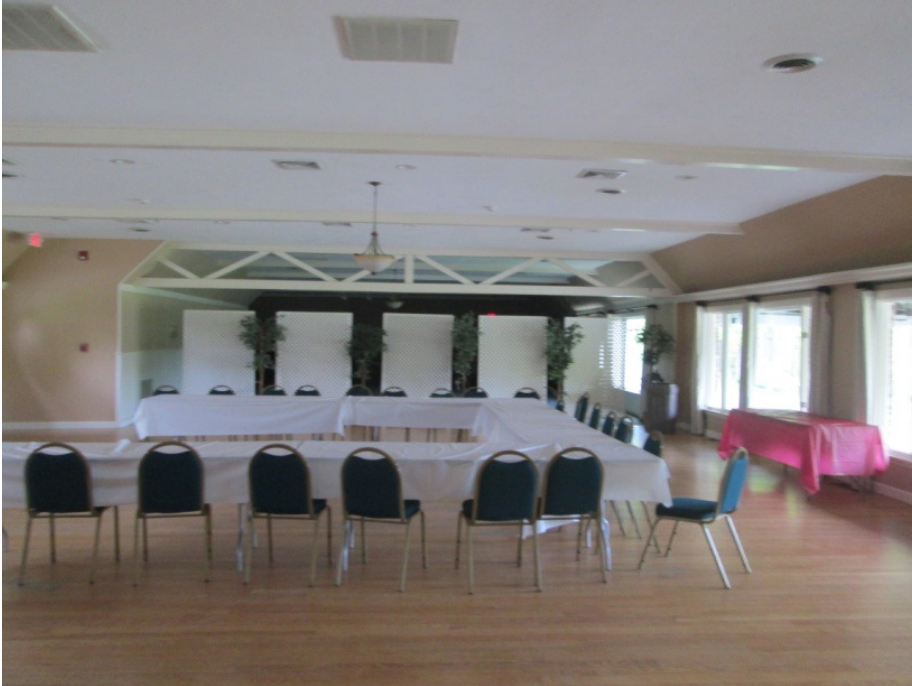
Photo CC1: Building contains two Large open areas suitable for large gatherings and events.

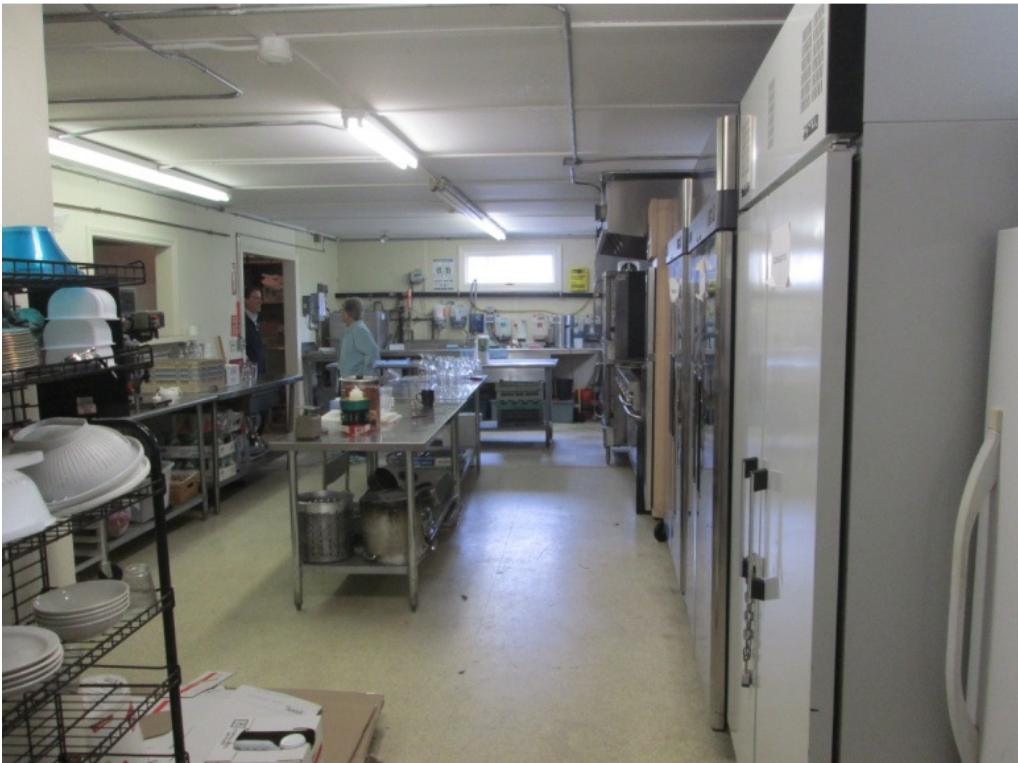
Photo CC1: Existing commercial kitchen is available for use.

- a) New elevator.
- b) Modifications to the kitchen to improve accessibility and general function. The kitchen equipment is not new and may need to be upgraded or replaced to best serve the Senior Center's needs.

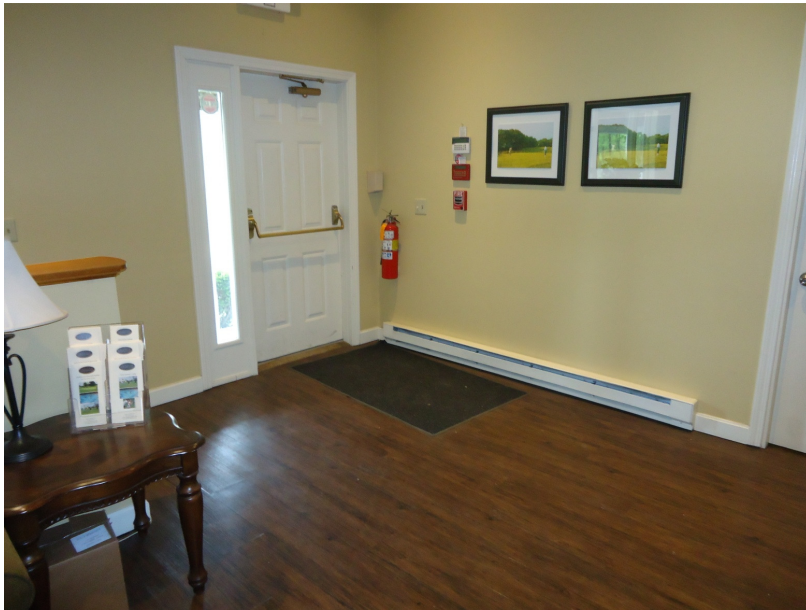
Photo CC6A: Main entrance to facility lacks an entry vestibule, resulting in energy loss during heating/cooling cycles.

- l) Renovate the basement toilet room facilities to current accessibility standards.
- m) Construct an entry vestibule to save energy costs.
- n) Add insulation in the attic to obtain R-40 for energy savings.

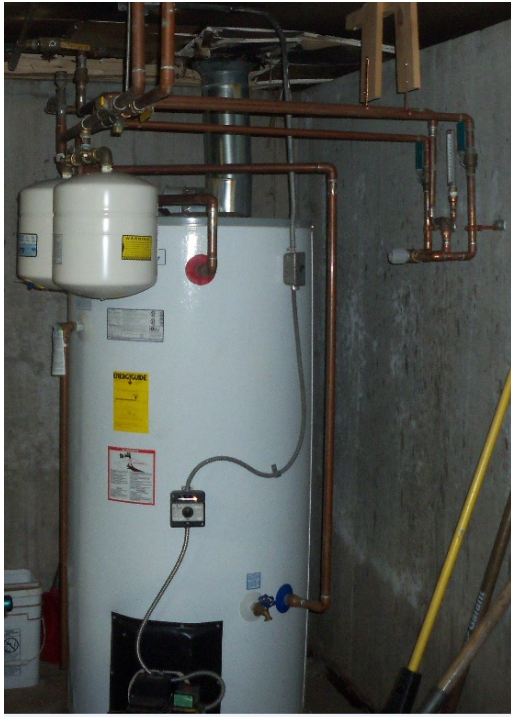
Photo CC3C: Existing domestic water system showing water heater, expansion tanks and temperature mixing devices.

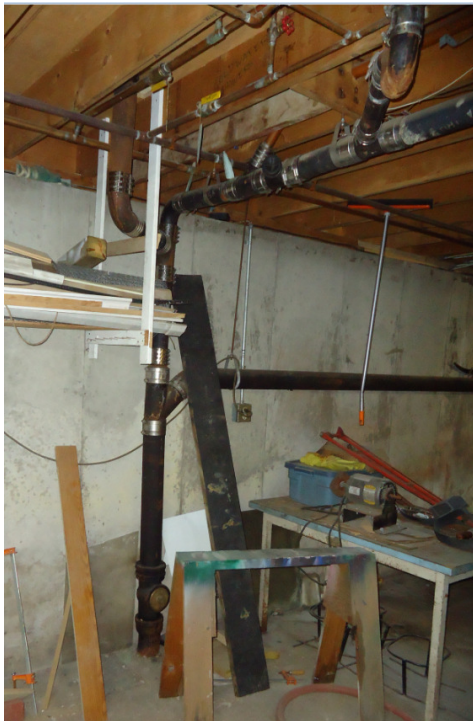
Photo CC4A: Existing sanitary service the building

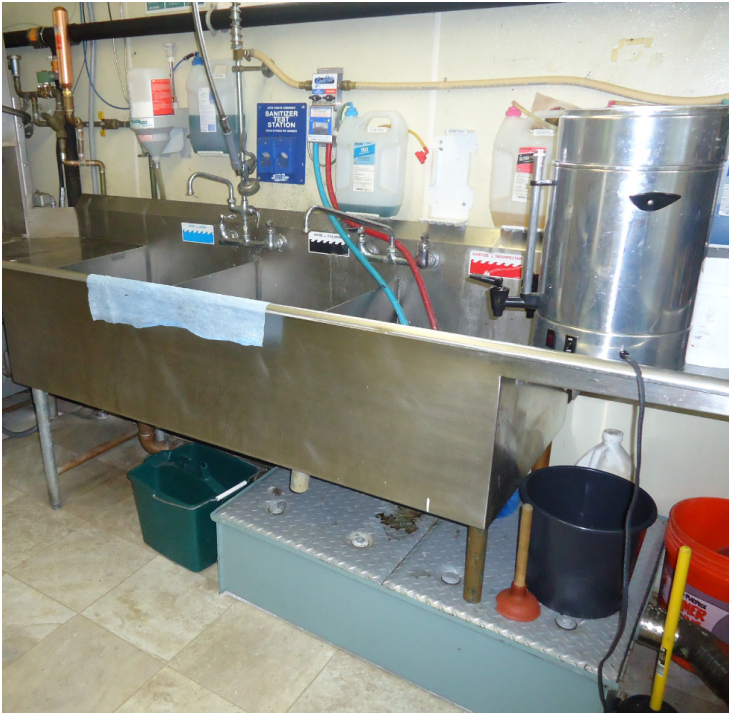
Photo CC4D: Existing 3 Pot Commercial Kitchen Sink

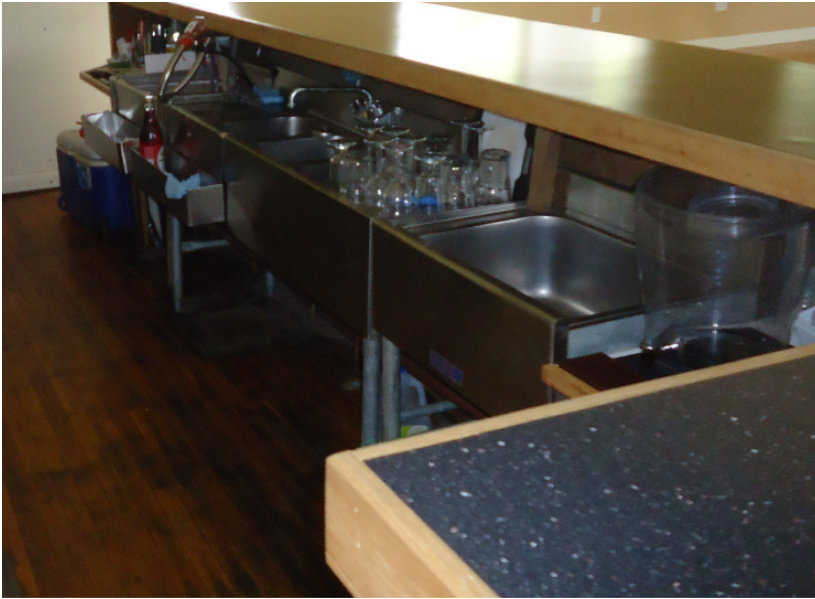
Photo CC4E: Existing Bar Plumbing Fixtures.

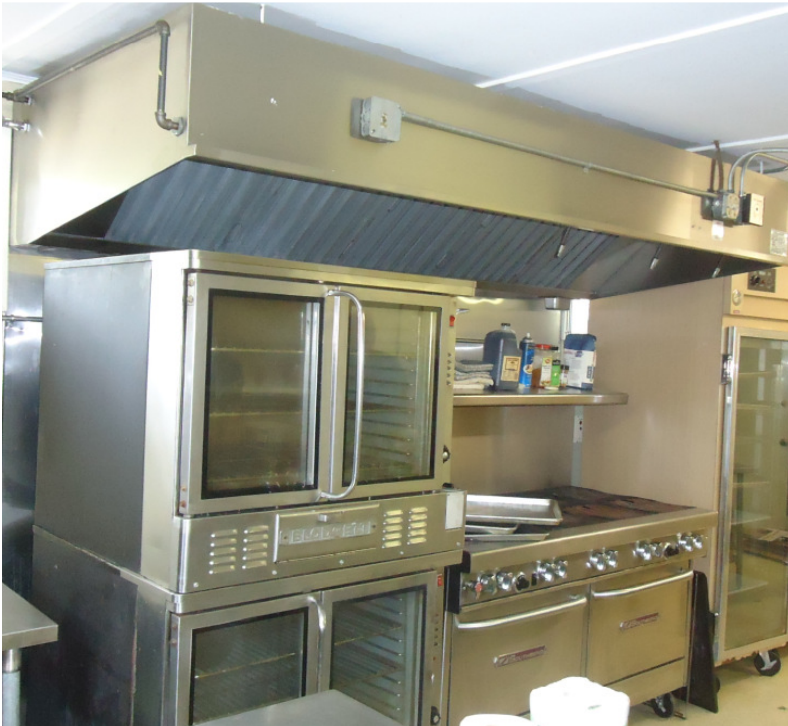
Photo CC5F: Type 1 grease exhaust system with fire suppression.

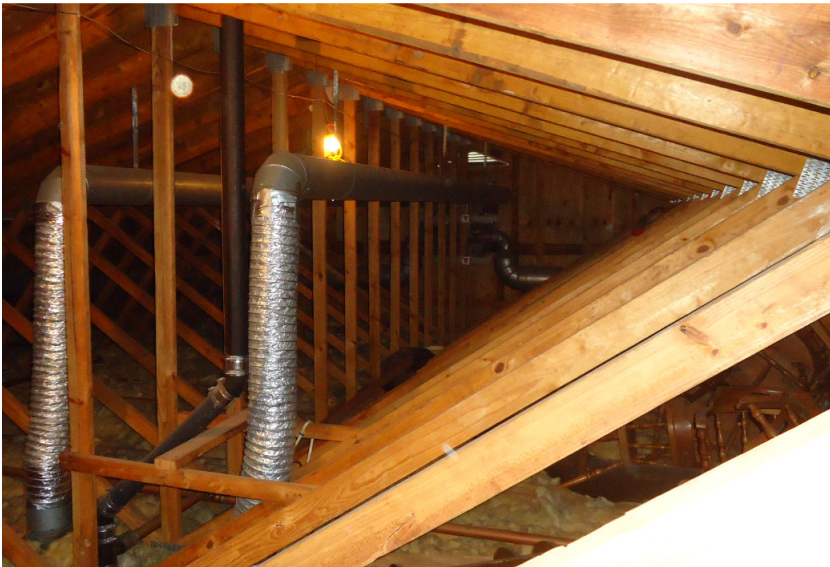
Photo CC5J: Exhaust systems serving the locker room.

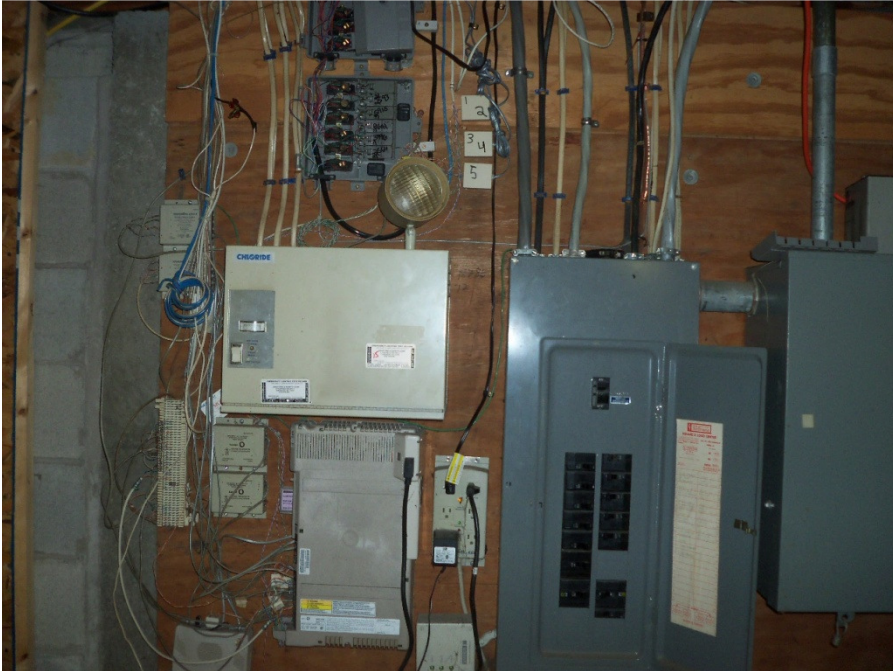
An increase in demolition is required, due to the removal of all Romex cabling.

Photo CC-1: Main service and example of Romex wiring

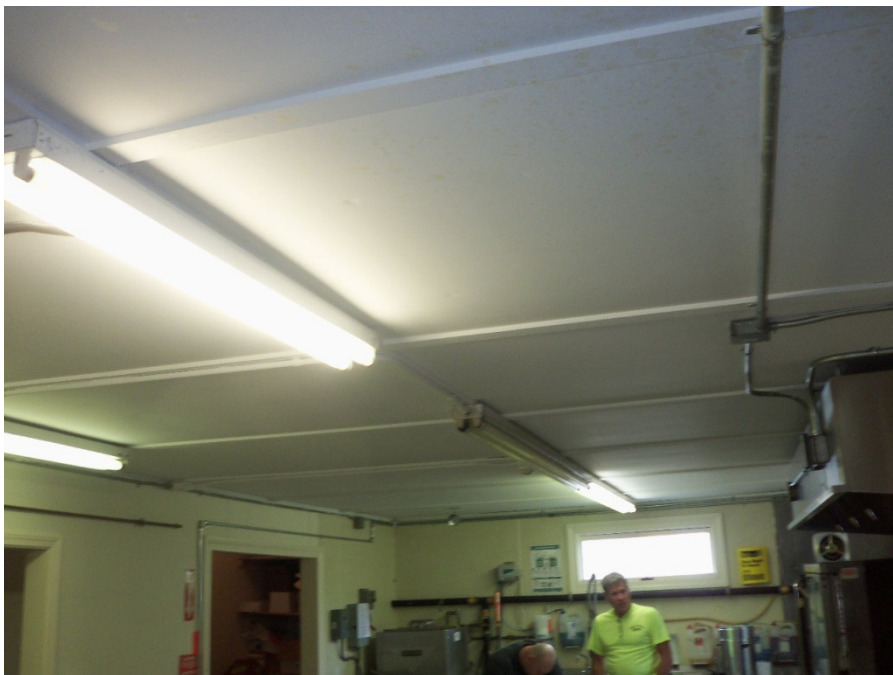
Photo CC-4: Exposed lamps

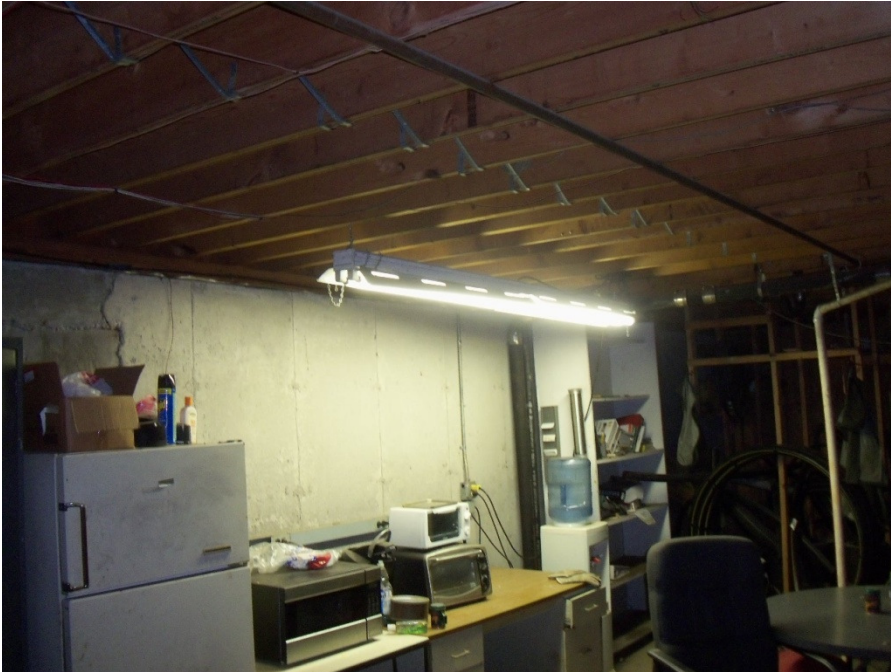
Photo CC-5: Basement Fixture

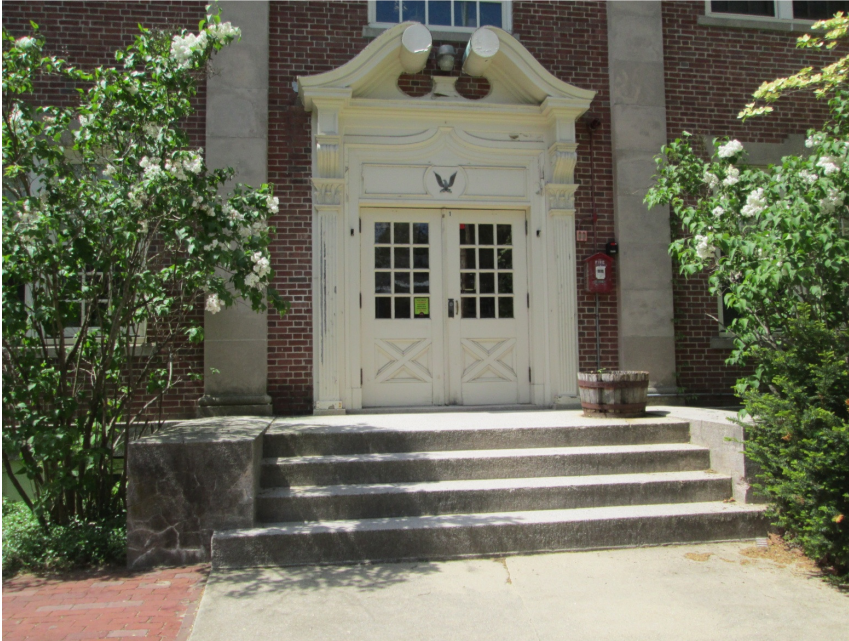
Photo PS4A: Main entrance is not accessible.

- g) New accessible ramp to the main entrance.
- h) Designated vehicular drop off area that is near the same level as the assessable building entrance. Seniors would benefit from being driven to the Senior Center by a friend, and to a designated drop off area that is near the accessible main entrance. With this arrangement, seniors or persons with mobility impairments can then navigate on their own from the automobile to the accessible building entrance.

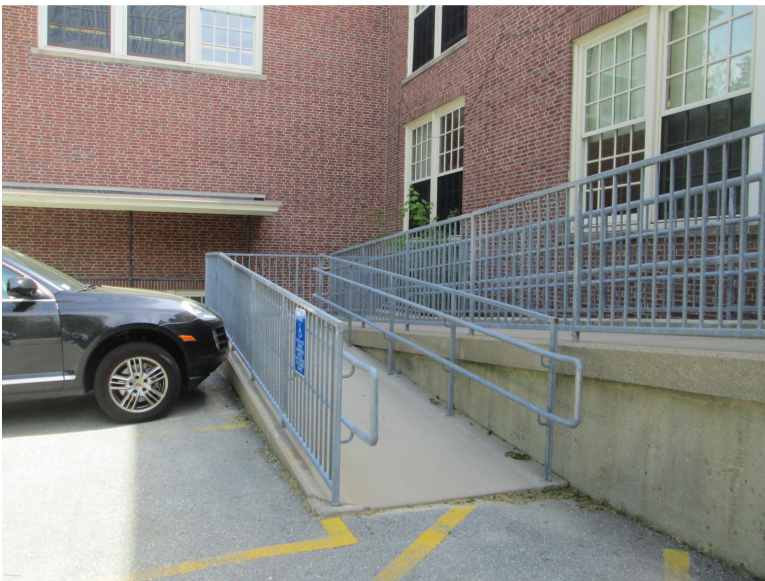
PS4B: Side entrance is equipped with an accessible ramp.

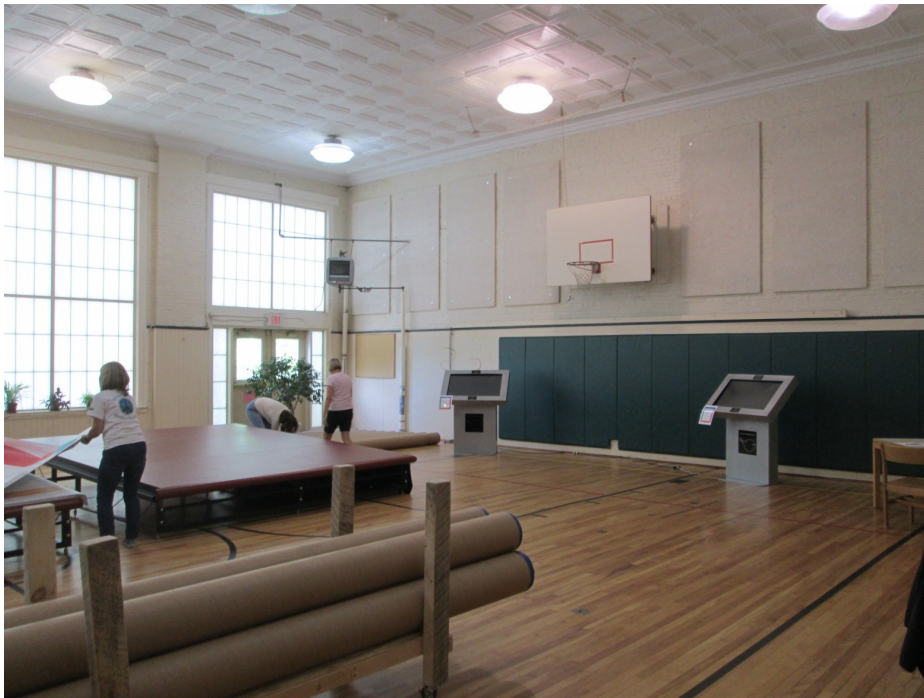
Photo PS8D: Building contains a large open gymnasium suitable for multipurpose activities.

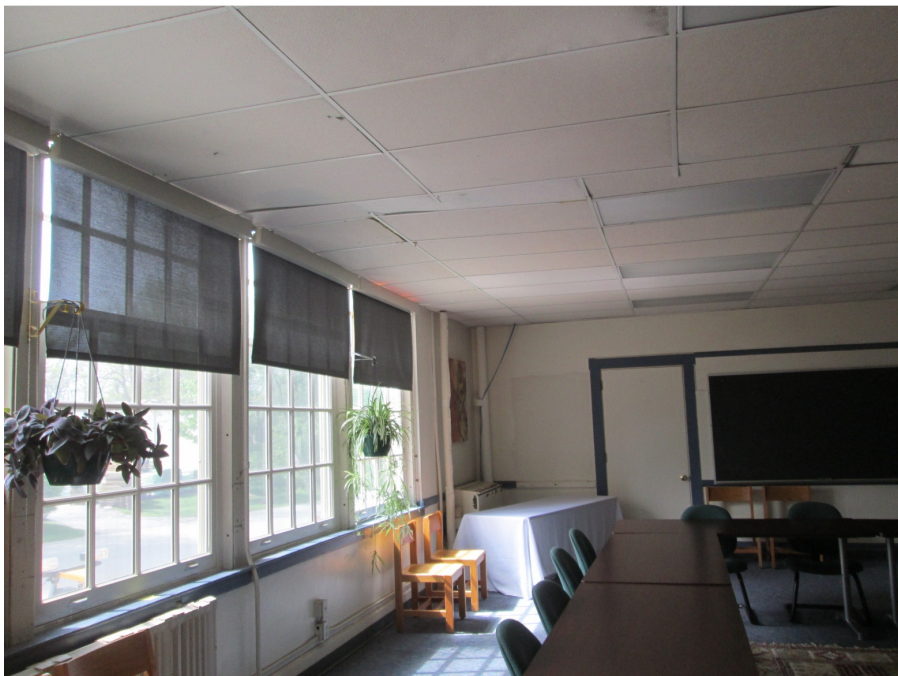
Photo PS8B: Building contains numerous individual spaces available to be programmed for senior activities.

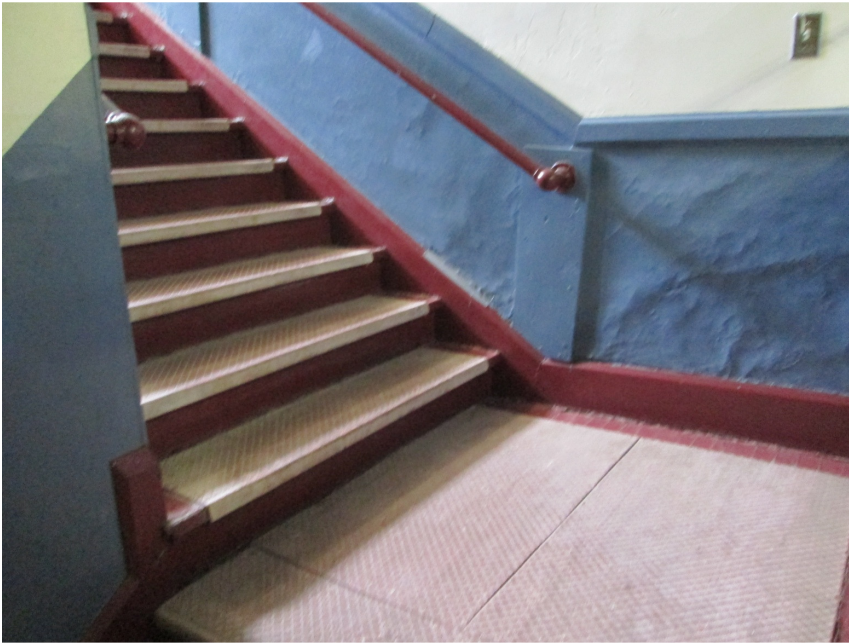
Photo PS4E: Non-compliant features include railings, varying riser heights, and projected stair nosings.

- i) At exterior stair to basement level, install new guard railings and stair railings.

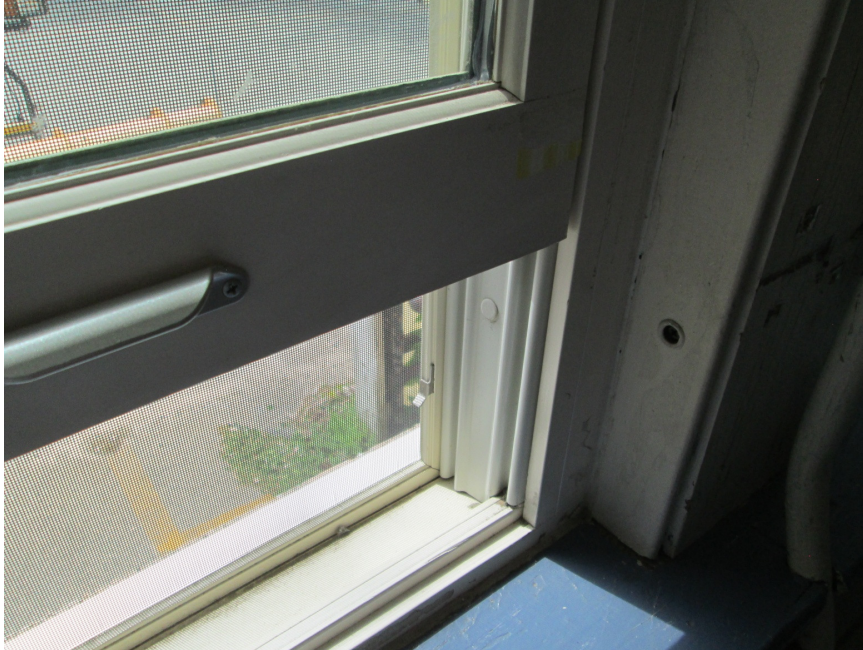
Photo PS8B: Entire building has been retrofitted with new energy saving insulated glass windows.

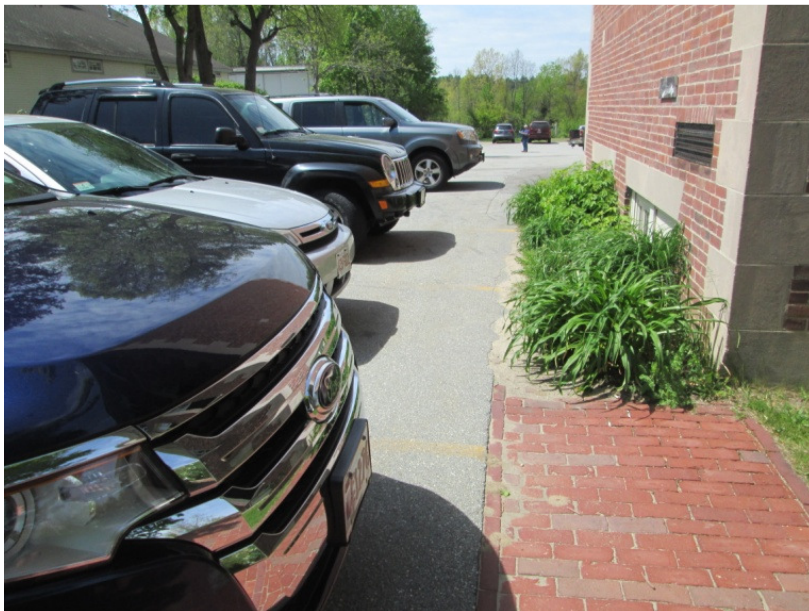
Photo PS9C: Near main entrance is level and could serve as accessible parking with small ramp to entry.

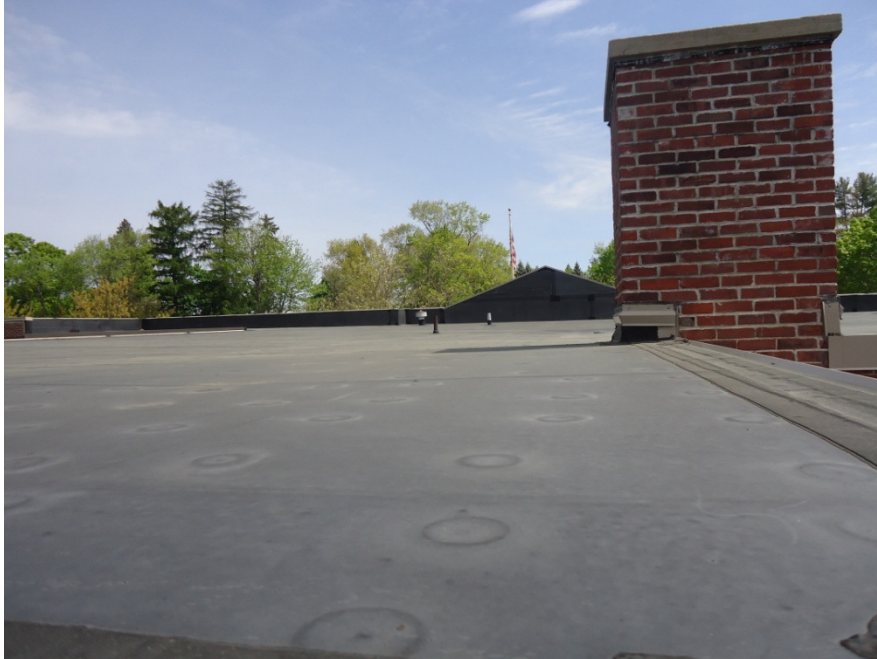
Photo PS7B: Roof is good condition.

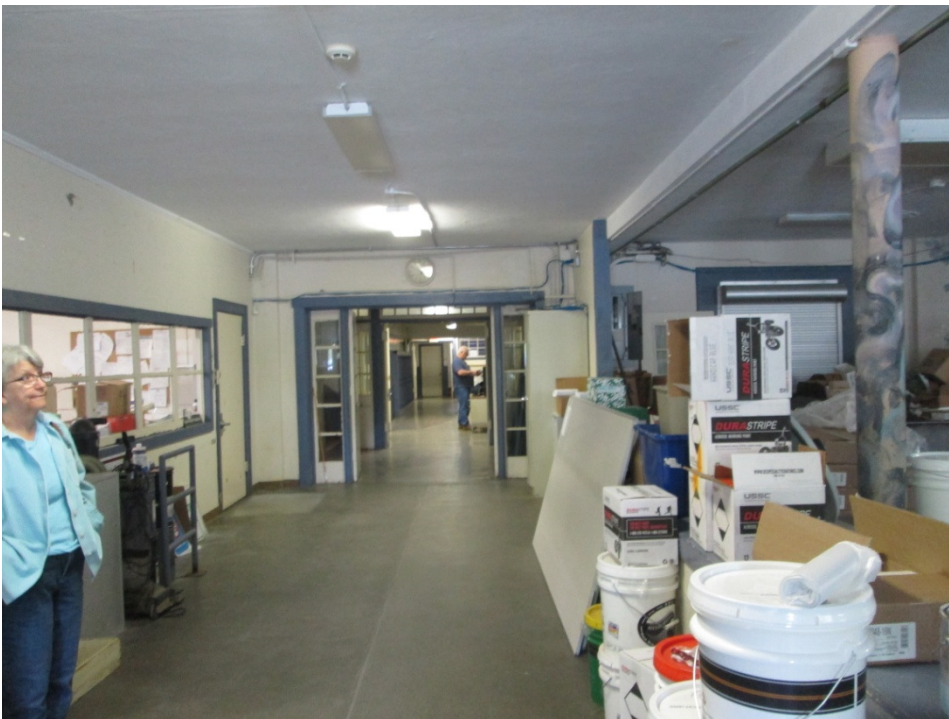
Photo PS5: Existing conditions at lower level.

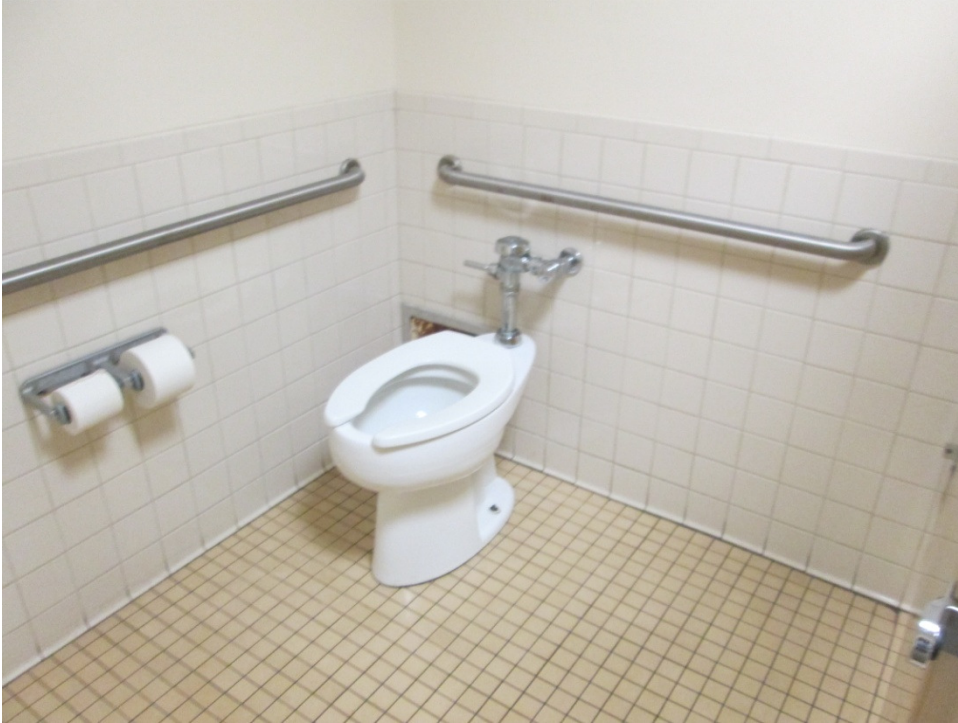
Photo PS4: Accessible toilet room facilities.

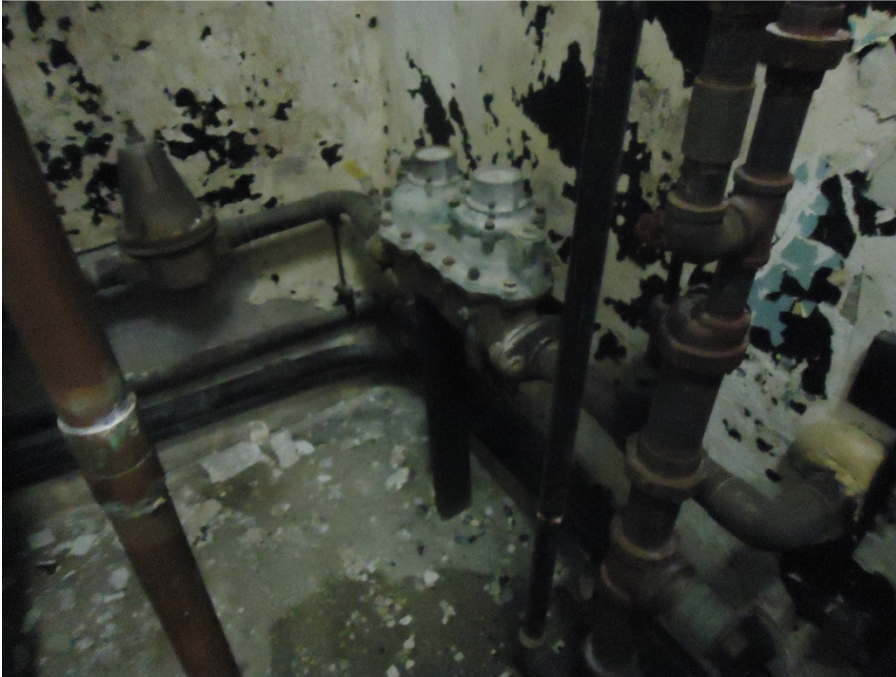
Photo PS3A: Incoming 2" Water Service with pressure reducing valve and backflow prevention.

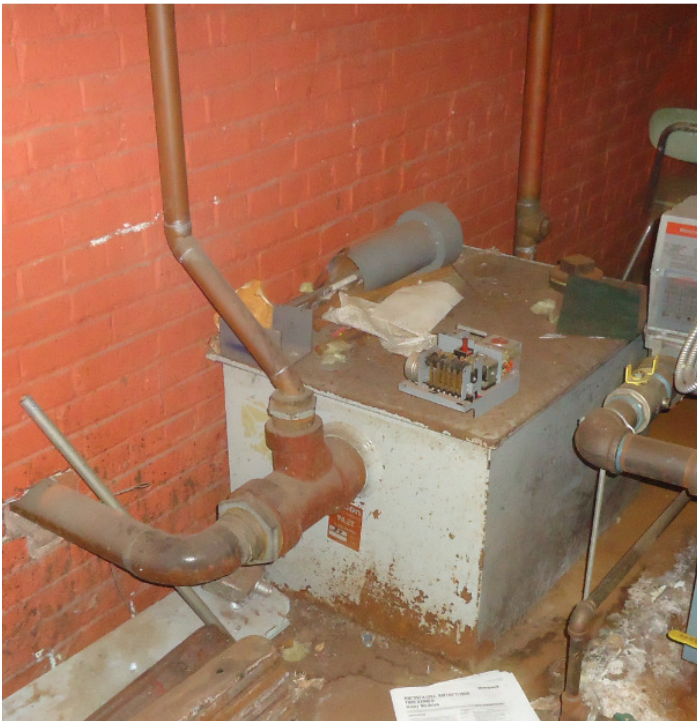
Photo PS3C: Existing Grease trap located in boiler room adjacent to kitchen.

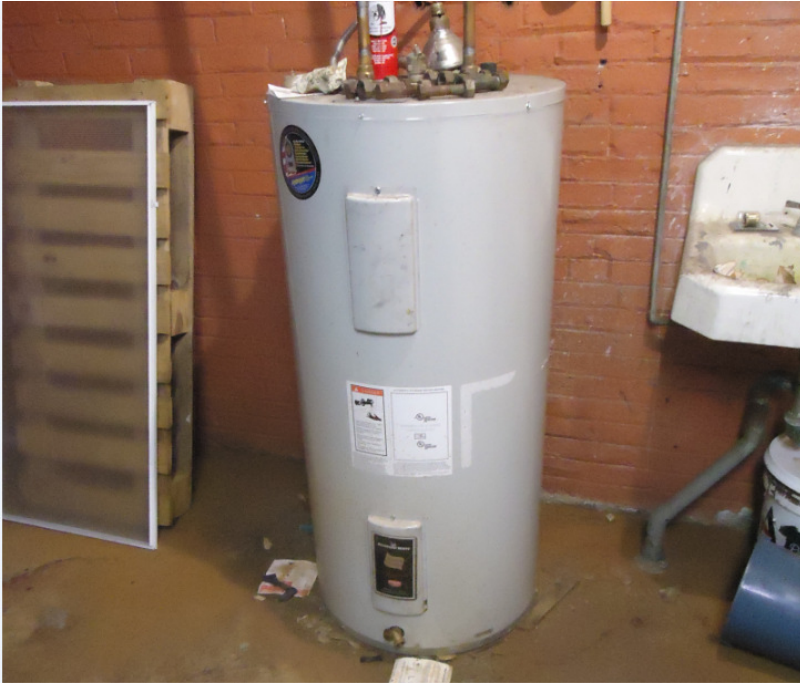
Photo PS3E: Existing Domestic Water Heater.

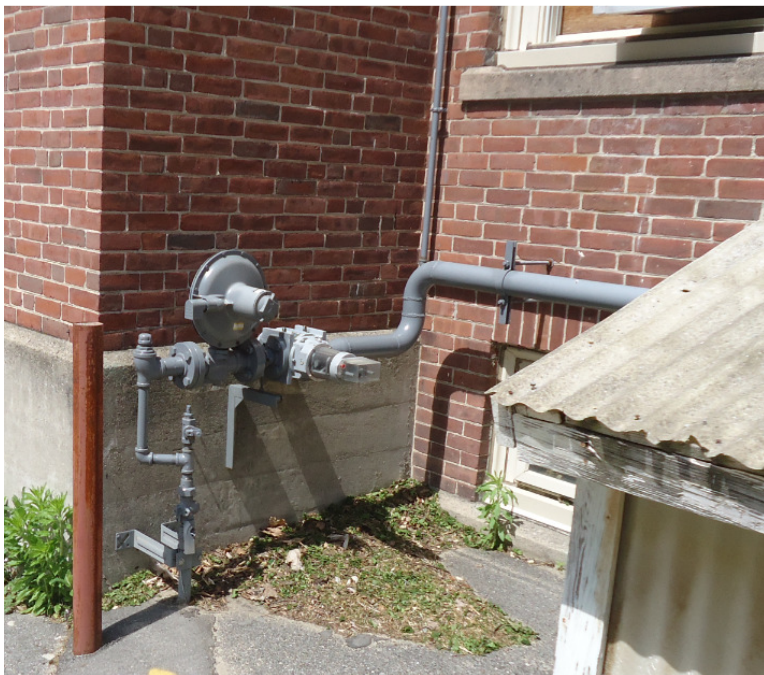
Photo PS3G: Existing Gas Service to the Building.

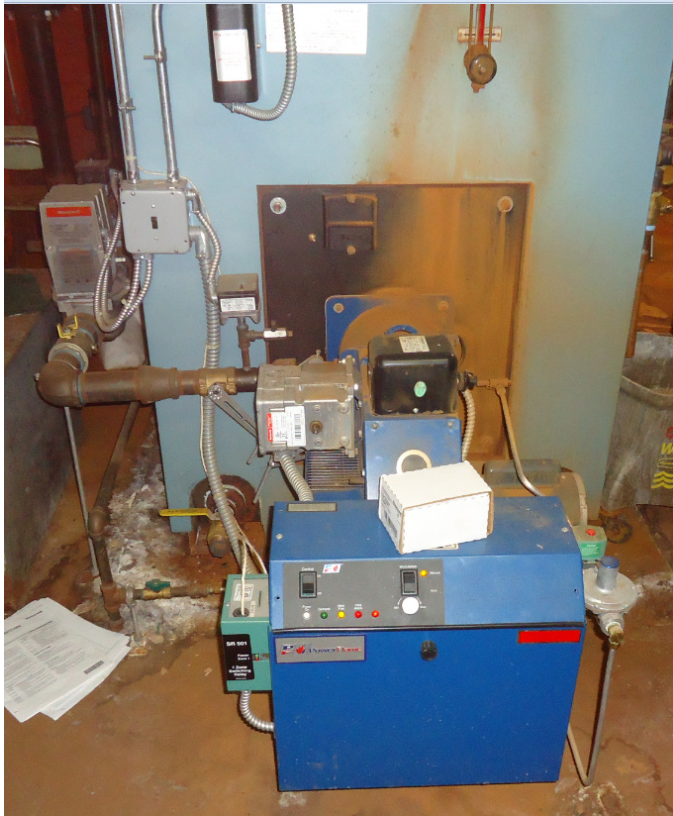
Photo PS4A: Existing Steam Boiler.

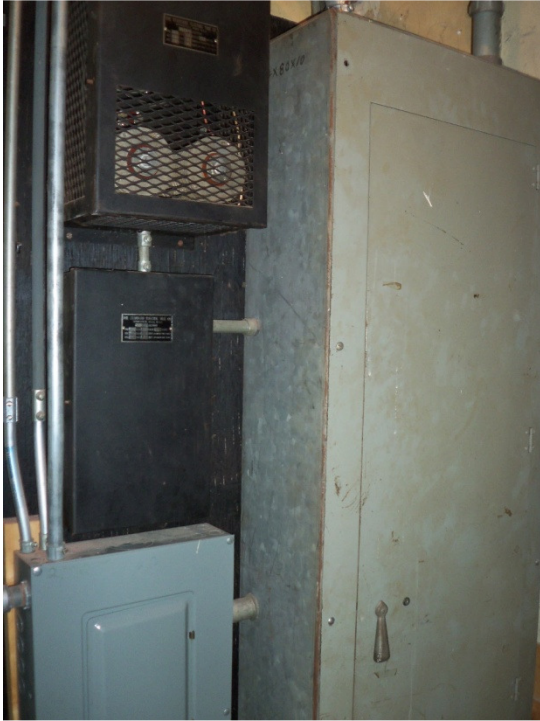
Photo PS-1: Service age and clearance

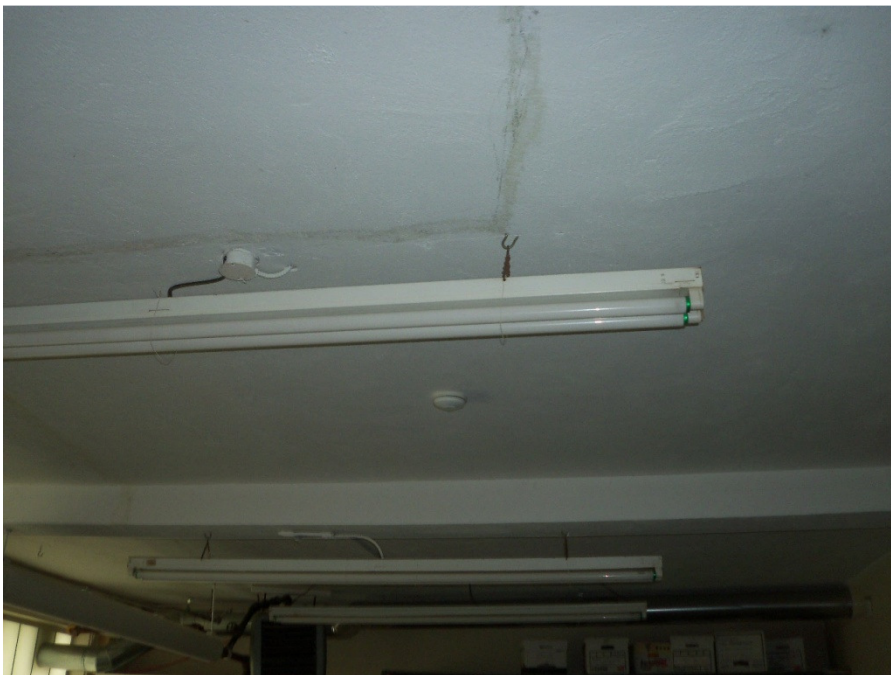
Photo PS-2: Exposed lamp fixture

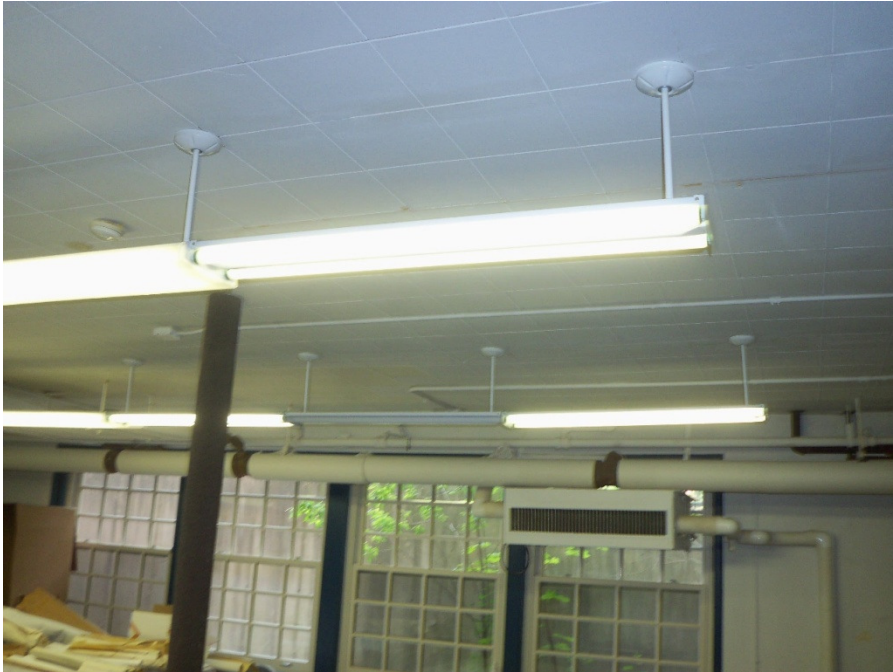
Photo PS-3: Pendant antiquated fixtures

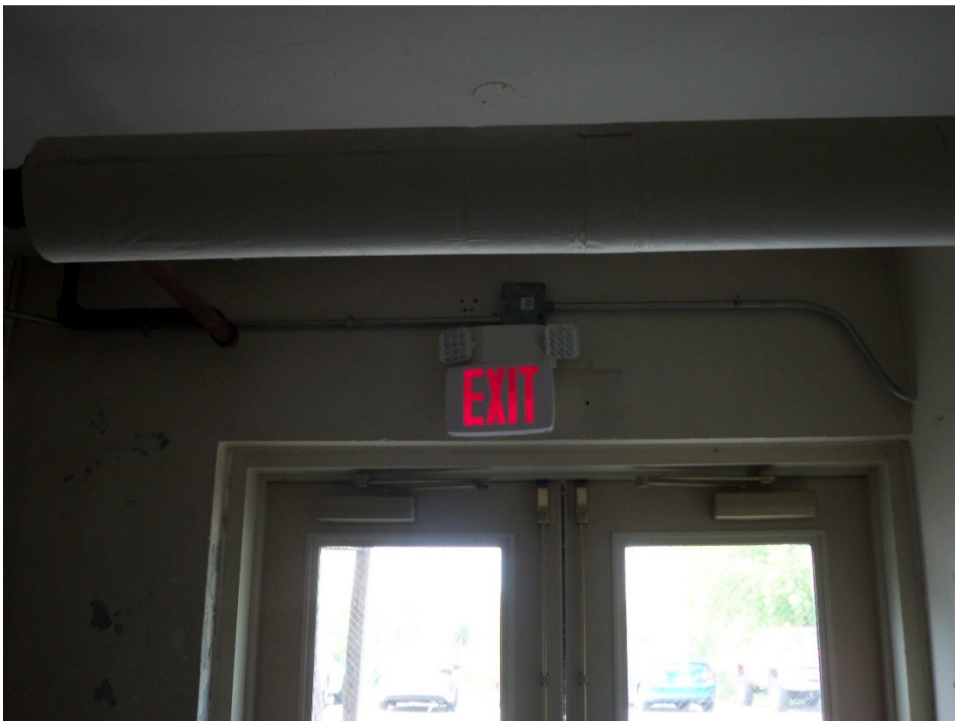
Photo PS-4: Egress Lighting

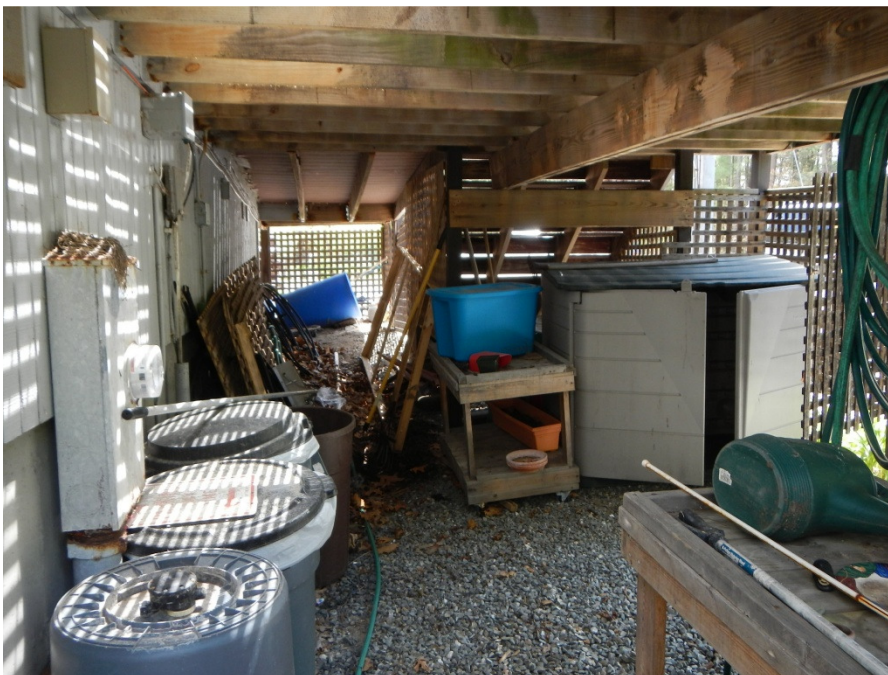
Photo GSC04: Storage below Main Entrance deck

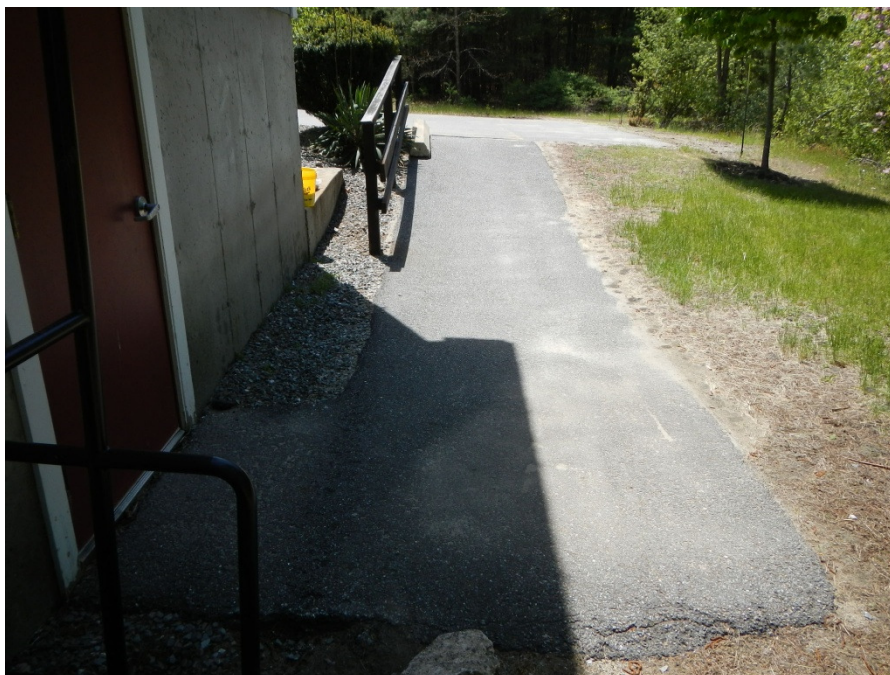
Photo GSC10: Non-Compliant accessible ramp to Lower Level

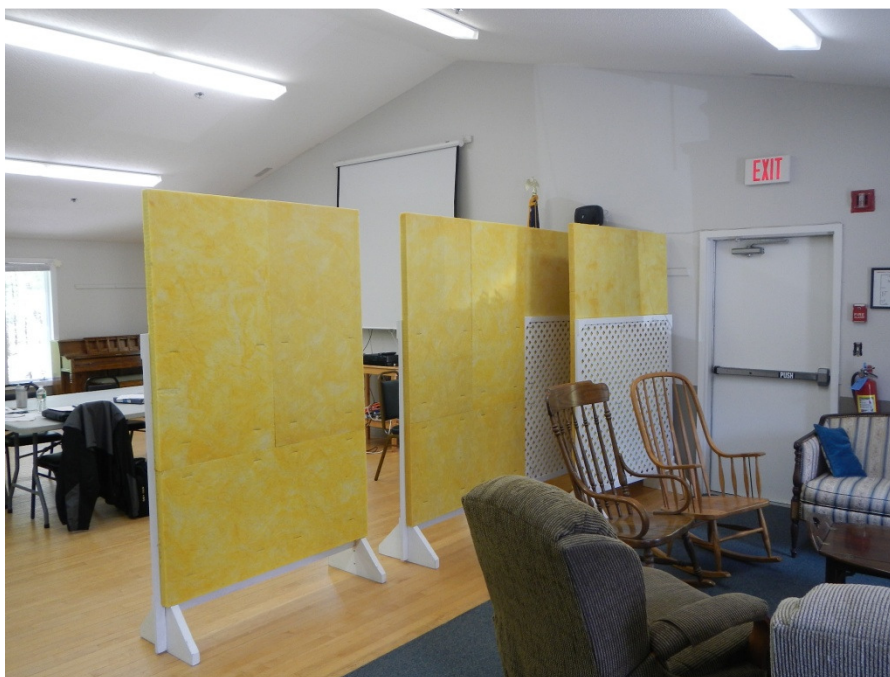
- a) Due to large contiguous Meeting Hall space to other functional areas there are poor acoustics between spaces and within the Meeting Hall. Acoustical treatments are insufficient and excess noise is a constant complaint of Seniors. Separation cracks in gypsum board joints observed at peak of Meeting Hall ceiling.
- b) Due to poor acoustics and multiple adjacent functions the main Hall cannot support multiple / simultaneous programs or activities.
- c) Similar to lower level there is insufficient storage space on the upper level and material and equipment storage occurs almost everywhere.
- d) There is insufficient program, activity and functional space on upper level to adequately provide services and requested programming and activities for all Seniors.

Photo GSC18: Temporary / Portable acoustical partitions in Meeting Hall

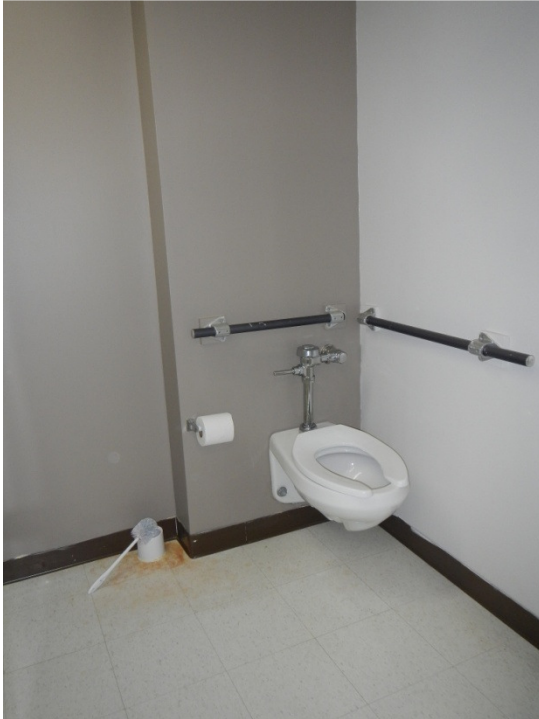
Photo GSC19: Non-Compliant Handicap Accessible Toilet

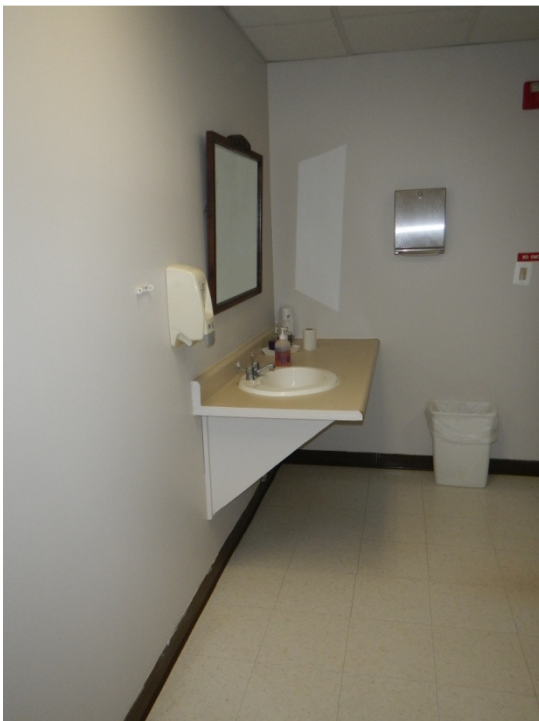
Photo GSC20: Non-Compliant Handicap Accessible Lavatory and Mirror

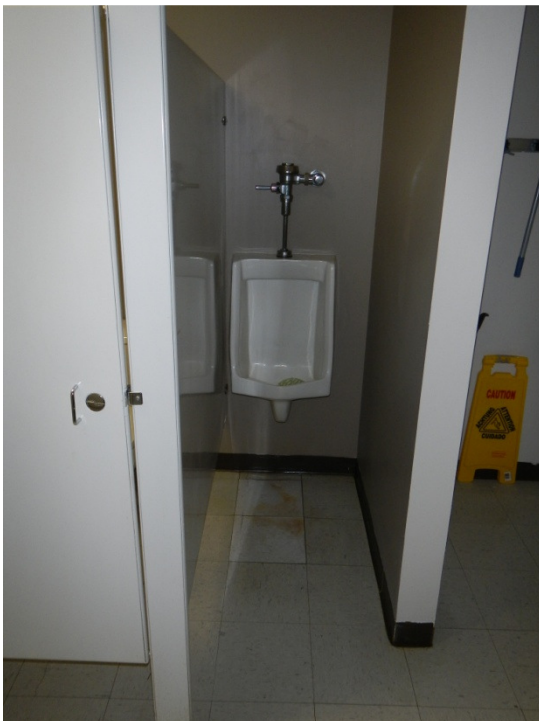
Photo GSC22: Non-Accessible Urinal

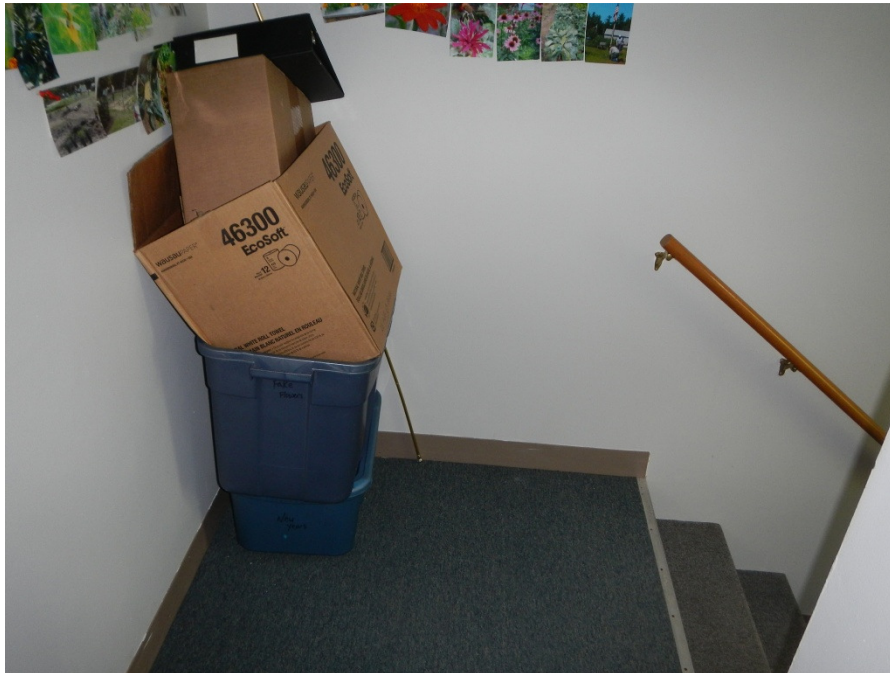
- d) Artwork is installed in interior stairwell and creates a code violation for an increased flame spread condition.
- e) Interior egress stairway is being used for storage which is a safety risk to occupants and a violation of code.

Photo GSC25: Interior Stair used for Storage

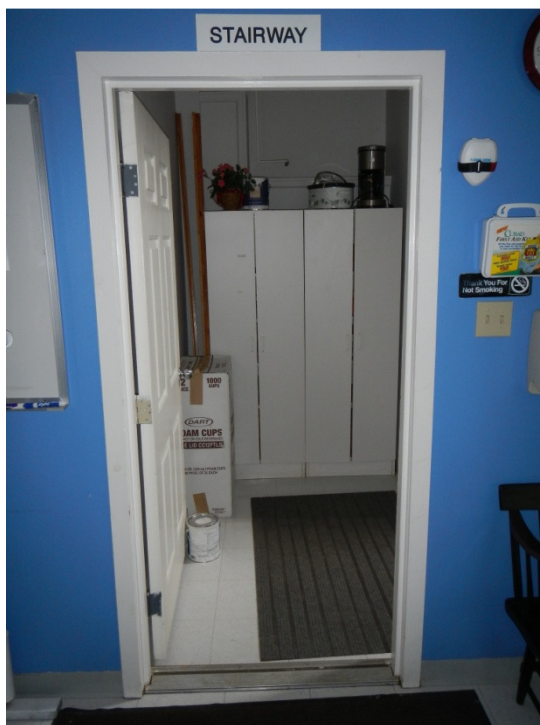
Photo GSC26: Interior stair used for Storage

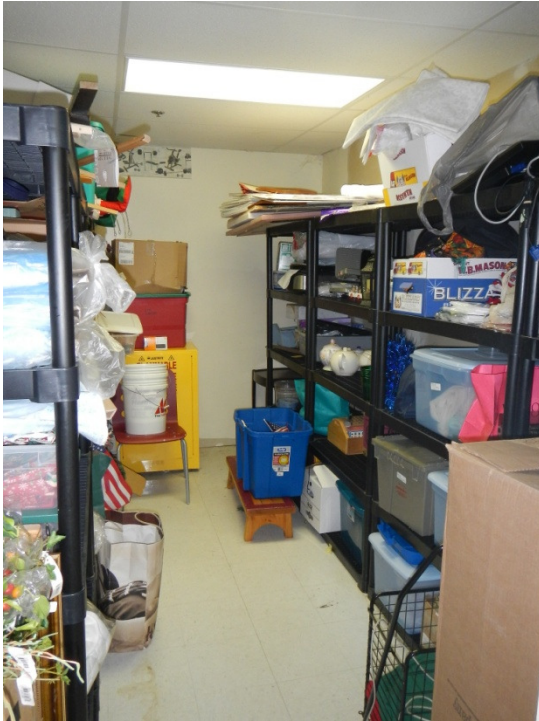
- a) Insufficient storage space requires material and equipment storage in program space.
- b) Insufficient program space does not allow for full or preferred programming.
- c) Lack of reasonable accessibility makes lower level under utilized. Minimum 8'-0" ceiling height limits possible programming and activities in larger multi-purpose area.
- d) Surrounding grade at doors is level or slopes toward building resulting in ponding water, icy conditions in winter, and ongoing deterioration of door thresholds and frames.

Photo GSC27: Lower Level Storage
