TOWN OF GROTON, MASSACHUSETTS

SENIOR CENTER FEASIBILITY STUDY

FINAL STUDY REPORT

October 3, 2016

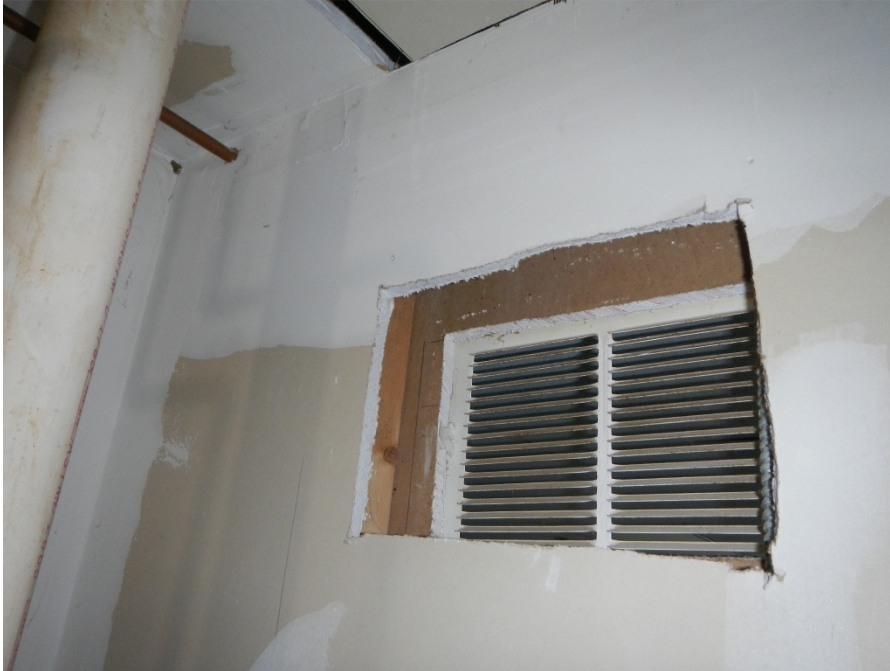
Photo GSC29: Unprotected opening in fire-rated wall construction

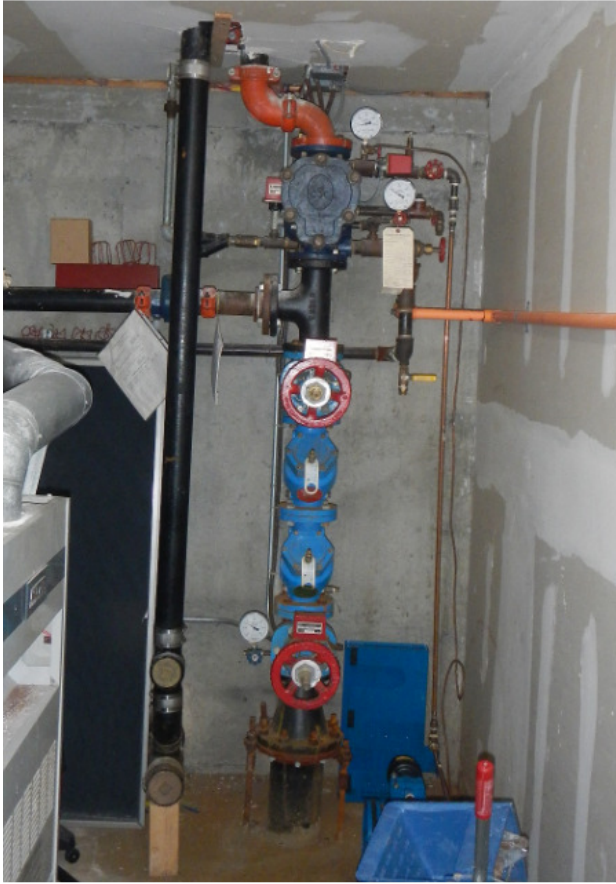
Photo GSC3A(1): Existing Incoming Fire Protection Service.
Also shows Existing Sanitary Exit from the Building Propped up by Wood

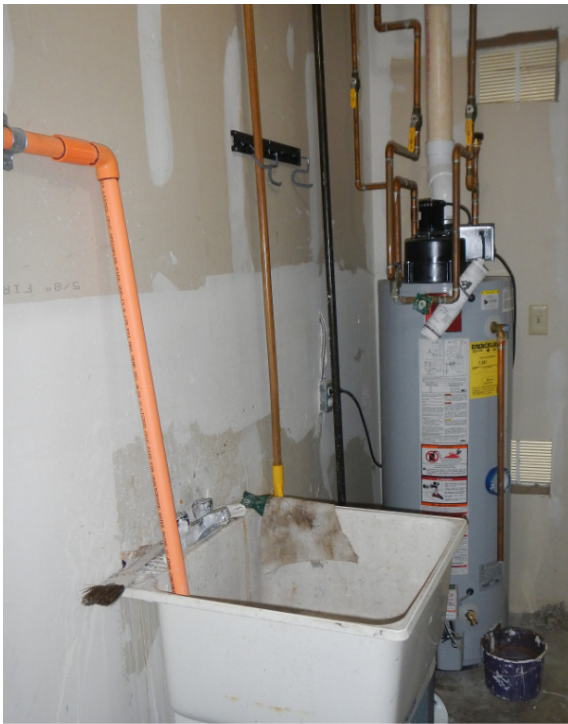
Photo GSC3B: Existing Domestic Water Heater. Note High and Low Openings into Adjacent Space for Combustion Air.

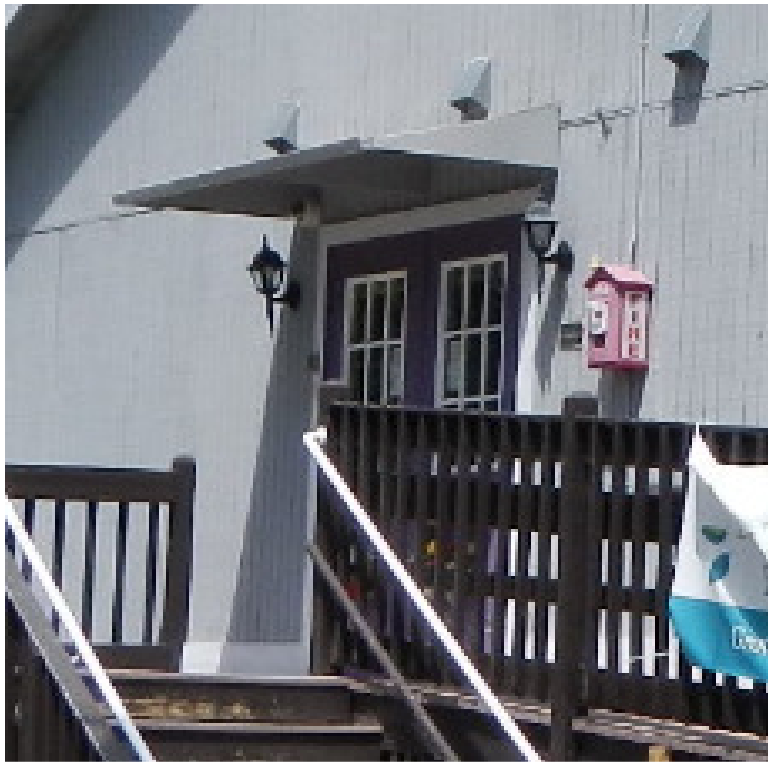
Photo GSC6D: Restroom Exhaust Terminating Over Entry of Building

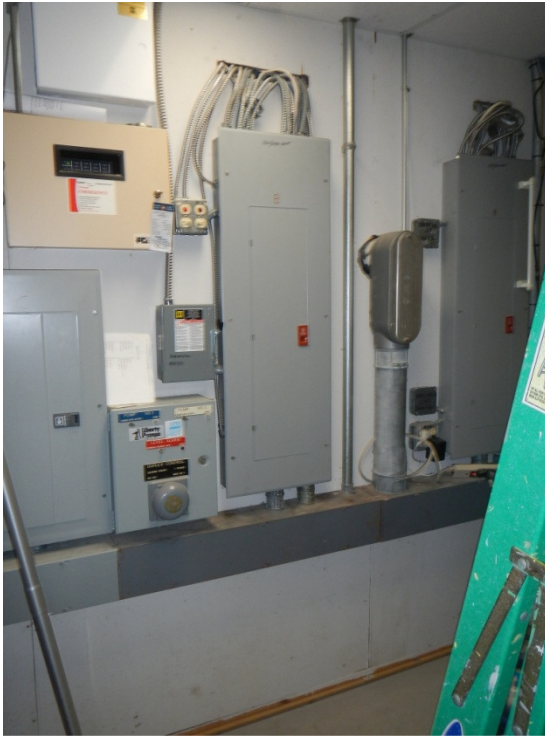
The main electrical disadvantage to existing Senior Center is the availability of 3-phase 15 KV power. The existing utility service is single phase, and would require 3-phase 15 KV voltage lines to be installed from the main road.

Photo GSC1: Existing Service

Upgrades to both electrical service and back-up power will have to be greater to accommodate the power requirement of an addition.

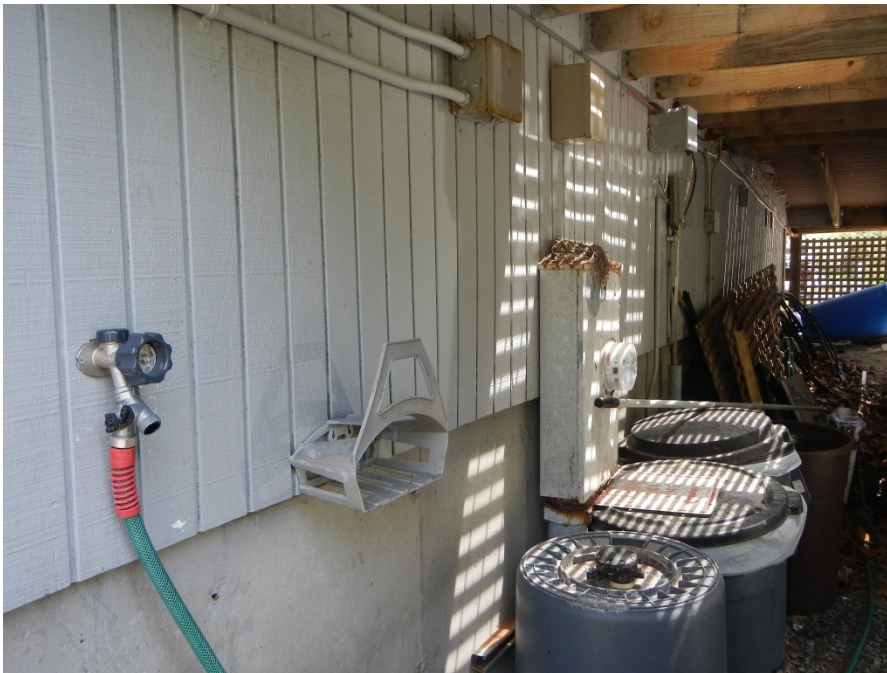
Photo GSC2: Existing Meter

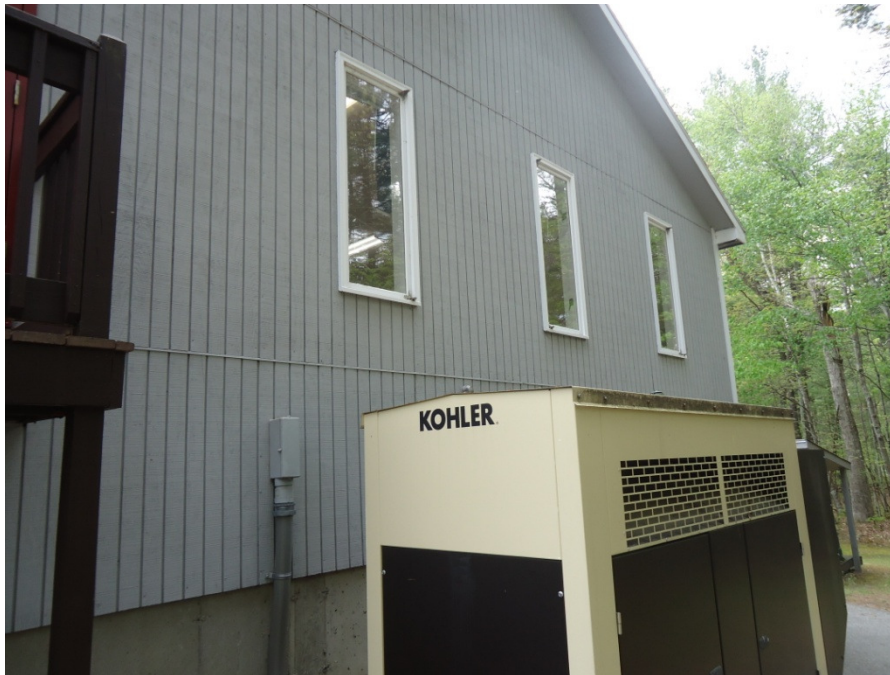
Photo GSC3 Existing Generator

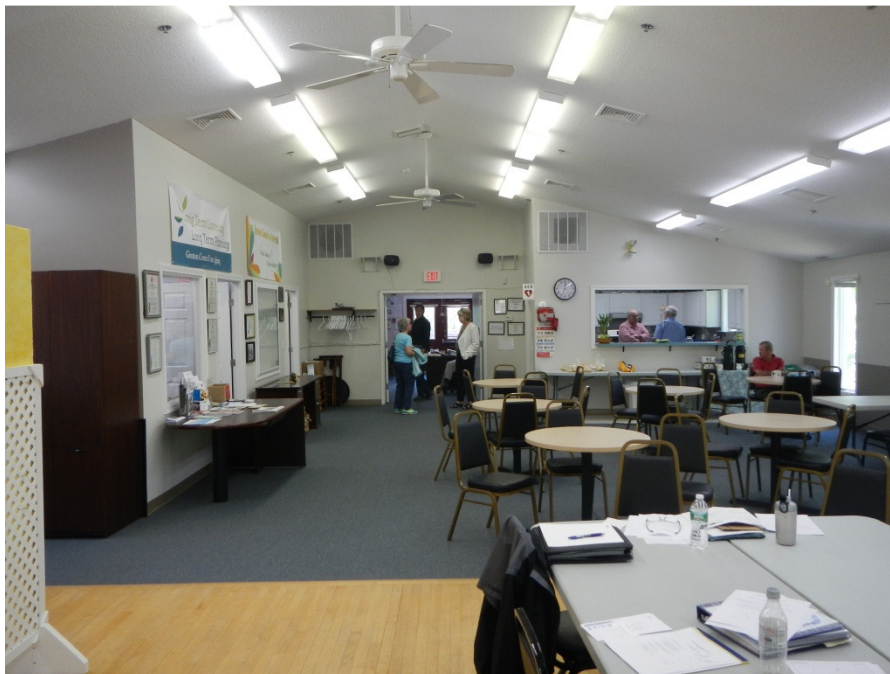
Photo GSC4: Existing Interior lighting

1.	Replace lighting fixtures with exposed lamps	2,000.
2.	Upgrade existing egress lighting for code compliance	3,000.
3.	Upgrade existing Fire Alarm System for code compliance	4,500.
4.	Upgrade exterior lighting	5,000.
5.	Miscellaneous Electrical repairs	5,000.
6.	Utility cost for service upgrade for Elevator	40,000.
7.	Upgrade distribution system to 3-Phase 600A 120/208V	36,200.
SUB-TOTAL		\$ 560,900.

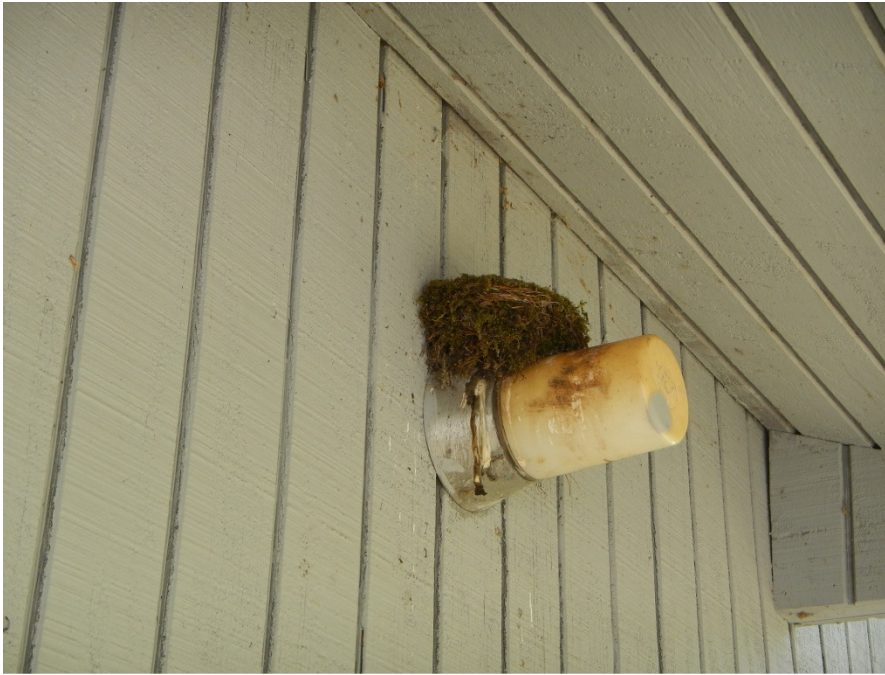
Photo GSC5: Existing Exterior Lighting

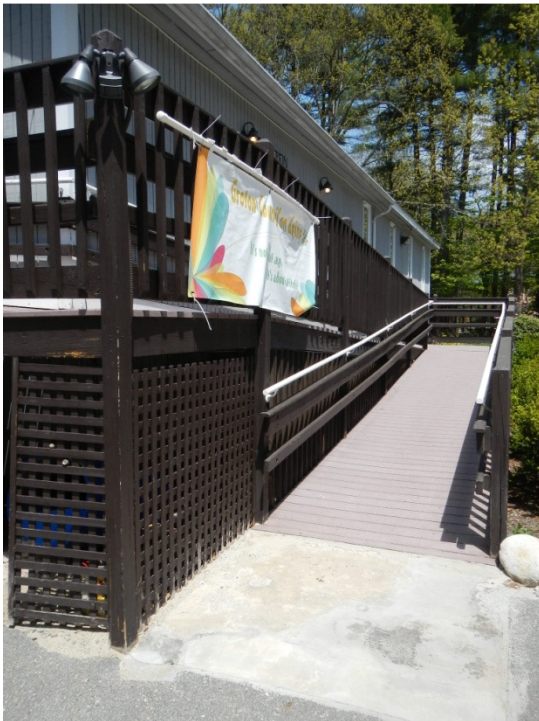
Photo GSC6: Exterior Egress Lighting

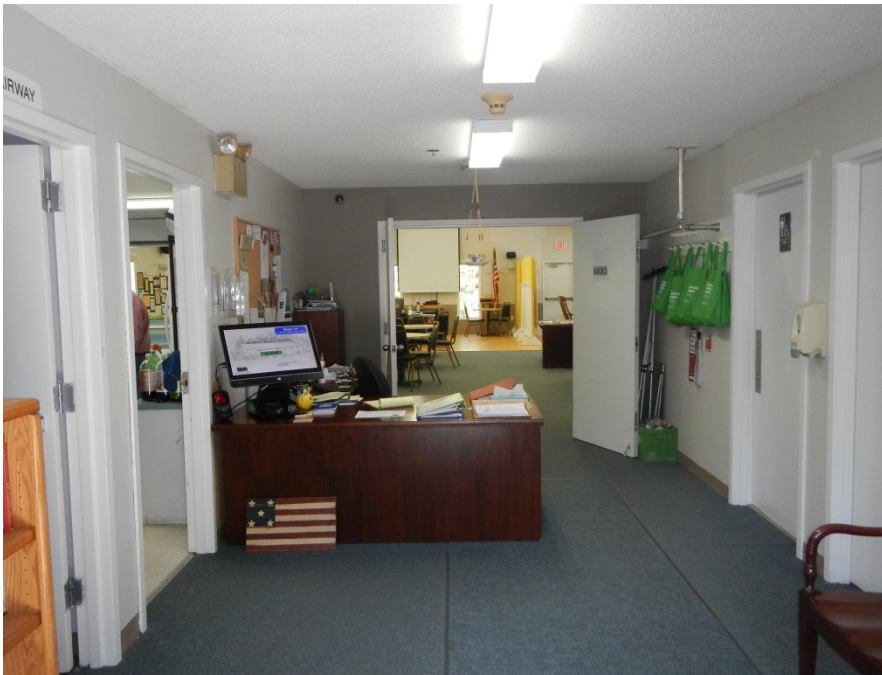
Photo GSC7: Fire alarm and Egress lighting
